Section 19 Flood Investigation

July 19th 2017 Floods

Alex Bebbington & Paul Owen
7 March 2018

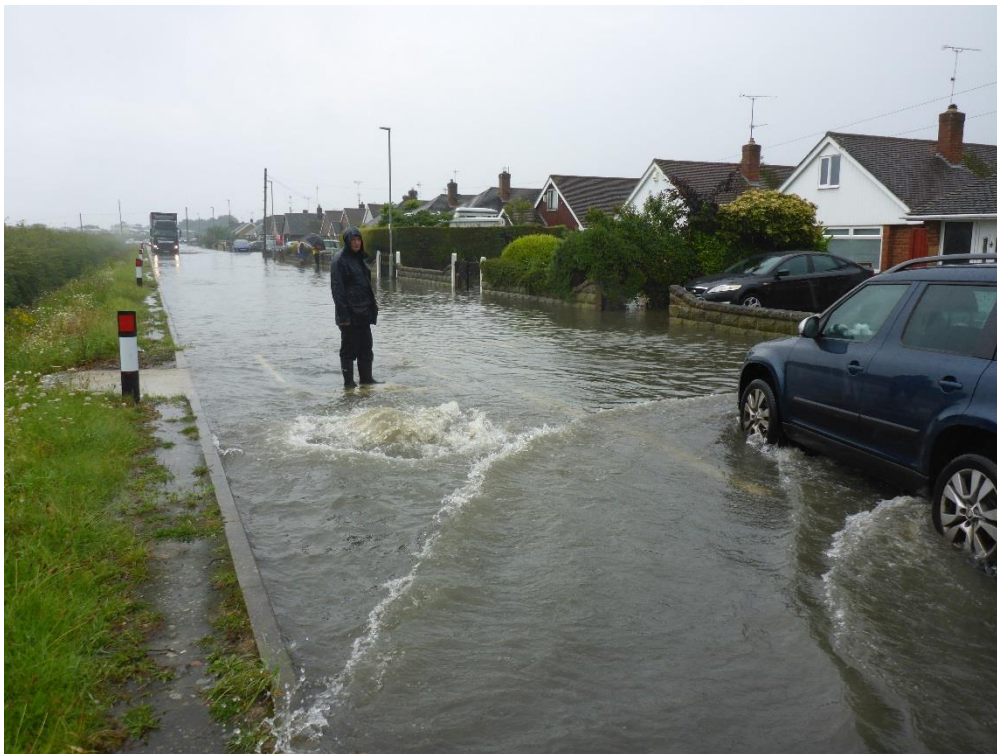
Figure 3 – Surcharging manhole cover on Ffordd Derwen

Surface water flood maps provided by Natural Resources Wales show that Ffordd Derwen is at risk of surface water flooding, with properties being particularly susceptible due to their relatively low elevation compared to surrounding areas, including the highway. Improvements were made to the

highway drainage system following a similar flooding event in July 2016, however the scale of the rainfall caused the improved drainage system to be overwhelmed.

Denbighshire County Council appointed consultants in November 2017 to carry out a drainage study which will examine the cause of flooding, the likelihood of reoccurrence, and make recommendations to reduce flood risk in future.

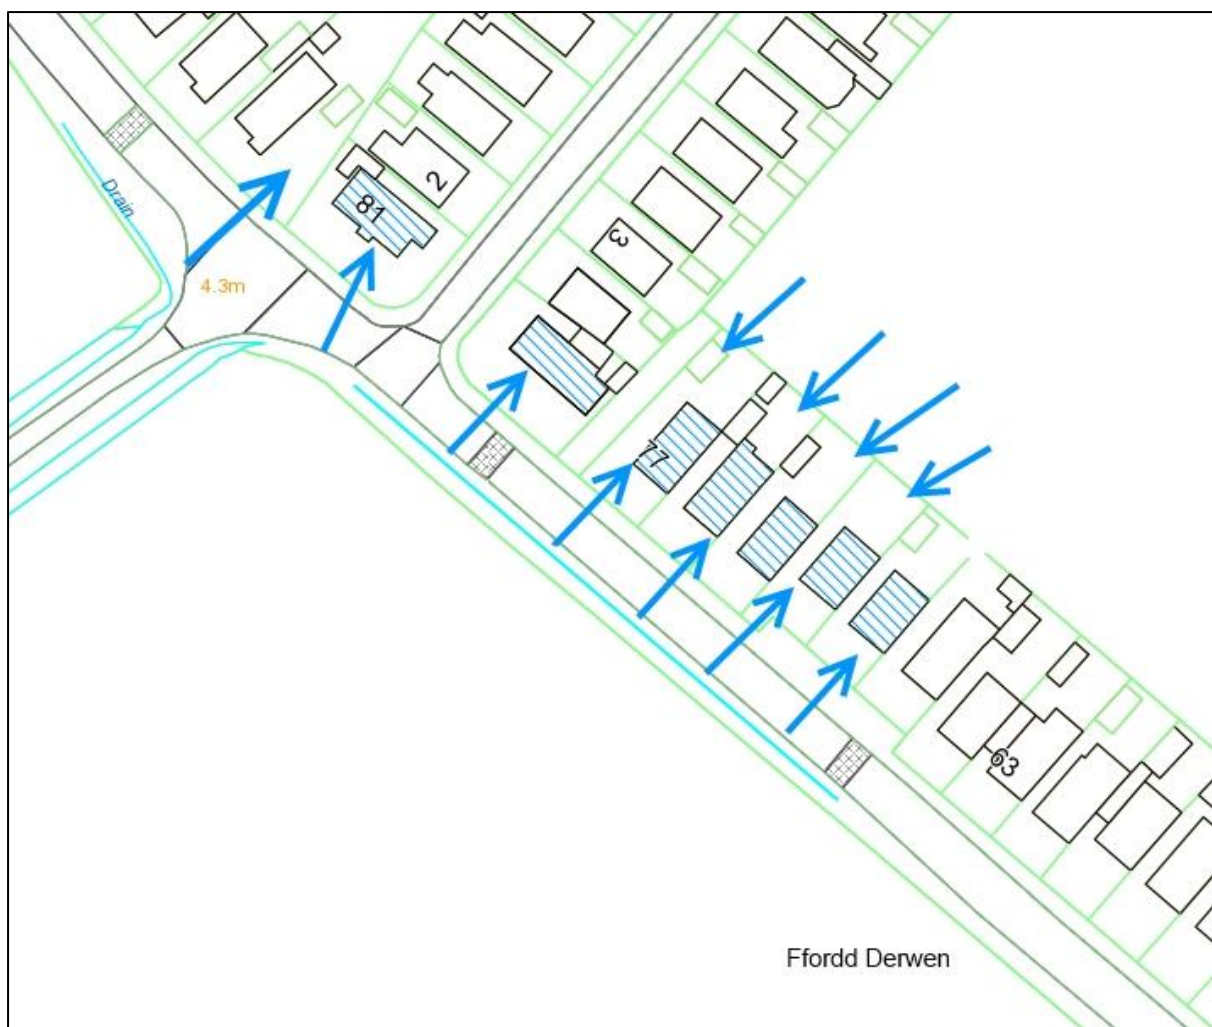
Figure 4 - Predominate source of flooding was surface water accumulating on highway as well as water coming in from rear of the lowest lying properties.

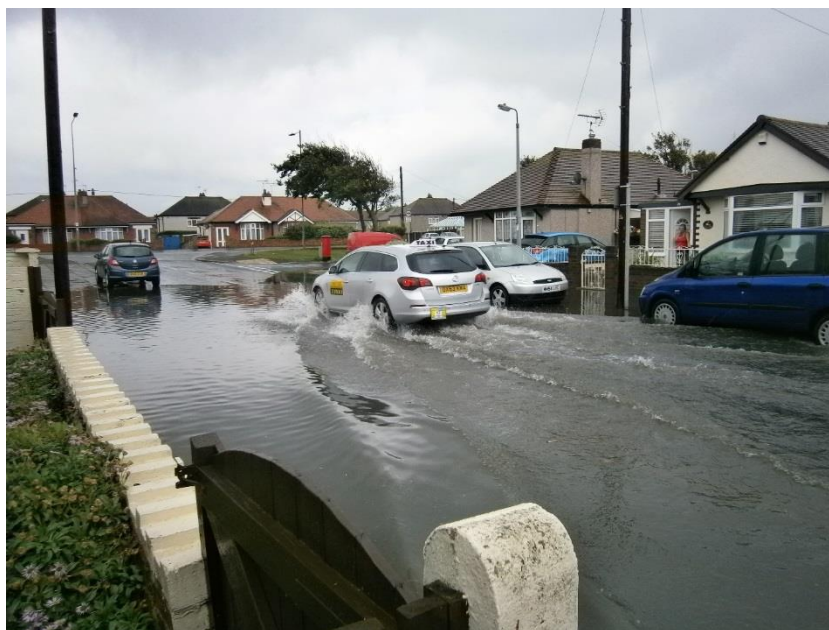
A combination of hydraulic overload exacerbated by Dŵr Cymru Welsh Water pumping station failure serving the combined sewer system coupled with the intense rainfall led to flooding along the front of properties on Coast Road and the southern end of Garford Road. As water accumulated on the highway in front of properties, the lowest parts of this area became inundated. Predominately water entered the properties via low lying garage door entrances and open air bricks. Internal flood damage to properties was minimal, however it is noted that the extent of the flooding was exacerbated by vehicles travelling along the flooded highway and creating waves. Dŵr Cymru Welsh Water has carried out hydraulic modelling investigations which have confirmed that the primary cause of flooding was that the sewer network was hydraulically overloaded and couldn't cope with flows. Flooding would still have occurred had the pumps been fully operational.

Figure 5 – Accumulation of water on highway at Garford Road, Rhyl

Currently Dŵr Cymru Welsh Water is reviewing the resilience of its pumping station assets and combined sewer network in this area. Dŵr Cymru Welsh Water has a duty to provide and maintain a system of public sewers so that the areas for which they are responsible are effectually drained (Water Industry Act, 1991). Sewerage systems are not, however, designed to accommodate flows from severe weather events.

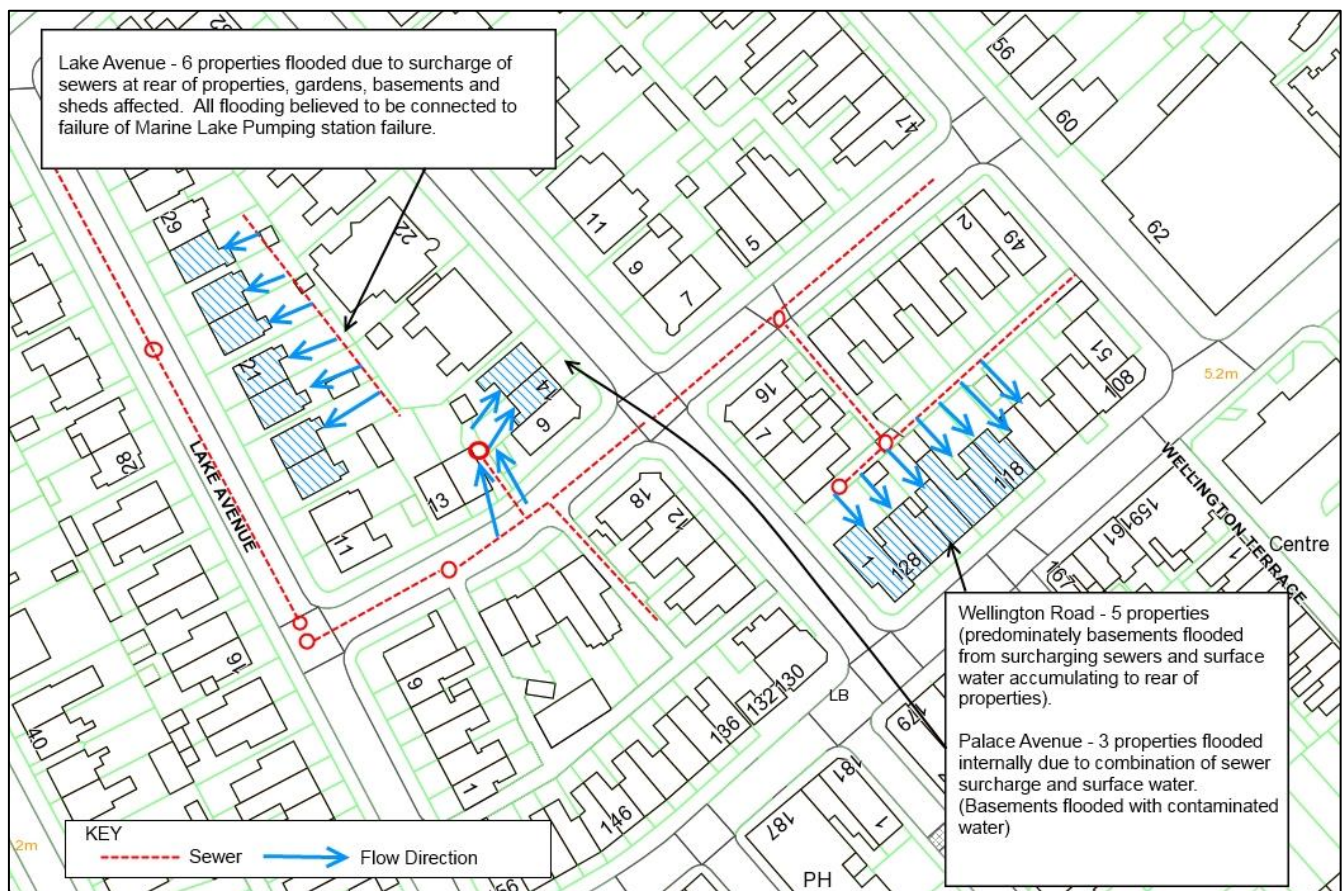
Figure 6 – Overview of combined sewer network which surcharged and caused flooding to properties

Upon investigation of the matter it was evident that the majority of flooding impacted upon properties through flood water entering lower ground basements and cellars. Dŵr Cymru Welsh Water has advised the Council that the primary cause of flooding was that the sewer network was hydraulically overloaded and couldn't cope with flows.

Dŵr Cymru Welsh Water has carried out works to address matters at these locations, and is continuing to improve the capacity of the combined sewer system to manage flood risk in the future.

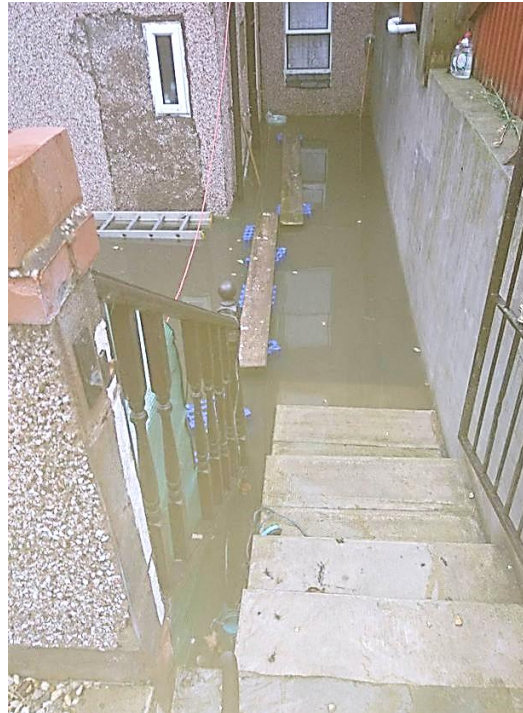
Figure 7 – Rear of Properties along Wellington Road suffered flooding due to a combination of surcharging combined sewer systems and surface water.

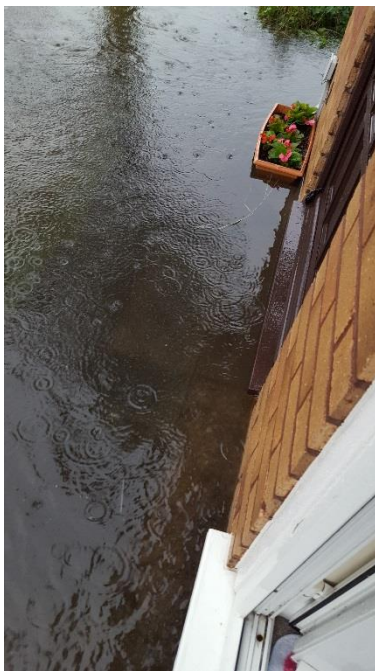
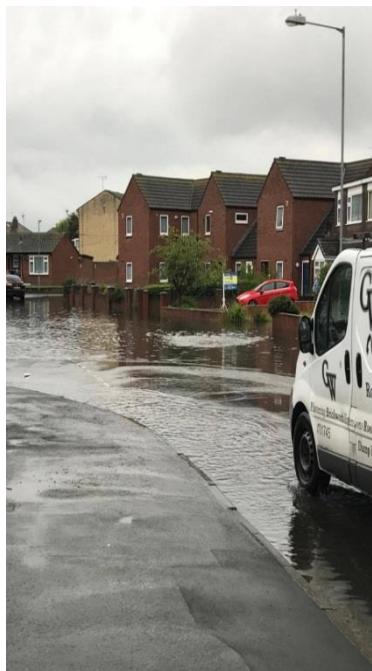
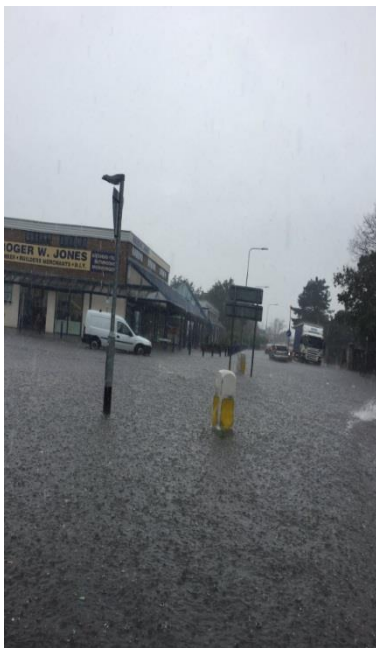
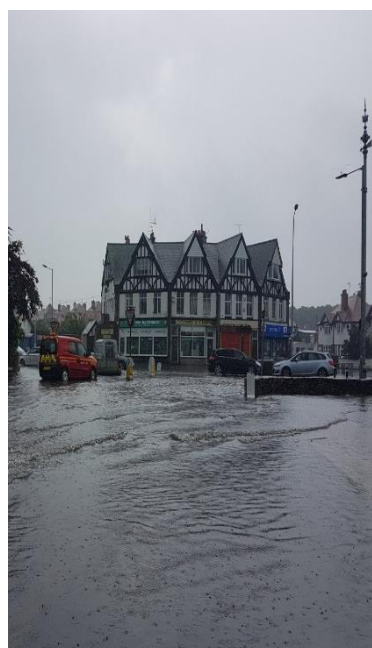
Prestatyn **Figure 8 – (Top Left – Flooding on Fern Walk, Top Right Flooding on Pen Y Maes, Bottom left Flooding on Cefndy Road, Bottom Right, Flooding on Vale Road)**

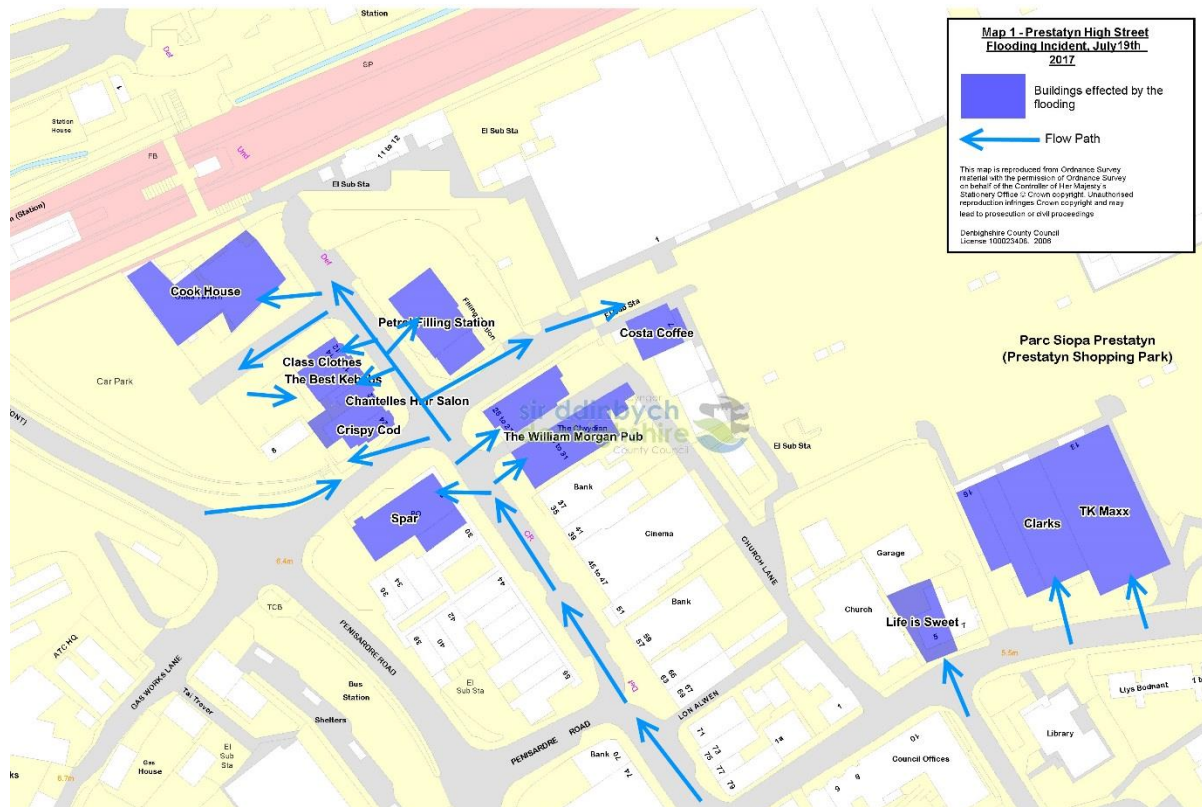
A number of factors are believed to have contributed to the severity of flooding at this location. However, the overarching cause is likely to have been hydraulic overload of the surface water drainage system as a consequence of the intensity of the rainfall event.

The topography of Prestatyn High Street acts to convey floodwater to the open area at the northern end the high street which acts as a bowl. Here the water ponds and the drainage systems in place were unable to convey the excess water away quickly enough leading to flood water ingress via the doorways of properties.

Figure 9 – Lower Prestatyn High Street and Shopping Park – Properties Flooded

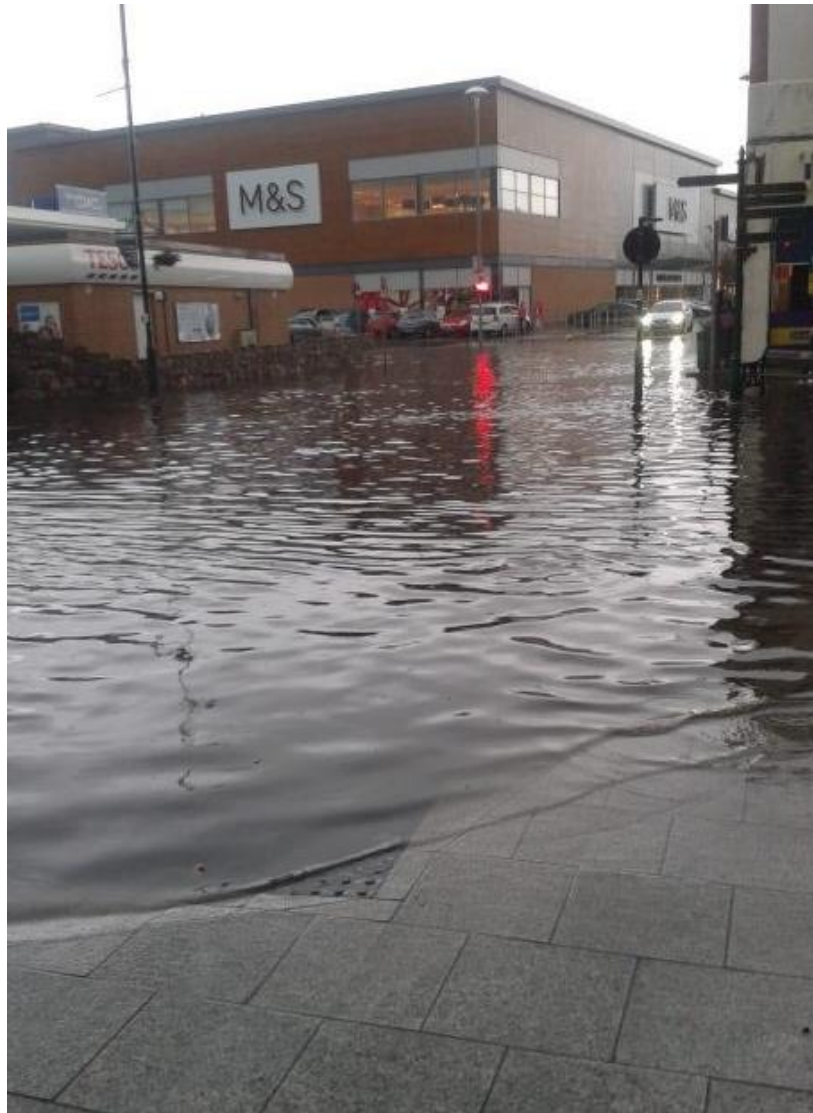
Figure 10 – Extensive accumulation of surface water on lower end of Prestatyn High Street

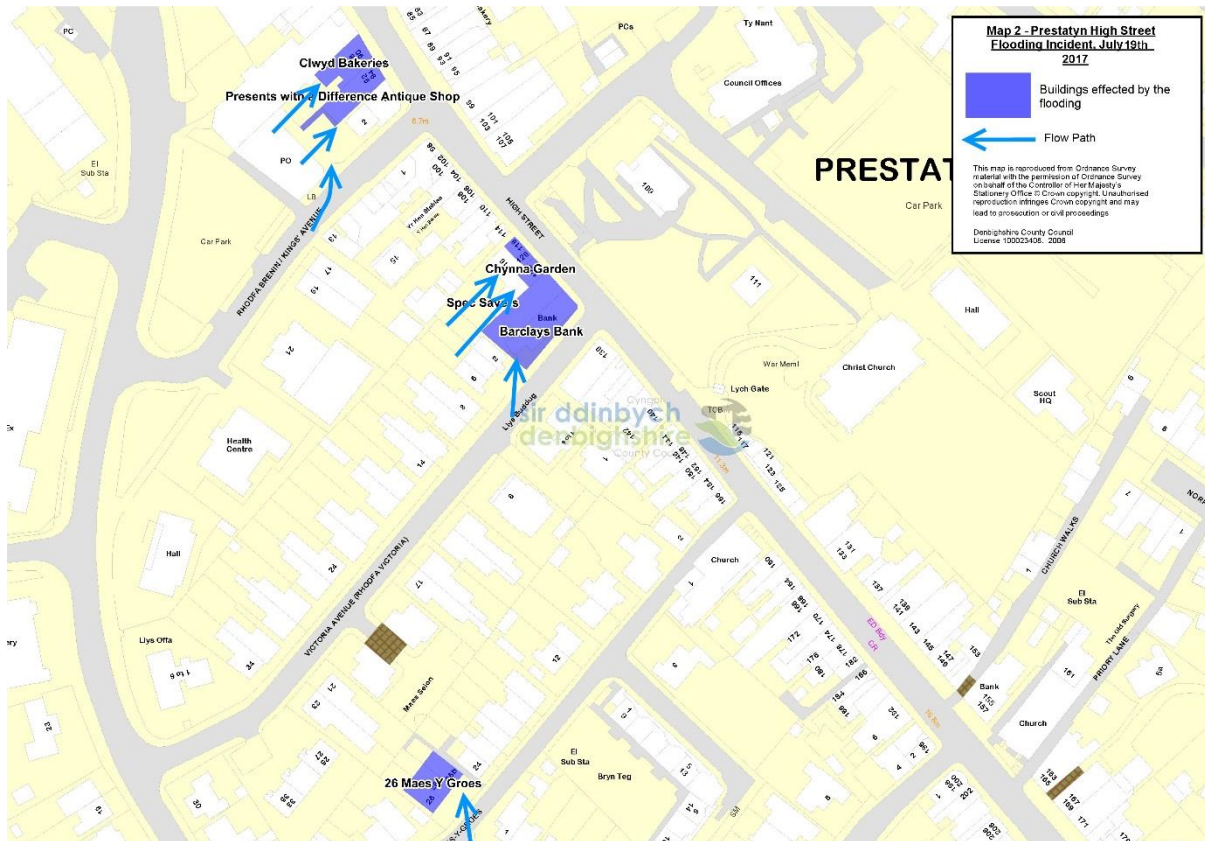
Figure 11 – Prestatyn High Street / Maes Y Groes – Properties Flooded

Incidences of flooding were also reported across other parts of the high street, to businesses and residential properties. Upon investigation, it was found that the businesses had flooded from private drainage systems failing, and excess surface water entering the properties from the rear.

On Maes y Groes road, excess surface water flowed directly into properties through front door entrances, due to the properties having floor levels at a lower elevation to the highway.

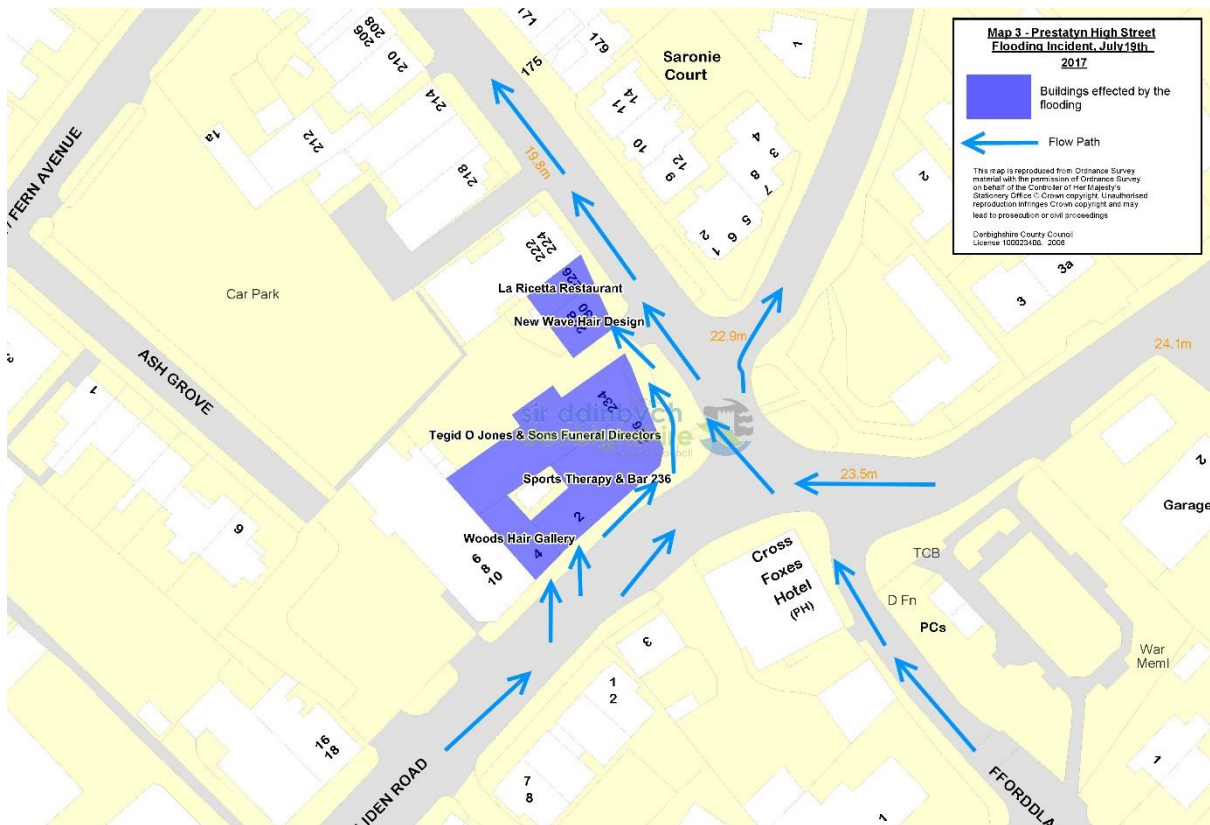
Figure 12 – Upper Prestatyn High Street – Properties Impacted by Flooding

Localised flooding also occurred at the top (south end) of Prestatyn High Street also. Upon investigation, it is considered likely that surface water accumulated on the footway between the highway and properties affected, as a result of the drainage system on Meliden Road becoming surcharged. Flood water entered properties through the front doors.

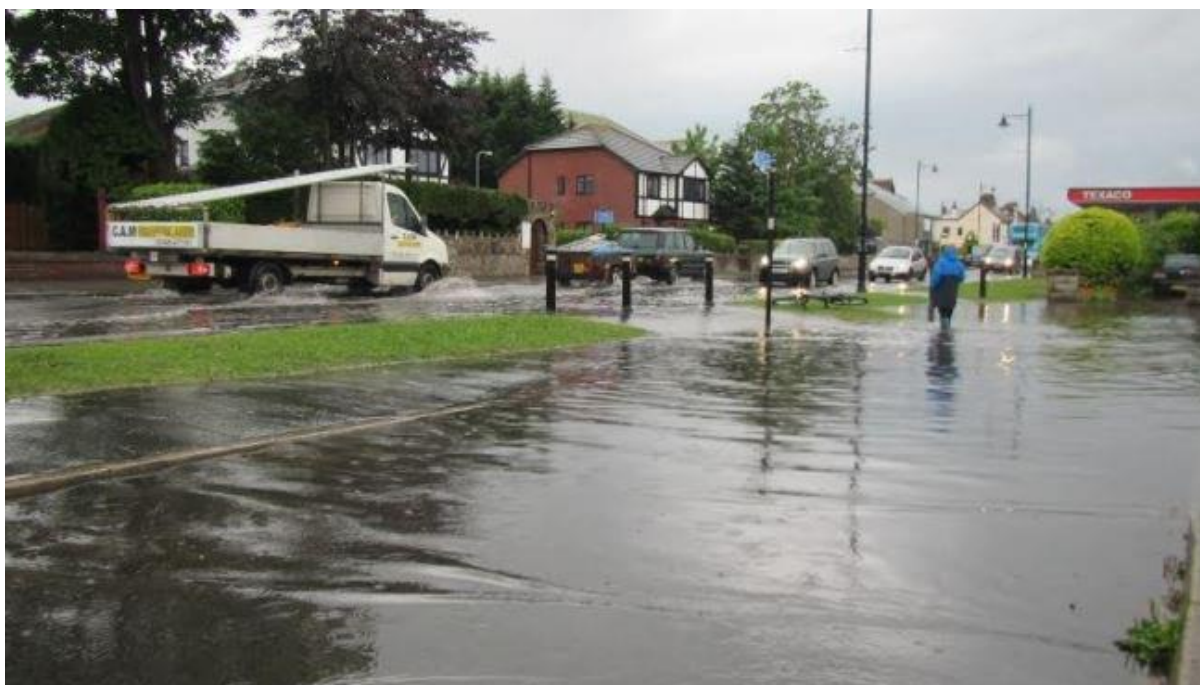
Figure 13 – Surface Water accumulating on Rhyl Road, Rhuddlan

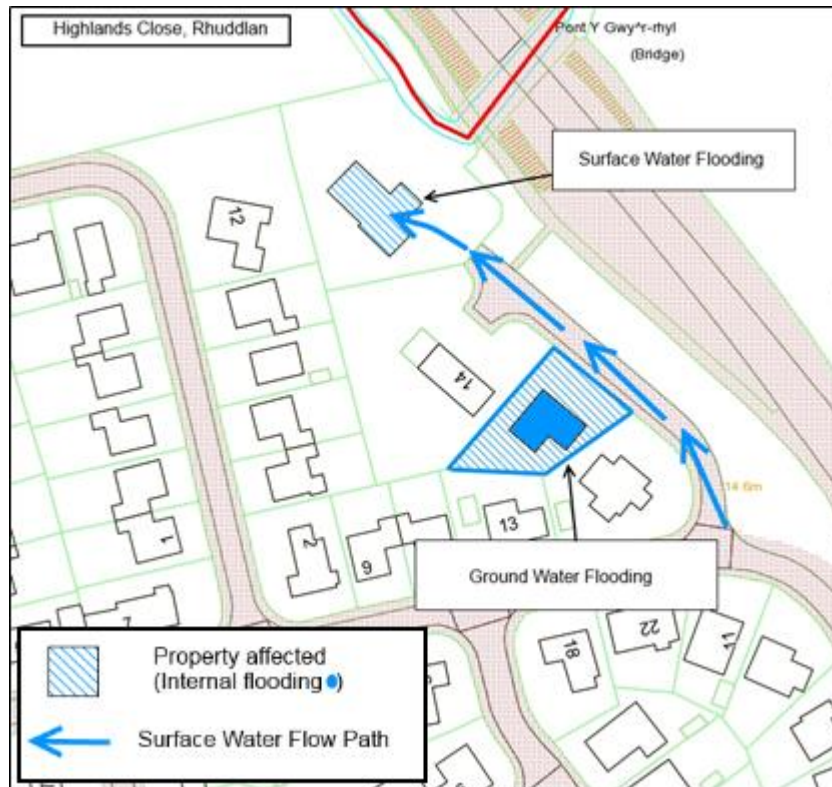
Figure 14 – Two properties suffered internal flooding from different sources

Properties off Highlands Close suffered internal flooding. On investigation it was identified that flooding had occurred from two different sources. Flooding from groundwater was identified as affecting the lower ground floor in one property, whilst another property was impacted directly by the flow of surface water from the highway, which is at a higher level than the property.

Following the 19th July 2017 flood, the Council has installed a new highway drain to help alleviate the problem.

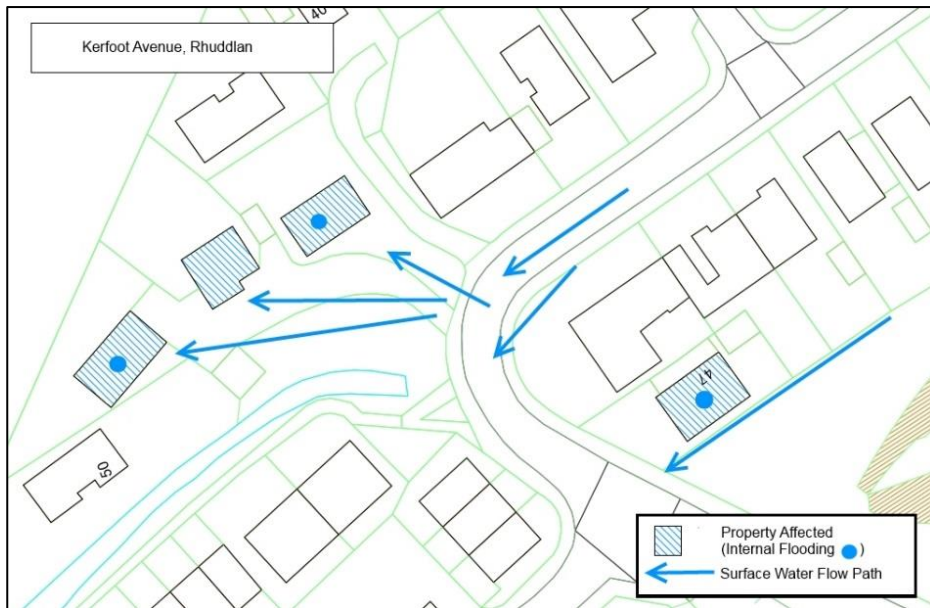
Figure 15 – Significant build-up of surface water led to garages of properties flooding on Kerfoot Avenue

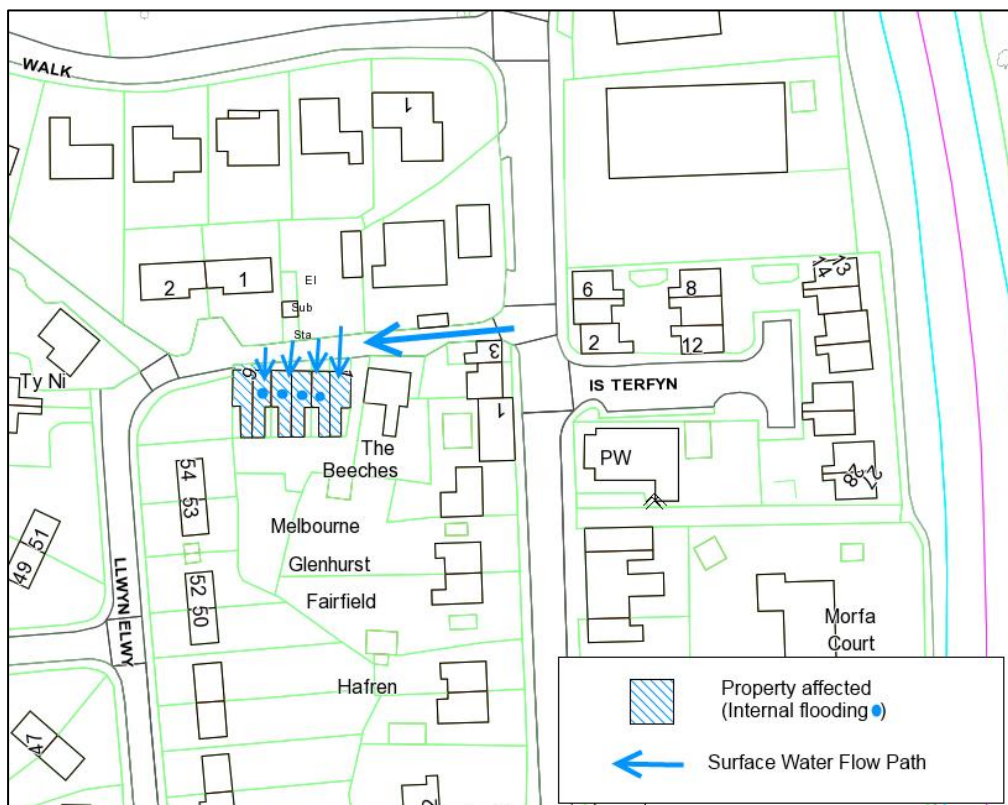
Approximately 5 properties on Caradoc Terrace flooded internally via front doors due to surface water failing to drain away at the front of the properties. The Council’s investigation has found that there is a possibility that highway drains at this location had become blocked during the flood event

Figure 16 - Low lying properties suffered internal flooding via front doors, other properties flooded due to private drainage systems failing.

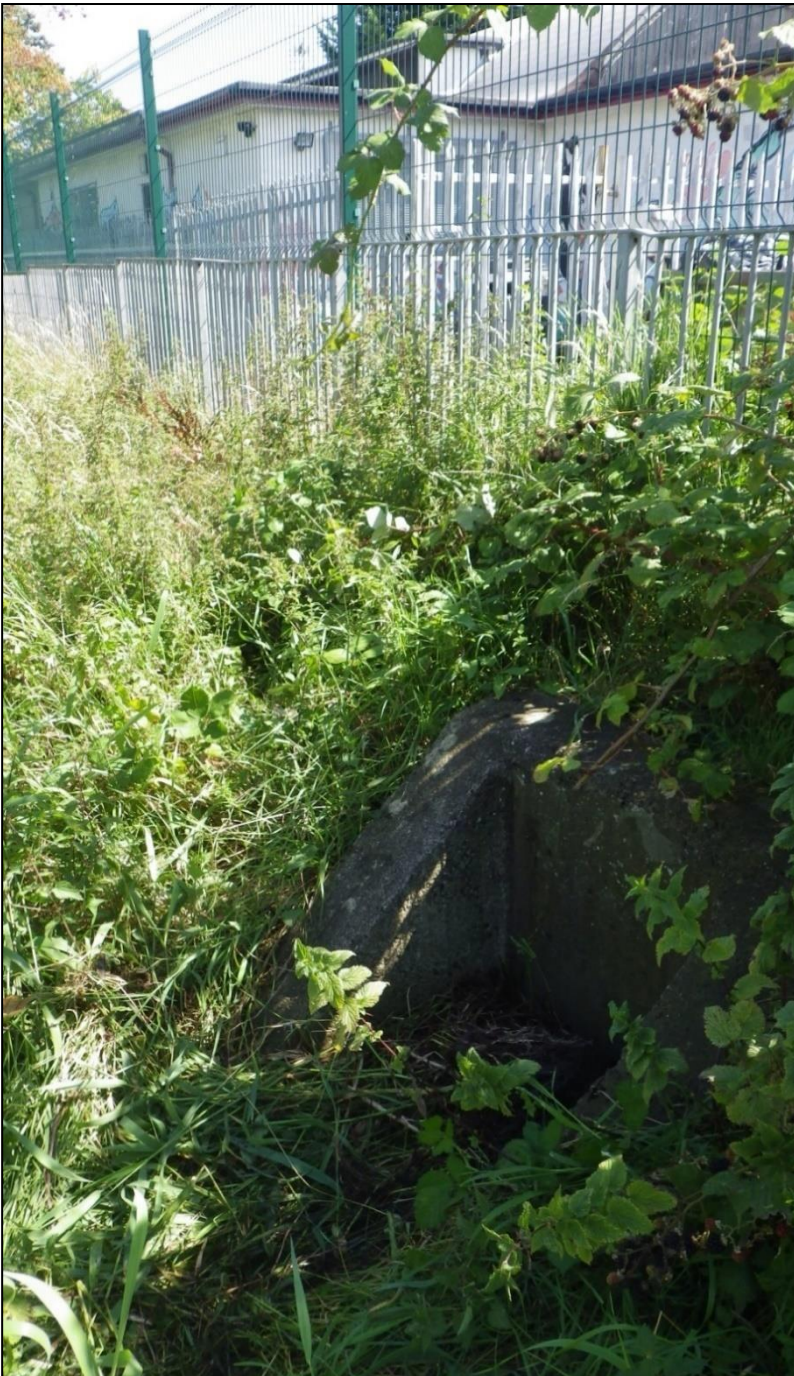
As mentioned earlier, there is an outfall next to the dance studio which drains surfacewater from the surrounding area of the un-adopted road in front of the dance studio and the garages behind the dance studio (Figure 5). Whilst surveying the Cut, after the flood event, it was found that this outfall was completely silted up (Figure 4), which would have prevented any surfacewater from being drained away from the dance studio, and the surrounding area. This would have exacerbated the surfacewater flooding to the dance studio

Figure 4: Outfall leading into The Cut, next to the dance studio.

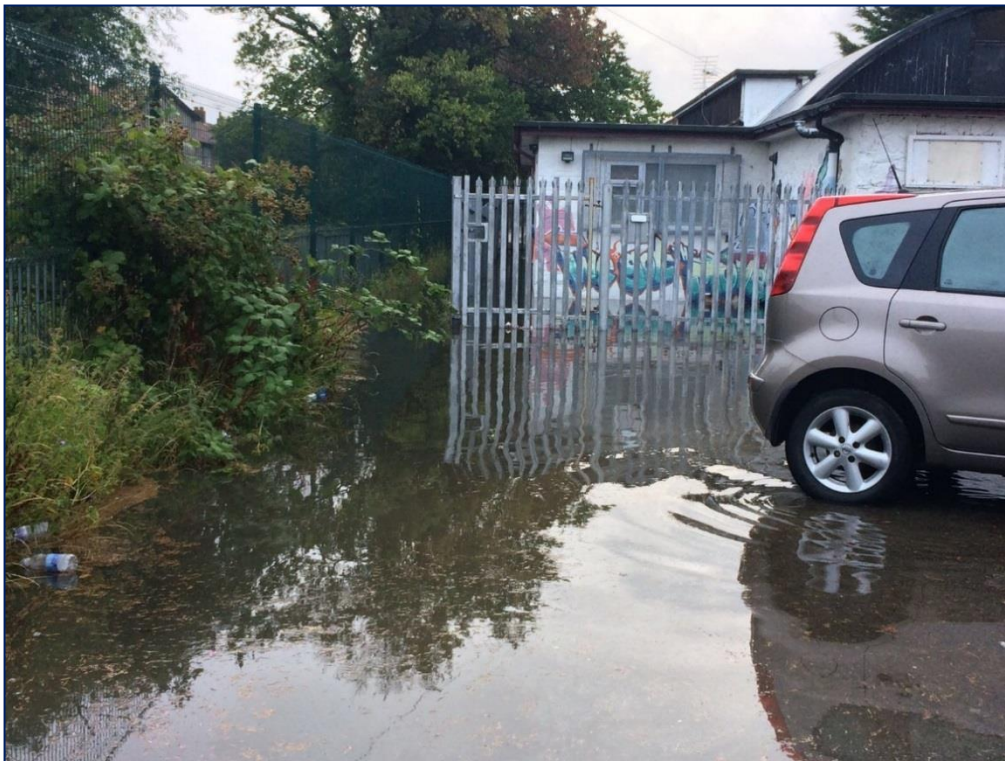
Figure 6: Flooding to Inferno Dance Studio. Front of the property

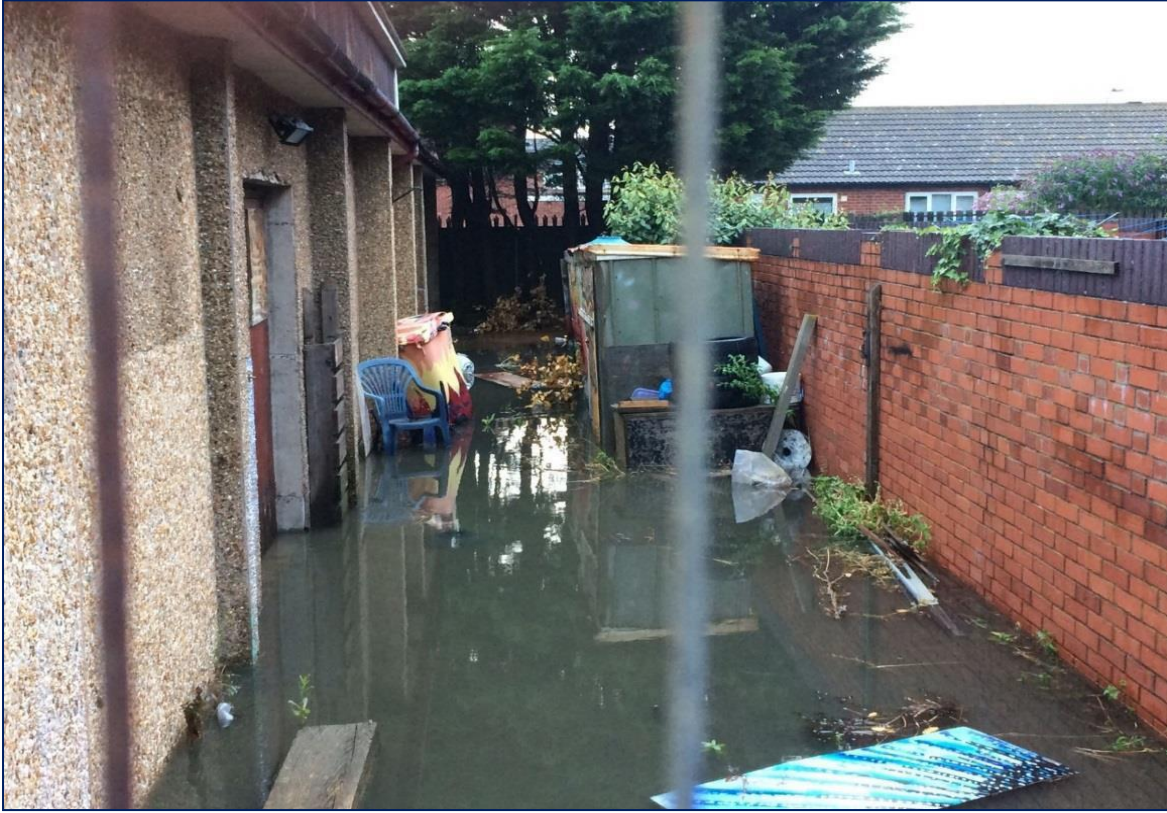
Figure 7: Flooding to Inferno Dance Studio. Rear of the property

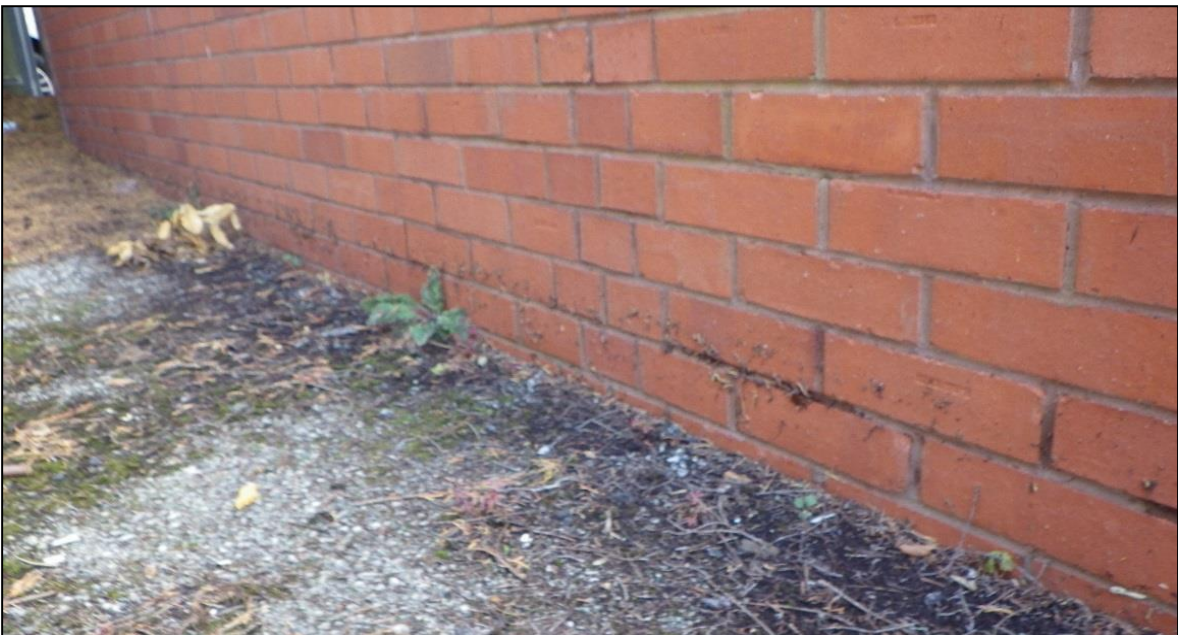
Figure 8: Wrack mark to Inferno Dance Studio rear yard wall.

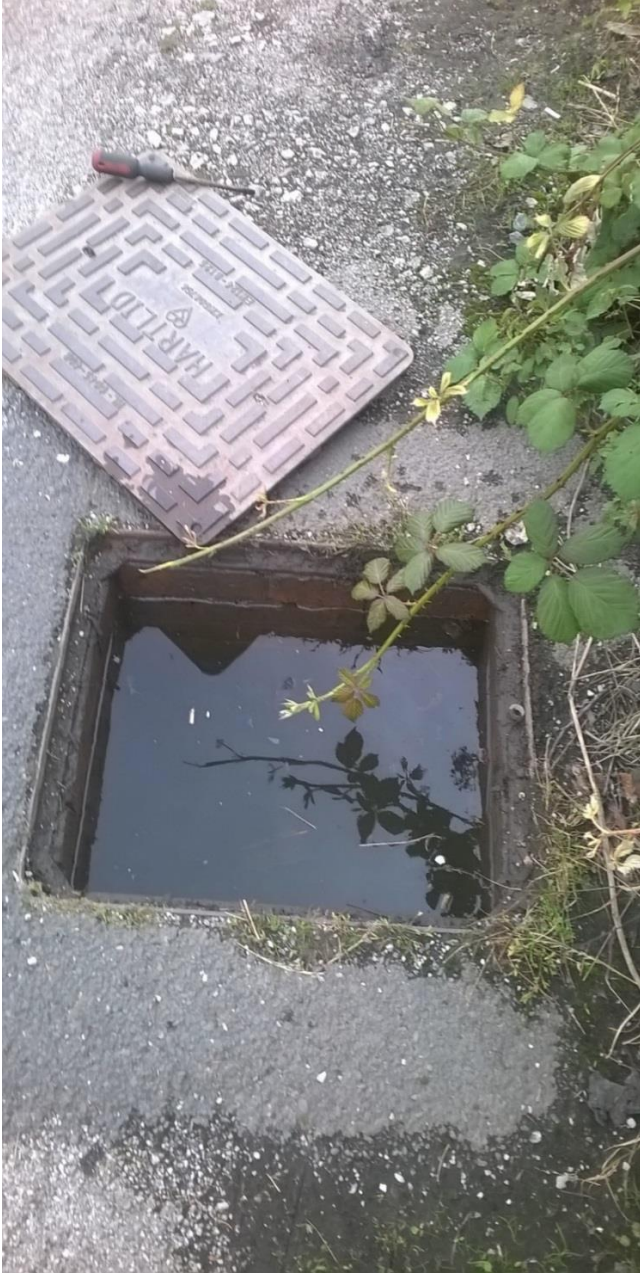
On Wednesday 16th August 2017 three NRW operatives attended site to locate the invert level for the outfall. Two inspection chambers were opened, both of which were full of water and silt (Figure 17). The outfall was dug out by hand as far as was possible (Figure 19) with further de-silting undertaken at a later date to obtain accurate survey levels. After the flap was exposed (Figure 18), the water level in the three inspection chambers quickly reduced (Figure 16), signifying that the surface drainage network does all discharge from this flap into The Cut.

Figure 17: Inspection chamber directly upstream of outfall

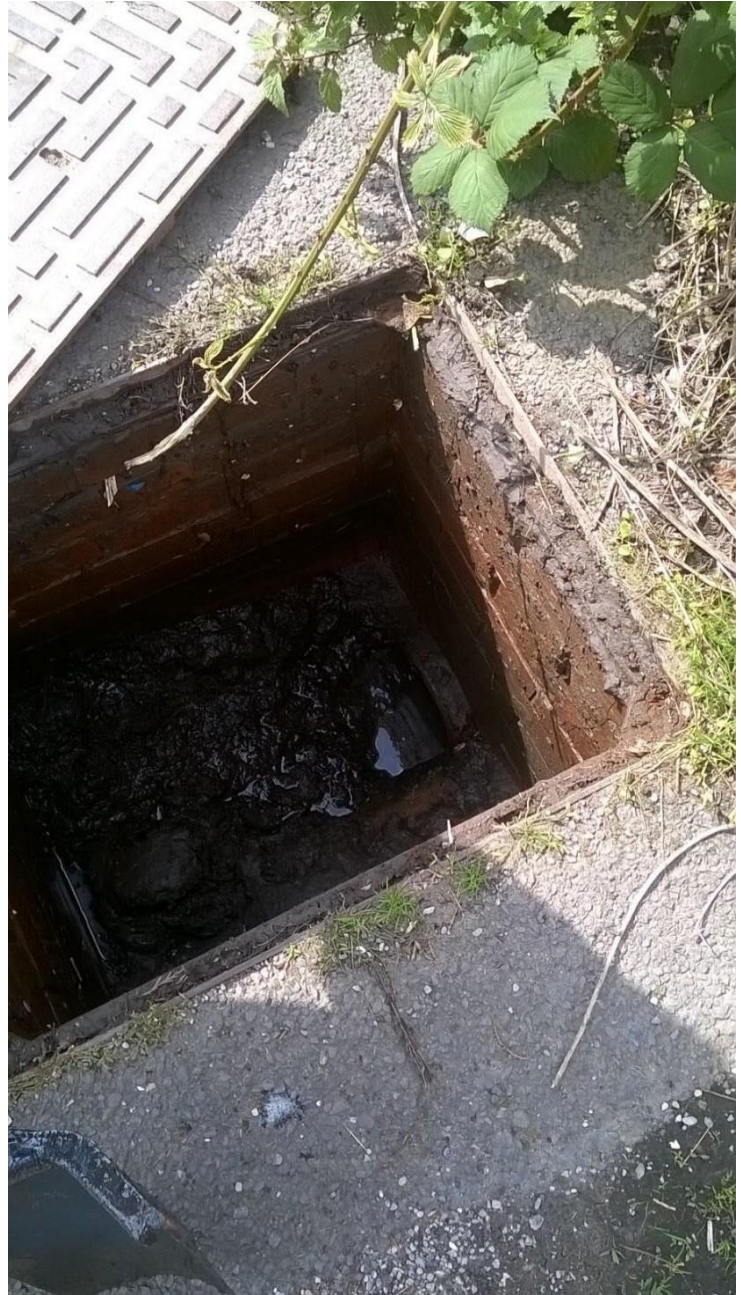
Figure 16: Chamber after the outfall de-silt

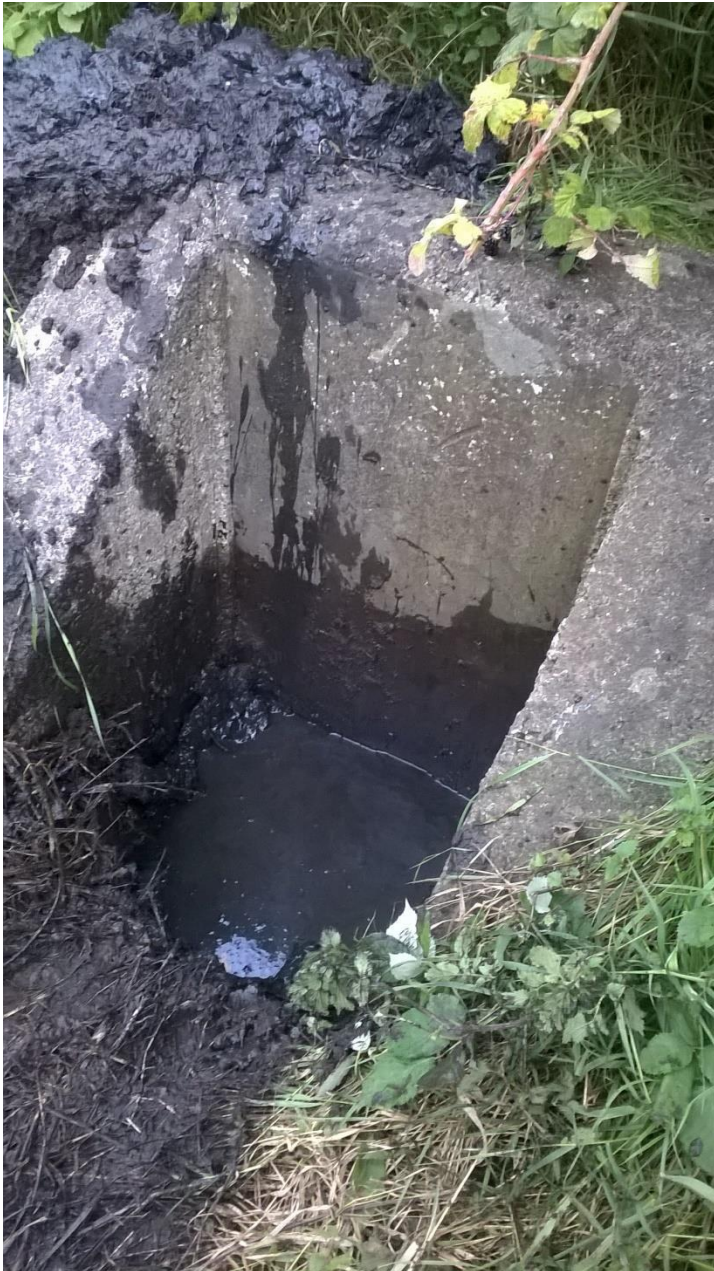
Figure 19: Outfall after minor silt removal

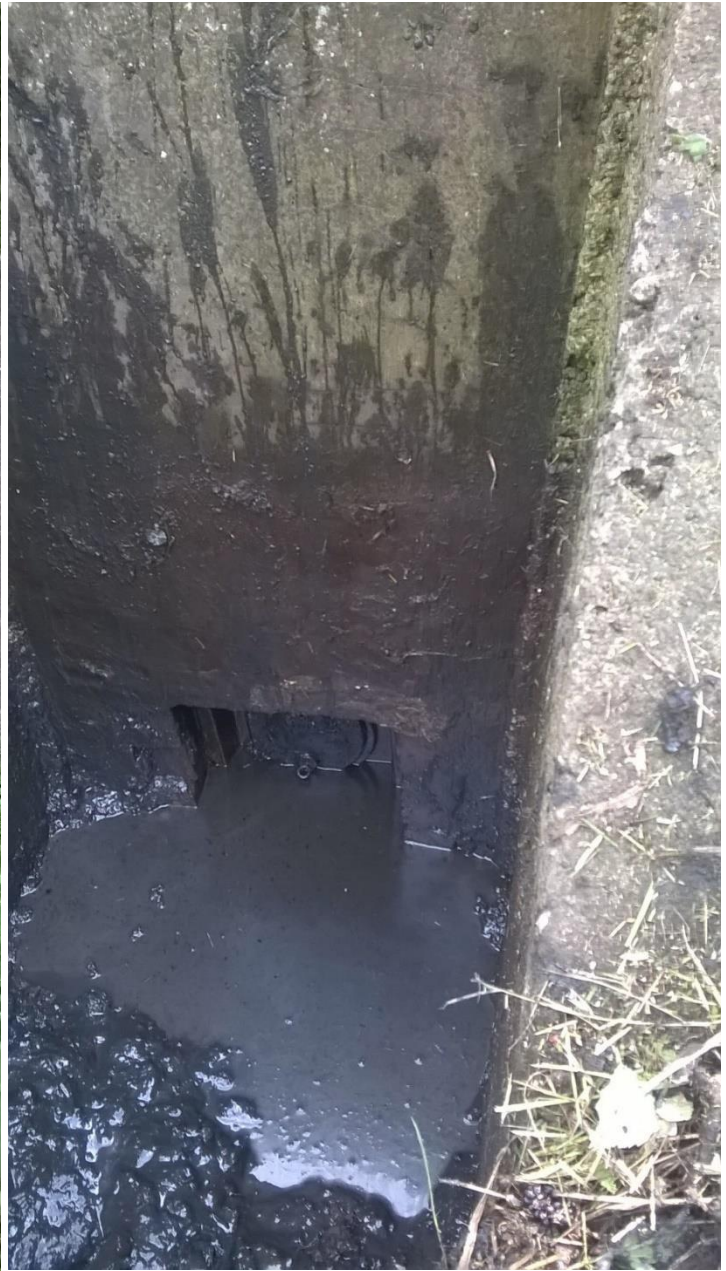
After digging out the outfall, the invert level on the flap valve was observed to be 2.30m AOD and the apron was approximately 2.20m AOD, although there was no solid apron observed, only a rough brick bed.

Figure 18: Post de-silt with metal flap valve visible
