Oak in rear garden of 118 Bro Deg, Ruthin

Date of inspection - 29 January 2021

Species – Pedunculate Oak (*Quercus robur*)

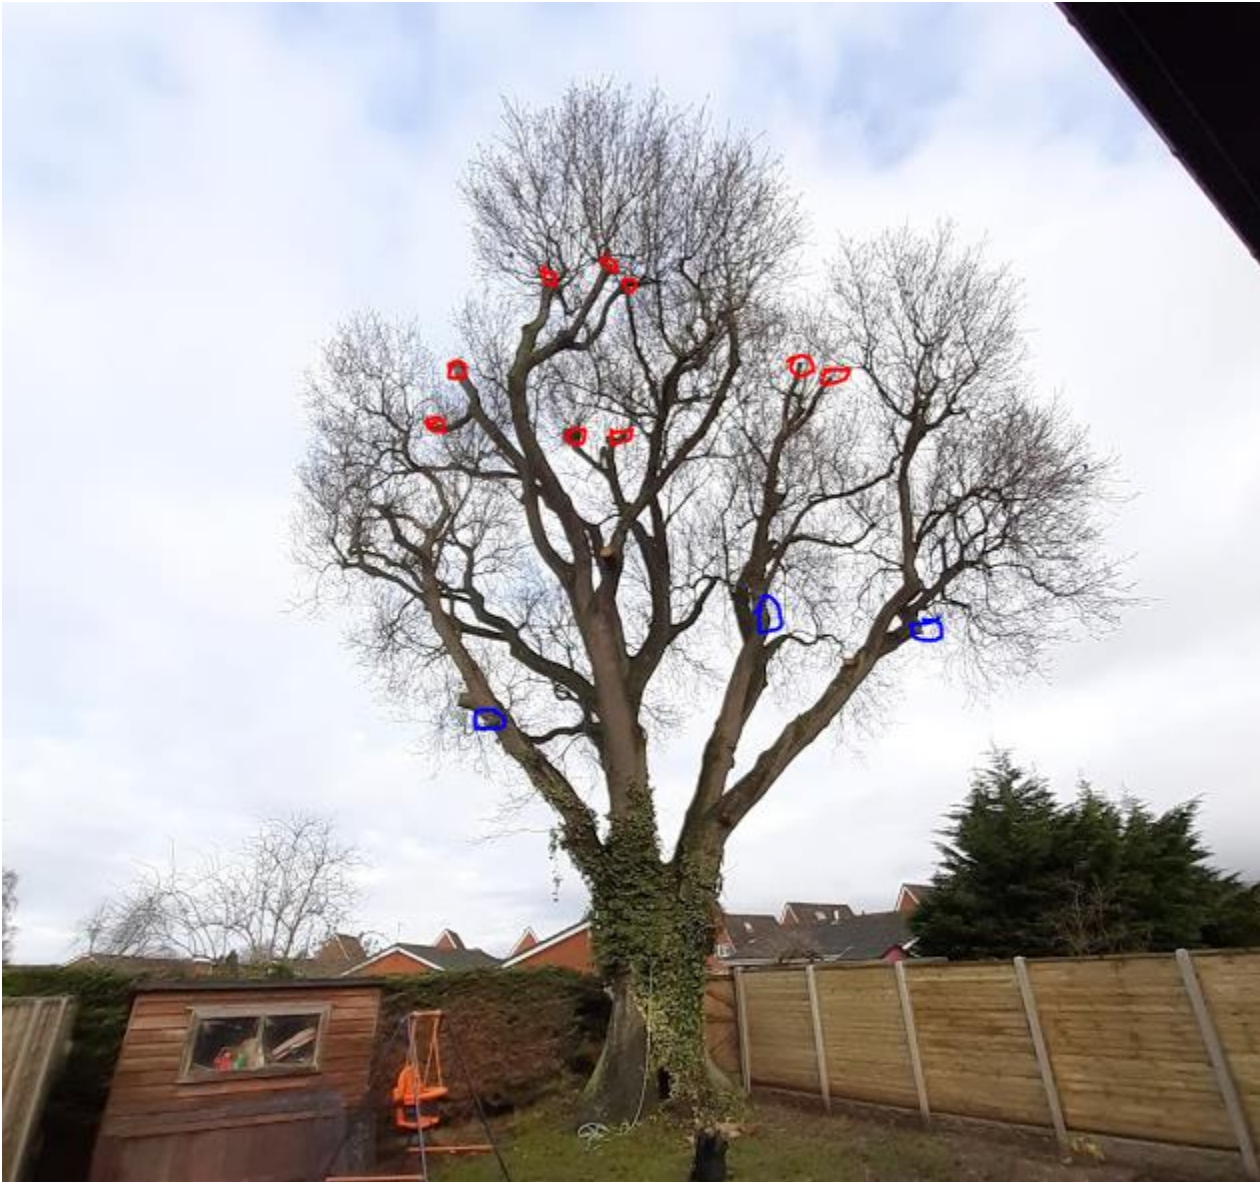
Plate 2.

Plate 2 is a photograph of the crown out of leaf from the rear garden of 118 Bro Deg and shows the old topping cuts in red and scaffold limb defects in blue. The two topping cuts left and second left in Plate 2 have resulted in the parent limb dying back to the main fork several metres below.

The three main limb defects identified in blue are lower down the crown. The limb to the left has evidence of some hollowing out. Below the recent pruning cut there are two points of decay with the lower one having staining beneath, possibly indicating water outflow from a cavity which extends downwards from the above point of decay. At and just above the stub from the pruning there is section of included bark. During my visit, the property owner advised me that the tree contractor was particularly concerned about this particularly limb being weak.

The limb defect shown in blue towards the middle of plate 2 is not visible from the garden of 118 Bro Deg because it is on the northern side. This is the defect shown in the short video submitted by the tree owner and included in the photographs submitted by Mr Logan of 56 Maes Cataban. The defect comprises of a longitudinal cavity with a wide opening, probably resulting from a branch tearing out some time ago. The limb on the right hand side of Plate 1 shown in blue appears to have resulted from another branch failure.

The Tree survey report by A. Williams submitted claims that there are large limbs showing serious signs of rot and recommends their removal. These points of decay have not been described in the report. However personal conversation with the owner advised that the left hand limb in Plate 2 and the limb subject to the video are the main cause of concern. These limbs and other defective branches could be pruned out to reduce the level of risk as part of remedial pruning to the tree, that also took account

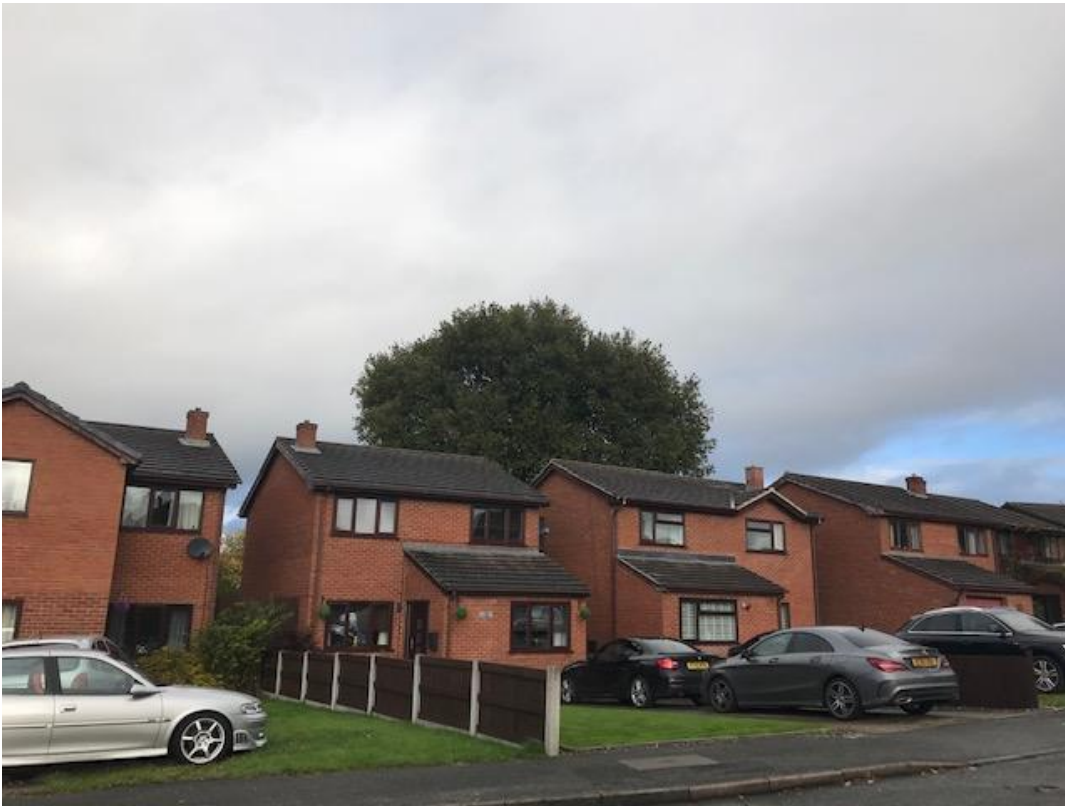
Plate 3.

Plate 3 shows top of the crown in leaf with good vigour and no evidence of dieback.

Due to the oak's size, visibility and its potential lifespan the tree has scored highly and definitely meets the criteria to be afforded protection by a TPO. The photographs taken of the tree in leaf demonstrates the significant amenity it affords to the area, where there are few other large trees (Plate 3).
