Flood Investigation Report

Brookhouse, Denbigh

9th February 2020

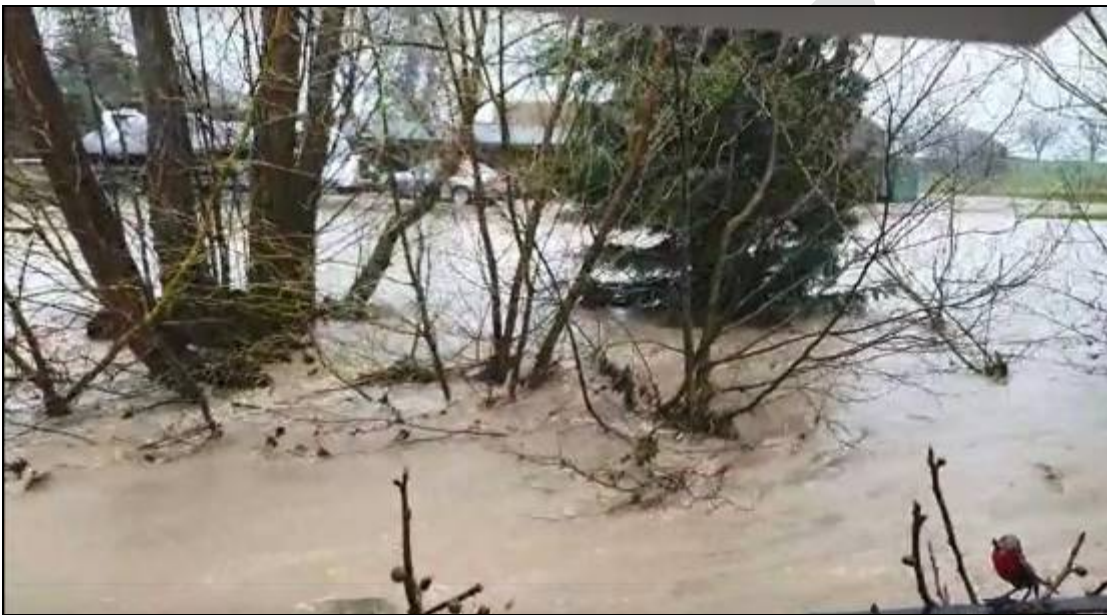
The rainfall caused the Afon Ystrad to overtop both its banks in the vicinity of and behind the properties at Brookhouse Road. Figure 5 shows the extent of the overtopping of the Afon Ystrad at the rear of Glan Llyn on the morning of the 9th February.

Figure 5 Video still of floodwater overtopping from Afon Ystrad at back of Glan Llyn/ Old Church during high flows (the trees in the middle of the photo are standing on the submerged far river bank). Source: Resident

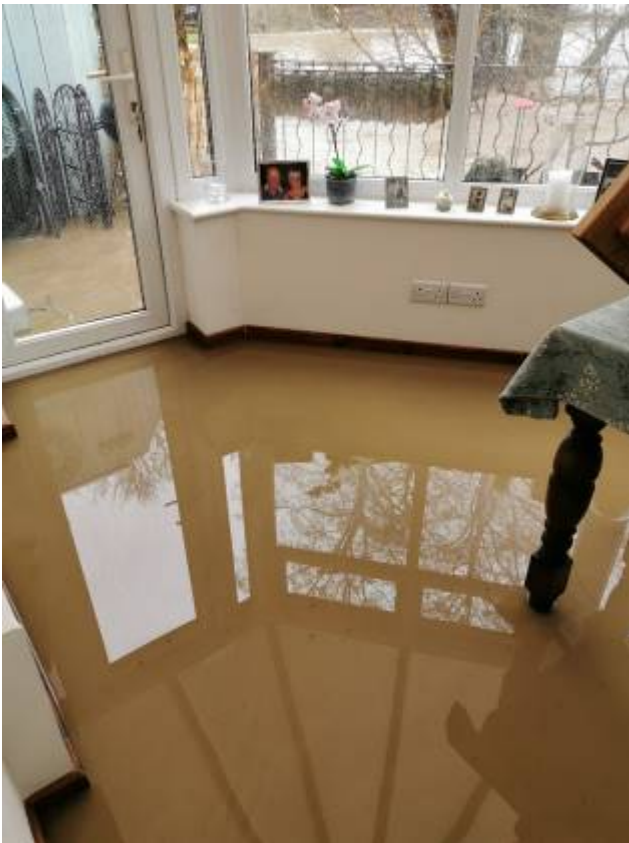
- Nos. 7 and 8 reported water entered their properties through the floor and the internal floor drains, not through the doors or over the IPP. The water entered and receded very quickly.
- At about 09:20 am, water began to enter the Old Church through the doors. There was no IPP installed, only sandbags to prevent ingress. The resident contacted both NRW and the local authority. The depth of internal flooding was about 4 inches.
- At about 10:20 am, the resident at Glyn Llyn identified that water had begun to overtop the wall at the side of the house from the Ystrad. This floodwater then entered the property through both the front and back doors and entered all rooms on the ground floor (Figure 6). The depth of flooding was 1inch. IPP was implemented after water had begun to ingress. The resident stated that they have laid new concrete flooring since 2012.

Figure 6: Photo of property ingress of floodwater from Afon Ystrad during Incident at Glan Llyn. Source: Resident

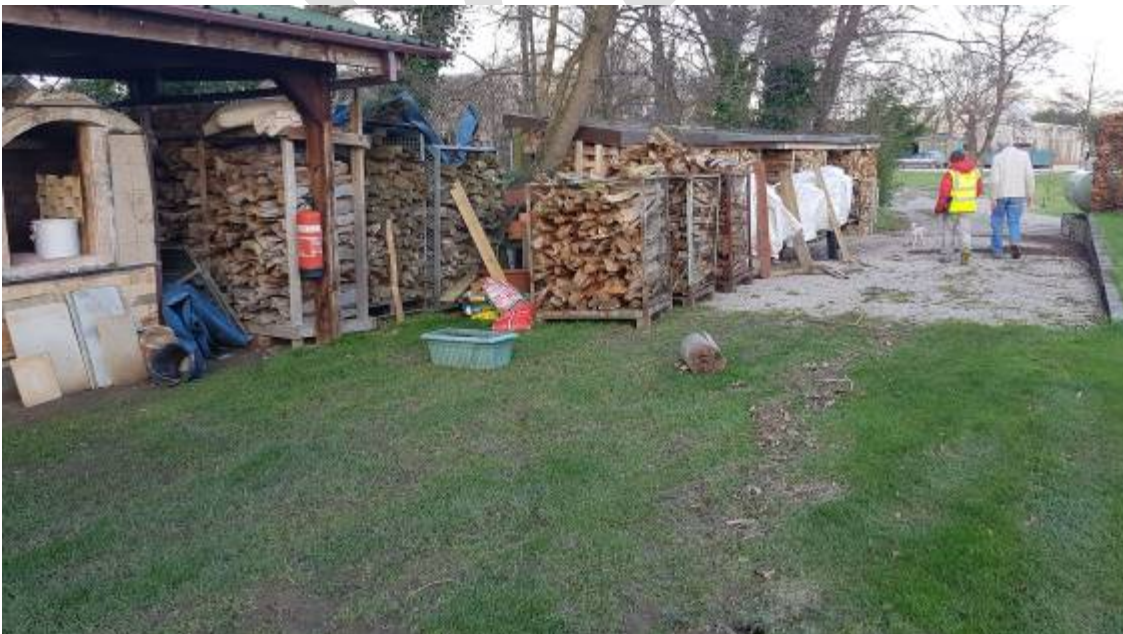
Figure 7: Photo of wrack mark left by Afon Ystrad at the back of the Pottery. Source: NRW

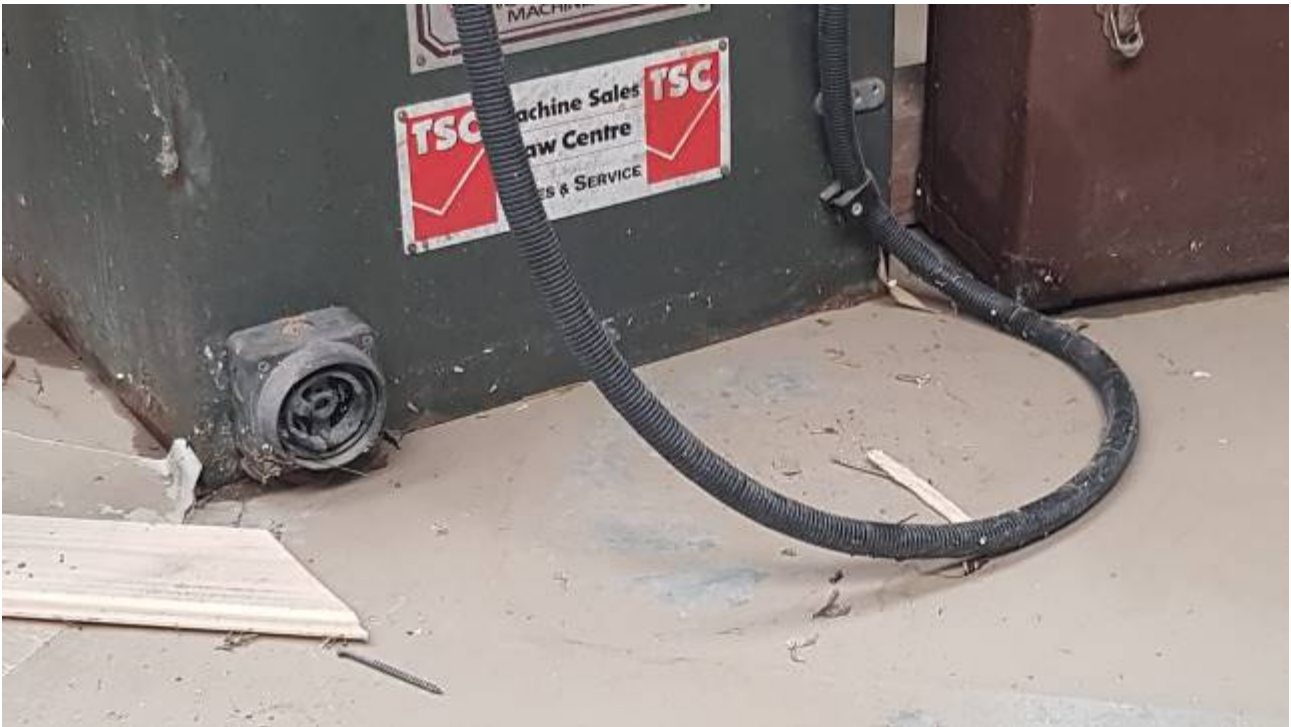
- Shallow water entered the outbuilding of the Brookhouse Pottery directly from the Ystrad. The depth of internal flooding in the shed adjacent the A525 was about 2 inches (Figure 8).
- Caller reporting flooding to No.9's kitchen during the event. Caller stated this cottage is higher than those downstream and believes that the properties lower down (i.e. *downstream*) on the terrace are also flooded
- The Residents in the properties in the middle of Brookhouse have always expected flooding to enter their houses via the front door, off the road. However, on the 9th February, the field in front of the houses was dry and there was hardly any water from the Ystrad flowing down the tarmac road towards the houses.

Figure 8: Wrack Mark in Pottery Outbuildings Source: NRW

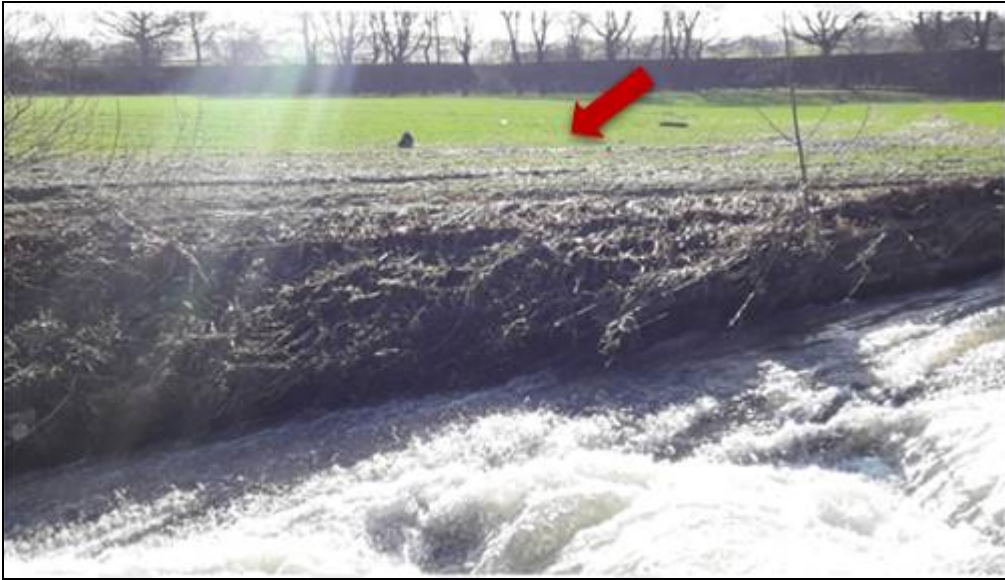
Figure 9: Photo of wrack mark left by Afon Ystrad on Right Bank just downstream of the weir 12 February 2020. Source: NRW

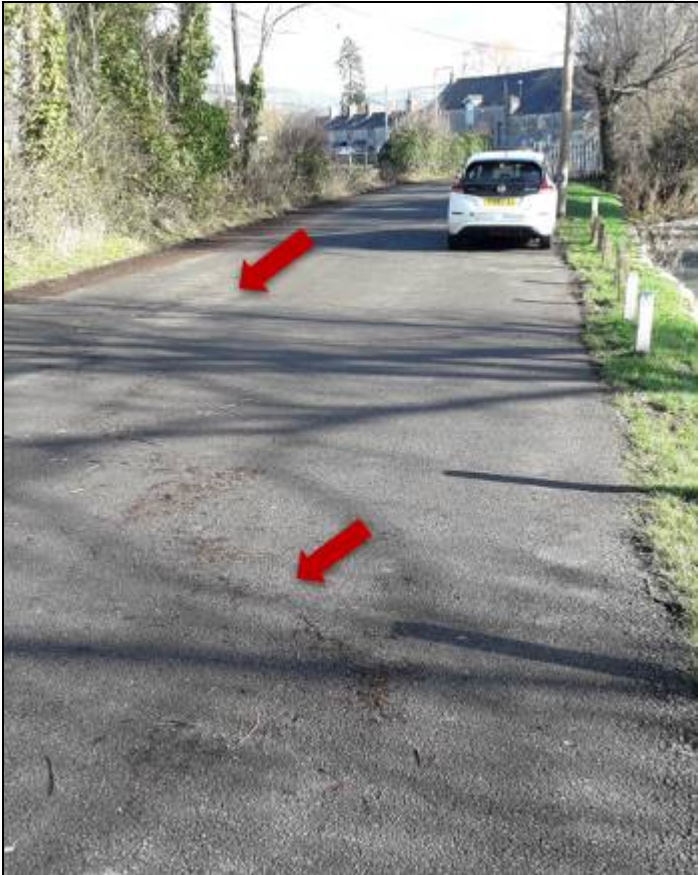
Figure 10: Photo of wrack mark left by Afon Ystrad on Brookhouse Road adjacent to right bank by weir at small layby. Source: NRW

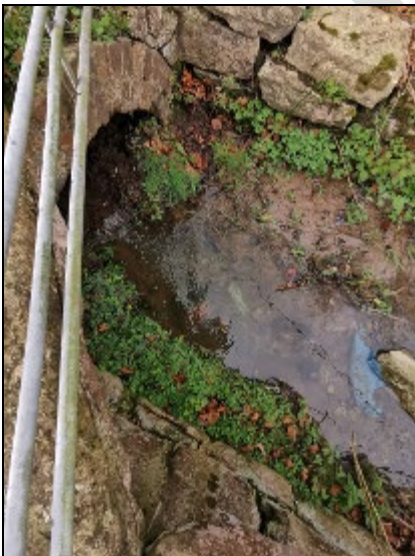
Several decades ago when the new road was built, the Mill leat appears to have been blocked off, however the archway still exists (See Photo below Figure 12) and a small flow into but not through is present.

Figure 12: Photo of Old Mill Inlet. Source: Denbighshire County Council.

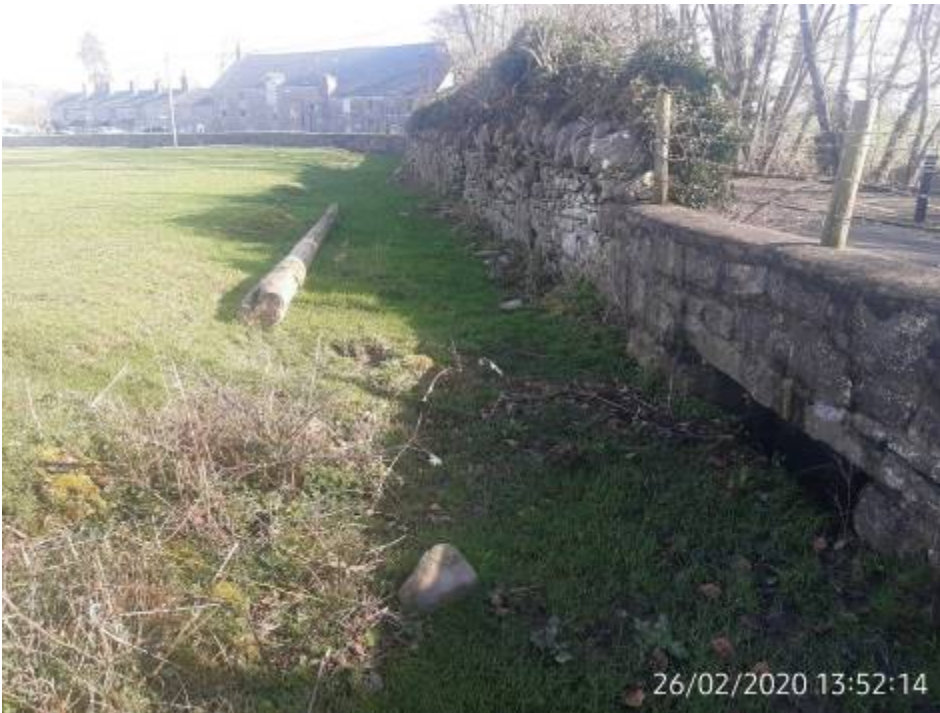
The Old Mill outlet to the field (Figure 13) was inspected after the event and was observed to be dry as expected as it is understood to have been blocked off.

Figure 13 : Photo of Old Mill Outlet. Source NRW

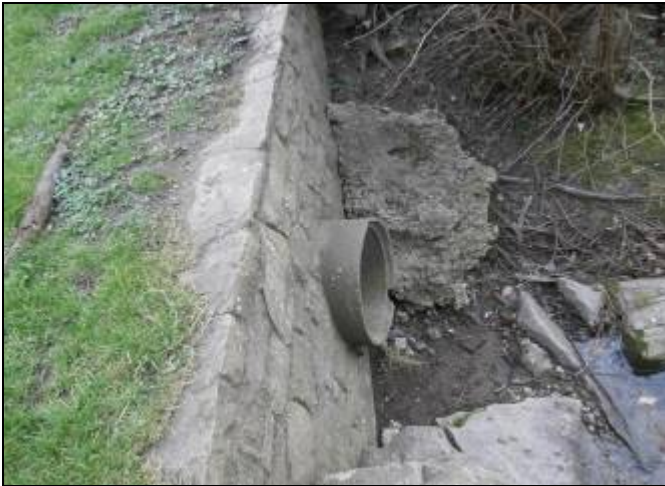
The Mill race/drain running along the wall in the field was clear, there is a 400mm diameter Outfall to allow surface water drainage from the field back into the river (Figure 15). This was clear and no debris was seen within the river itself.

Figure 15 - 400mm Outfall associated with Mill Race Drain

- DCC should investigate the possibility for Non-Return Valve to be add to Mill Race Drain Outfall to reduce risk of water from Afon Ystrad entering field. Home owners are advised to assess whether further flood resilience measures can be installed at their properties.

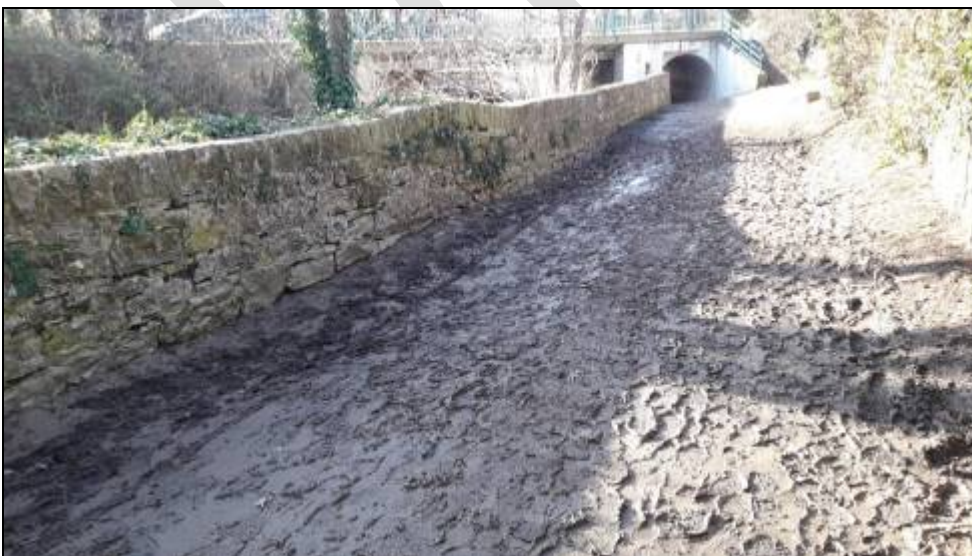
Water and wrack debris were seen on the landward side of the wall that runs along the Ystrad from the subway to the A525 (Figure 16). However water did not flow into the pedestrian subway as has been the case in previous events, as there was no reported problems by residents and during the site visit, the subway was seen to be dry with no wrack and no silt present (Figure 17).

Figure 16: Wall on Left bank from A525 to Brookhouse Mill. Crack in wall potential seepage routes Source: NRW

It is likely that the floodwater seepage was through the wall to the footpath as there is no evidence to suggest the Ystrad overtopped the wall in this area. This is further supported by observations made by residents at the Brookhouse Mill, which identified that the peak water level in the Ystrad was at the at the soffit of the footbridge (see figure 18 below).

- DCC should investigate the potential of seepage through wall on Left bank of the Ystrad from A525 to Brookhouse Mill Wall where wrack debris and evidence of pooling water were observed the day after.

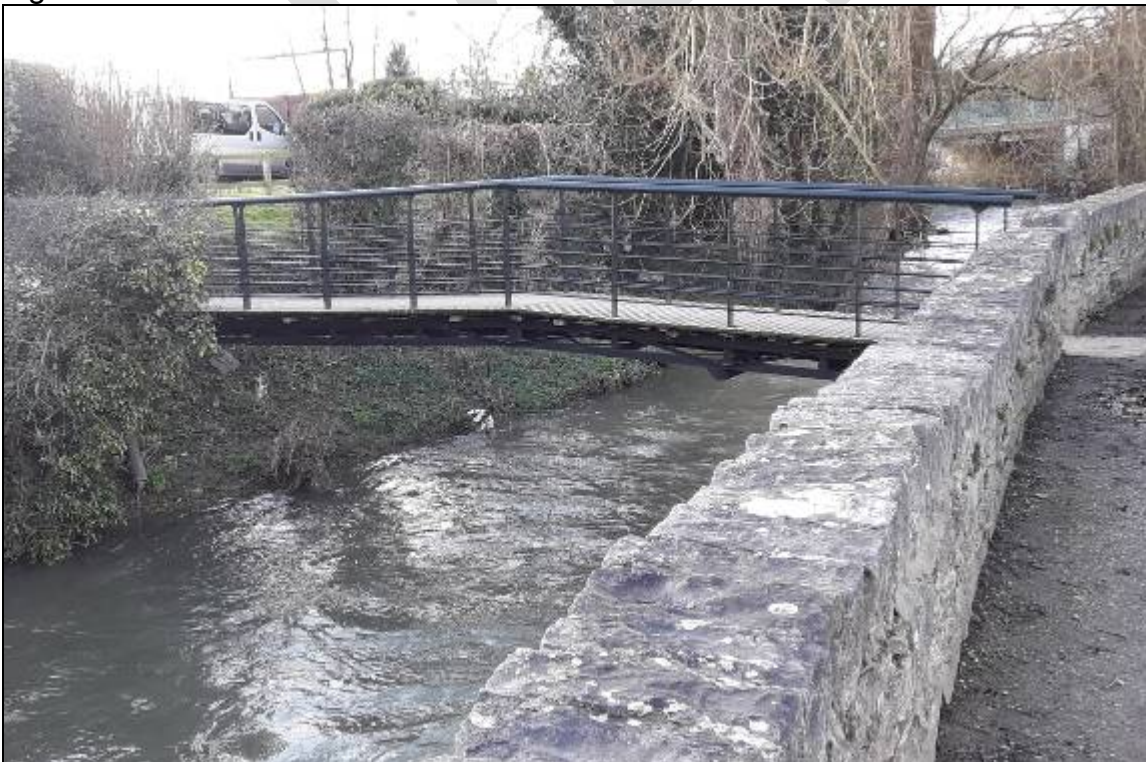
Figure 18: Footbridge over River Ystrad at Brookhouse Mill. Source: NRW

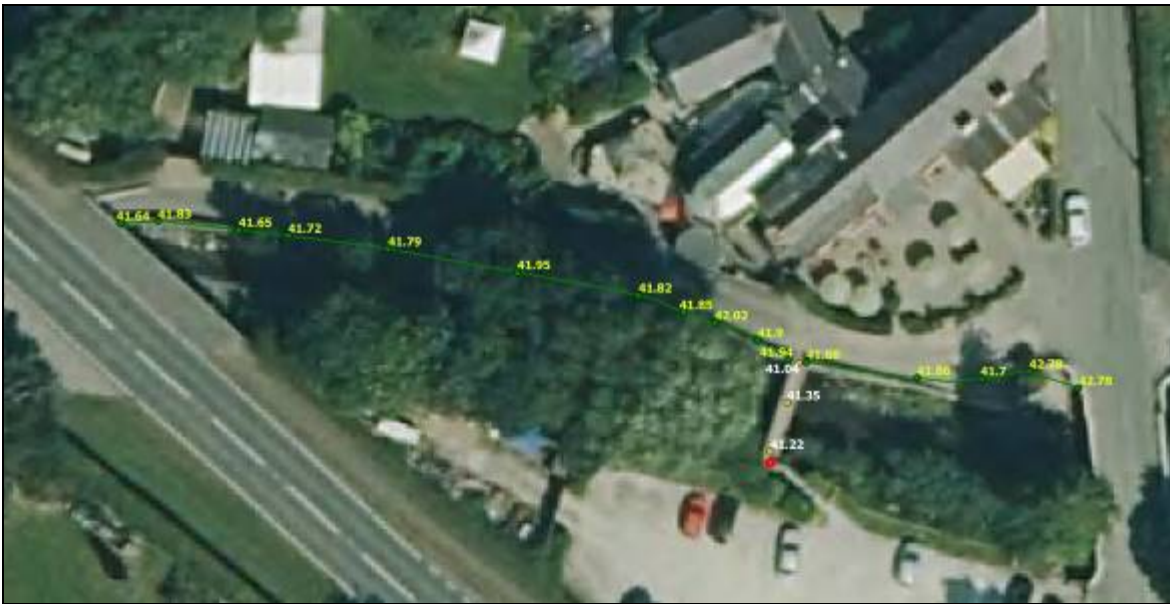
The footbridge soffit is at 41.02mOAD, which is lower than the top of the wall, as shown in Figure 19.

Figure 19: Surveyed levels of Wall on Left bank from A525 to Brookhouse Mill and footbridge deck levels

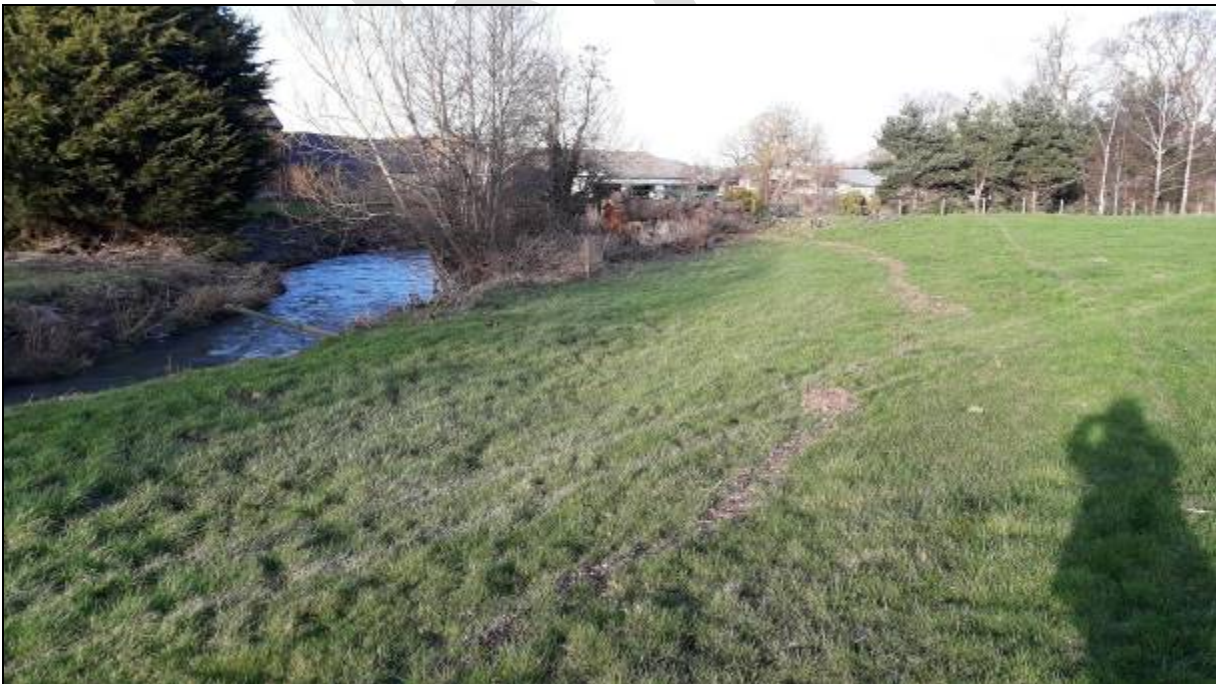
The Afon Ystrad also overtopped its bank further downstream of the A525 near Brookhouse Farm (Figure 20), however there was no internal flooding reported. The farm owner reported several locations along the Ystrad, downstream of the A525, where trees had fallen into the river during the event causing partial blockage of flow.

Figure 20: Wrack mark on right bank of Ystrad, downstream of A525, opposite Brookhouse Farm. Source: NRW
