Flood Investigation Report Ruthin 20 January 2021

This investigation report is a best estimate representation of the flood incident at Ruthin, written as a formal way for Natural Resources Wales to record the incident. It is based on evidence gathered by Natural Resources Wales' officers through several sources and is deemed as fit for purpose at the approved date.

It was considered appropriate to carry out an investigation as 23 residential/business properties suffered from internal flooding following heavy rainfall on the 20 January 2021. The Afon Clwyd overtopped the raised flood embankment between Cae Ddol and the Crispin Yard Car Park on the Clwyd's right bank and flooded 22 properties. One property was also flooded internally by the Clwyd in the Maes Ffynnon estate.

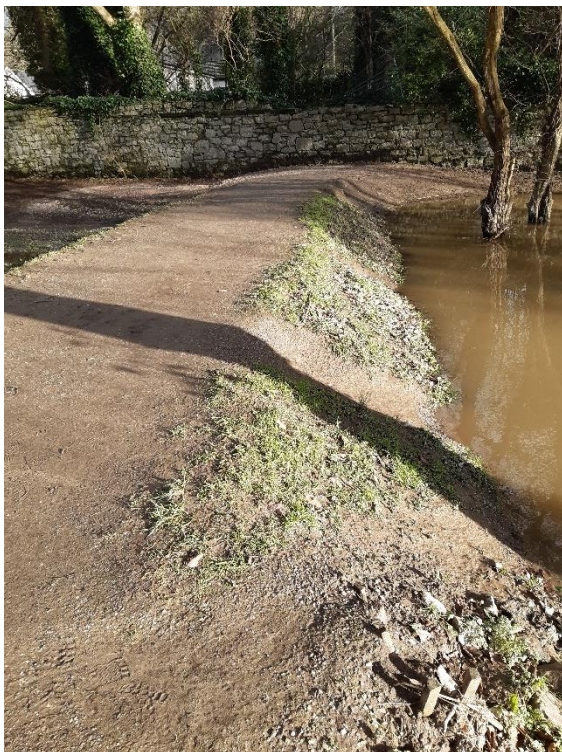
Figure 4: Cae Ddol embankment near skatepark (source: NRW staff)

Residents detailed that around 3-4 pm, the Clwyd began to inundate the park areas around Cae Ddol. As the Clwyd continued to rise, the Cae Ddol embankment near the skatepark (see Figure 4) overtopped and floodwater began to fill the Crispin Yard Car Park and the public conveniences.

The location of overtopping of the Cae Ddol embankment was similar to that which overtopped during the 2012 flood event. According to residents, in February 2020, sandbags were placed along the crest of the Cae Ddol embankment which stopped the Clwyd from overtopping to the car park, it is presumed that Denbighshire CC undertook this work as NRW has no knowledge of this.

1. Temporarily raised the Cae Ddol embankment through the use of sandbags to increase the standard of protection for the properties on Mill and Clwyd streets.
2. Undertaken a full topographic survey of the Ruthin flood alleviation scheme.
3. Undertaken an asset condition walk through to check on any post flood defects.

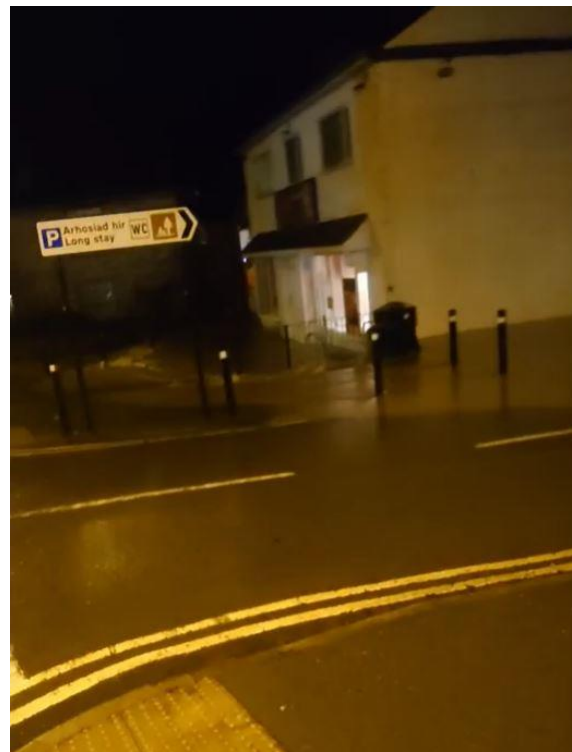
Figure 5: Floodwater at the car park entrance (Source: Real Fans of Ruthin Facebook page)

Around the same time (6:30 pm), floodwater entered 'Ty Carrog'. The floodwater had flowed north from the car park (south of 'Crispin'), towards the car park entrance on Clwyd Street and into Mill Street (see Figure 5). The properties along Mill Street were flooded not long after, with 1 Mill Street reporting internal flooding at about 7:15 pm.

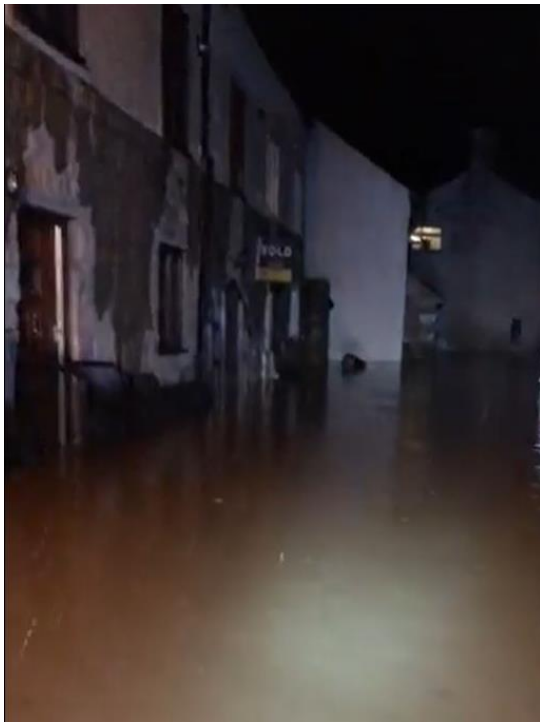
Figure 6: Flooding on Mill Street
 (Source: Real Fans of Ruthin Facebook page)

The Clwyd floodwater ponded on Clwyd and Mill streets (Figure 6 and Figure 7) as it was unable to drain back into the river due to the steel plate flood wall (see Figure 9) along Clwyd Street, designed to stop the Clwyd downstream of Pont Howkin overtopping to Clwyd Street. The masonry wall alongside the gaol also trapped the floodwater from returning to the Clwyd.

The roadside gullies along Clwyd and Mill streets were overwhelmed by the volume of water (as they are designed for local runoff) and anecdotal evidence from residents suggested some needed unblocking, so were unable to drain the ponded water efficiently.

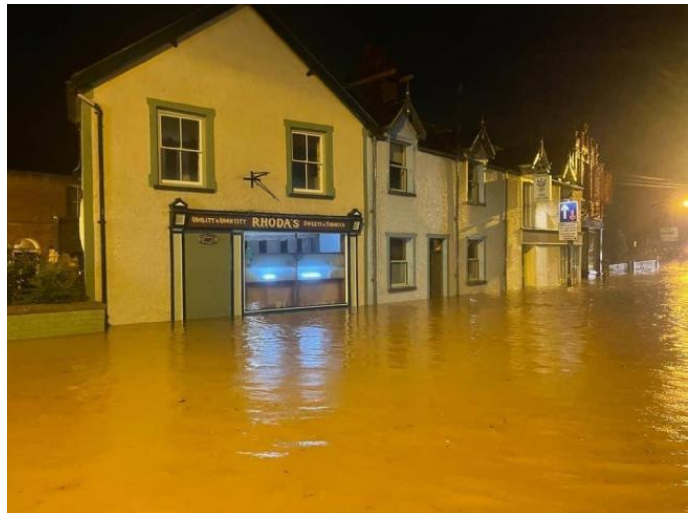
Figure 7: Flooding on Clwyd Street (Source: NWP Rural Crime Team twitter page)

The floodwater on Clwyd Street peaked at about 9:30-10 pm, reaching the front step (did not enter) of 'Royal Oak' on Clwyd Street.

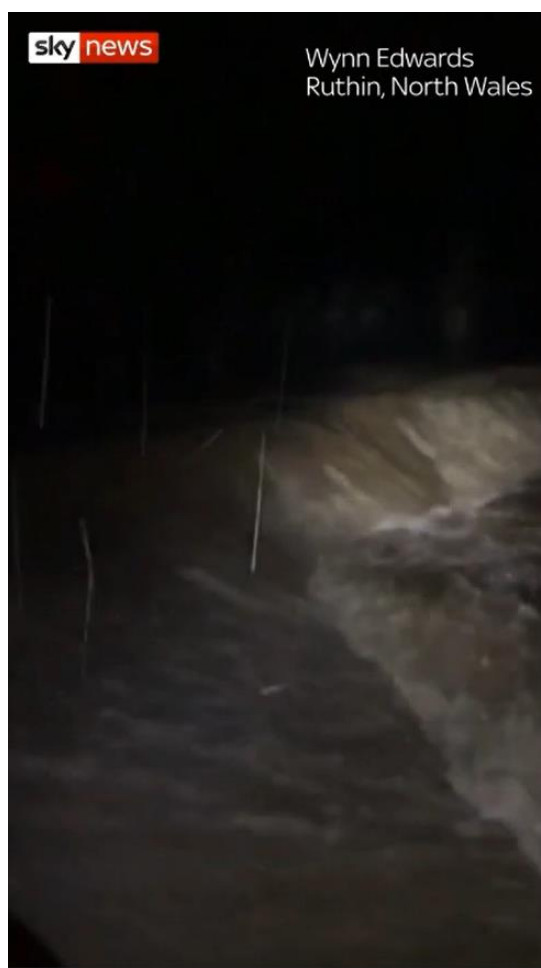
Figure 8: Overtopping of the Cae Ddol embankment (source: Sky News³)

As a result of the rising river level, the Afon Clwyd overtopped the Cae Ddol flood defence embankment and flooded areas of Mill Street and Clwyd Street in Ruthin. Areas around Maes Ffynnon estate and outside of 1 Mwrog Street were also affected by Clwyd floodwater.

In total, there were 17 residential and 5 business properties that were flooded internally along Mill and Clwyd streets due to the Clwyd overtopping the Cae Ddol embankment.

On the 20 January 2021, after heavy rainfall fell on an already saturated Clwyd catchment, the Afon Clwyd overtopped the Cae Ddol flood defence in Ruthin. This floodwater that overtopped the defence, was unable to drain back into the Clwyd and as a result, 22 properties were flooded internally along Mill and Clwyd Street. There is evidence that other lengths of the defence scheme through Ruthin were close to overtopping aswell, impacting on the design freeboard, which demonstrates the flood event experienced was significant.

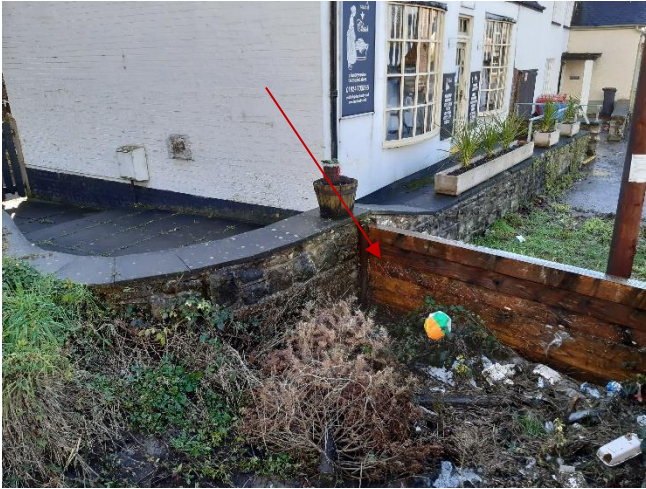
Figure 10: Wrack mark at stop logs (Source: NRW staff)

According to observations from Waterco staff, the floodwater from the Clwyd was seeping between the stop logs (Figure 10) immediately upstream of Pont Howkin bridge. This water was flowing towards properties (Figure 11), however there was no reported internal flooding in this area.

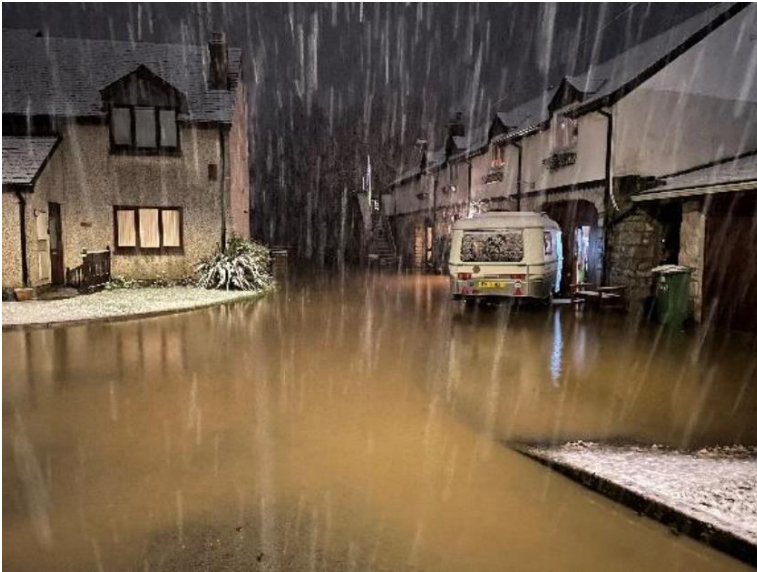
Figure 12: Maes Ffynnon estate (source: Waterco)

Denbighshire CC have confirmed there was internal flooding at 24 Maes Ffynnon, which was caused by water coming up through the ground outside once the Clwyd levels had reached a height above ground level. This was also the case for 15 to 19 Maes Ffynnon, with water coming up through the back gardens/patio over a period of 3-4 hours, accumulating in approximately 8-9 inches of water, but not enough to enter through conservatory/back doors. Levels started to drop around 8-9 pm.

The Clwyd did not overtop the Maes Ffynnon wall, peaking about 0.3 m below the top. Nor was water observed to be seeping through the stone wall. Instead, floodwater was coming up through the manhole and roadside gullies.

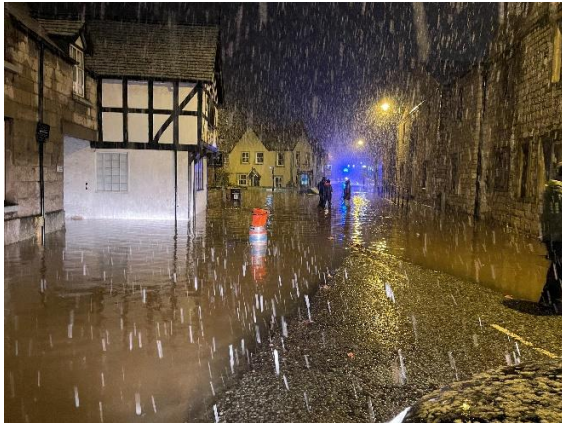
During the site visit, we observed the flood water extent to be from approximately 10m short of the local chip shop, Finns, to the eastern side of the BP Garage road bridge. Due to the depth of the flood water, we were unable to inspect further than the extent of the flood extent.

View from the chip shop towards Mill Lane

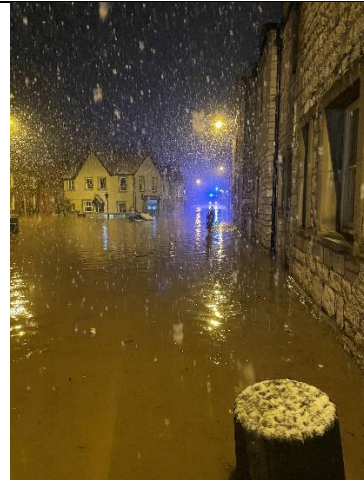
View from opposite the chip shop towards Mill Lane

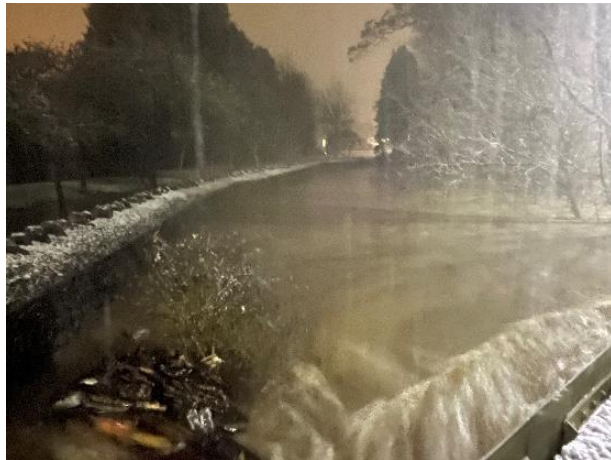
The road crossing at the fire station appeared to be at full capacity, with an imminent risk of overtopping. This could have caused flooding to the fire station and the properties along Park Road and into Parc-y-Dre and Cae Seren.

View upstream from fire station road crossing

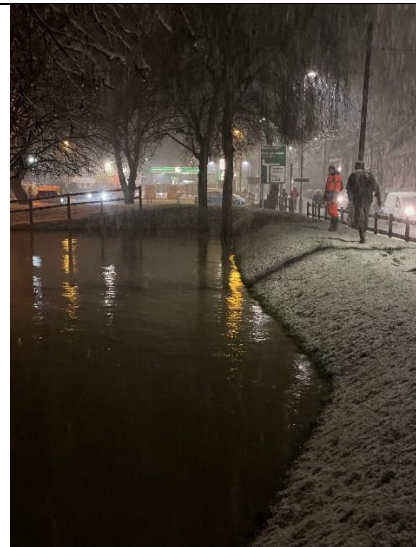
We attended the area twice and no flooding was observed. Flood water stayed within the former Gaol bunded area.

View showing available capacity within the bunded storage area

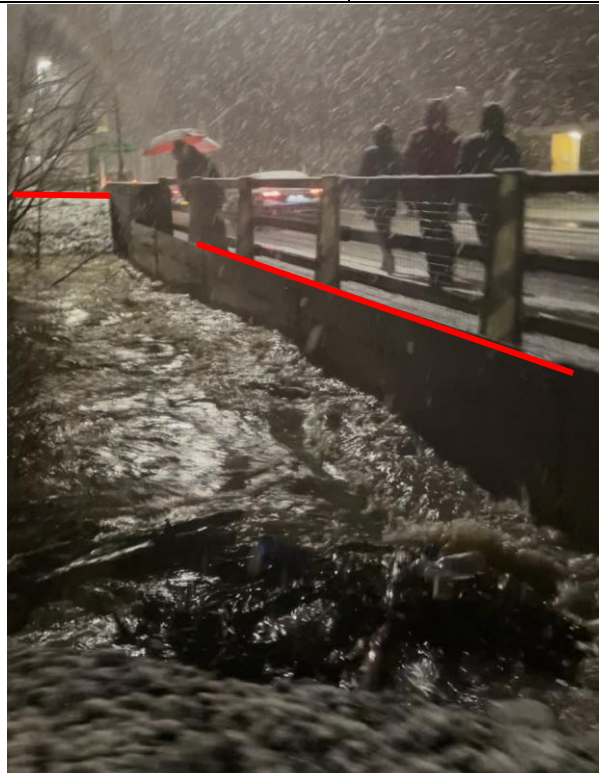
A potential low spot in the flood defences was observed at the fire station road crossing. The parapet threshold appears to be some 300mm lower than the top of the earth bunds. The water level in the bunded area was approximately 500mm lower than the top of the bunds.

View of the fire station road crossing and bunded area.
Note the difference in level (shown in red) between the top of bund and bridge threshold

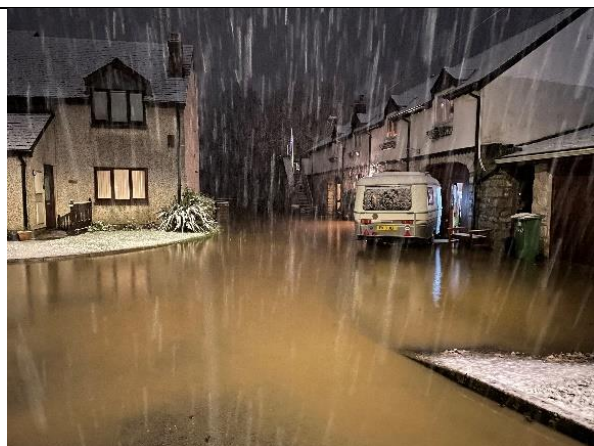
Approximately 200m upstream of the outfall, highway gullies were observed to be surcharging and flooding towards Maes Ffynnon. It is assumed that the gullies discharge into the culvert. The cul-de-sac appeared flooded, but no properties appeared to be affected internally.

View into Maes Ffynnon cul-de-sac
