<b>PROJECT</b>	Addendum to Brookhouse Flood Investigation Report
<b>PURPOSE OF NOTE</b>	Additional investigation following flooding of property during Storm Christoph (20 <sup>th</sup> January 2021)
<b>WATERCOURSE</b>	Afon Ystrad
<b>FILE NOTE PRODUCED BY</b>	Neil Taunt
<b>DATE</b>	05/03/2021

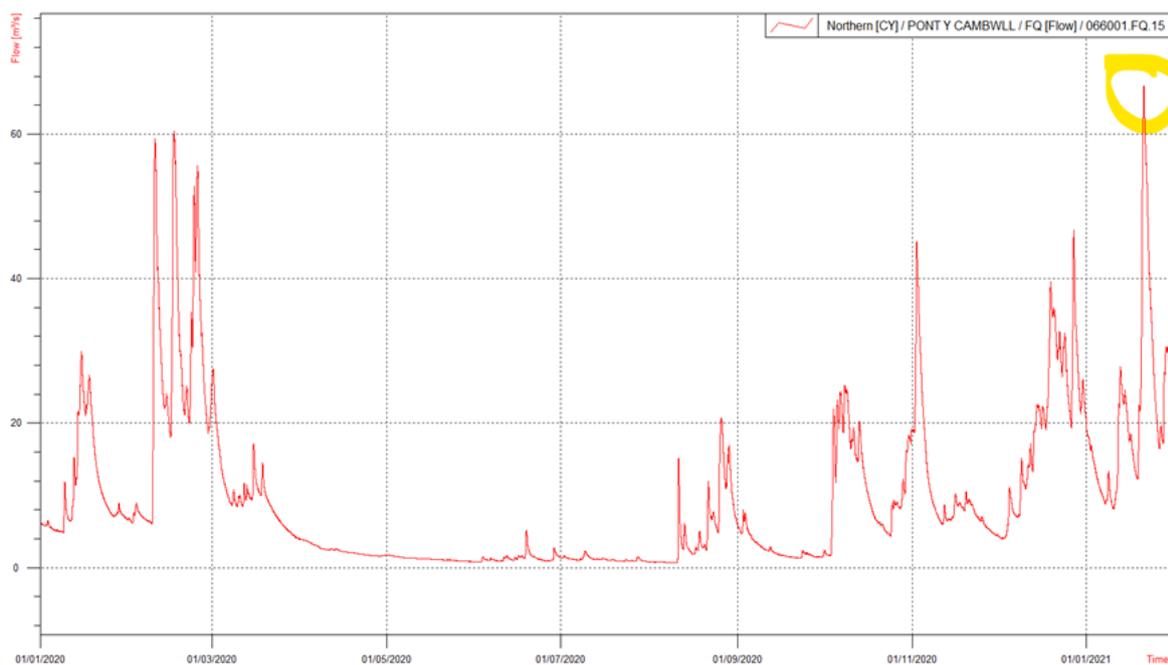
**Figure 1:** Pont y Cambwll gauging station hydrograph

Pont y Cambwll gauging station is located downstream of the Ystrad confluence and Denbigh on the River Clwyd at SJ0698570963. The hydrograph in Figure 1 shows flow at that site from January 2020 to the end of Jan 2021. Storm Christoph peak is circled. Base flows were high at the start of the event from previous rainfall and whilst this isn't the Ystrad catchment it does give a representation of conditions in the wider Clwyd catchment.

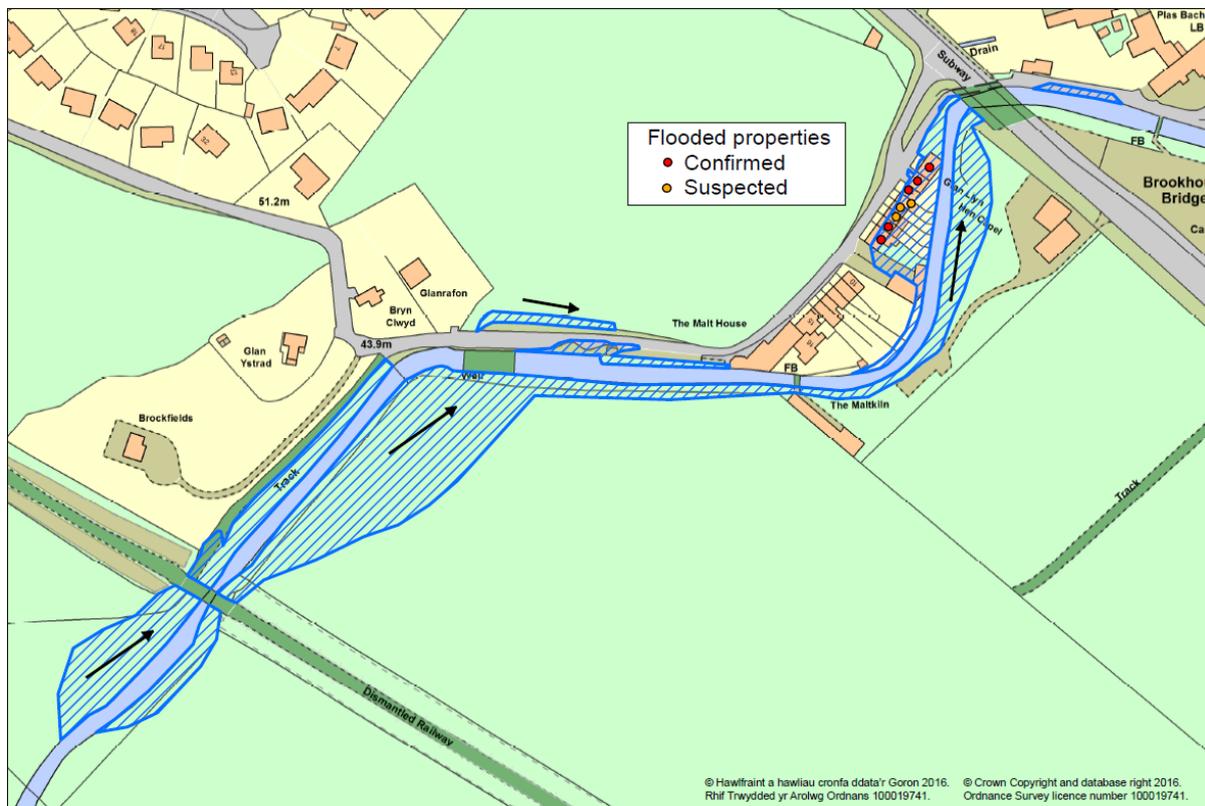
**Figure 2:** Storm Christoph flood extent, indicative flow routes and impacted properties.

Figure 2 summarises findings of the investigation, indicating affected properties, flood extent and indicative flow routes.

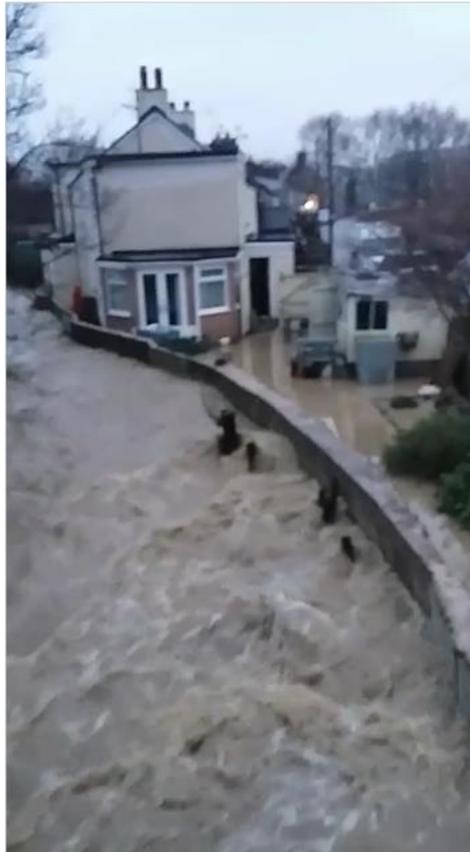
Image 1. Extract from local residents' video at the approximate peak river level.

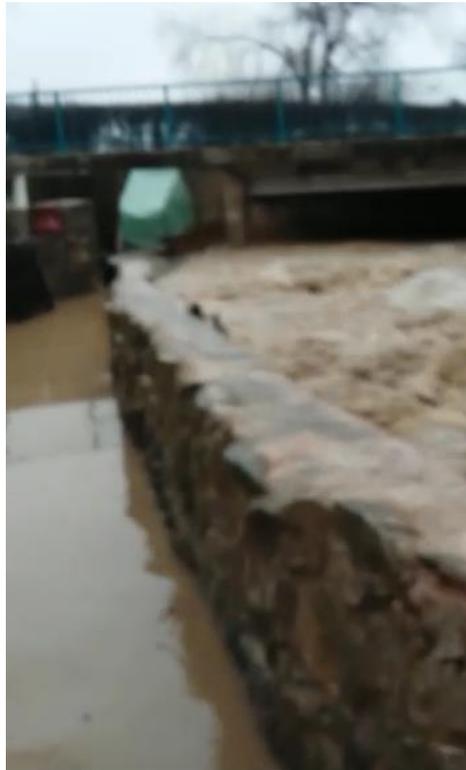
Adhoc walls on the left bank of the watercourse did not overtop during the event. Photographic evidence contained within Appendix A would suggest water levels were able to equalise across the wall located at the downstream extent of the residential properties. The homeowner of this property did suggest a hole had been installed in the wall to allow this to happen as on previous events surface water had accumulated behind the wall and resulted in internal property flooding as door threshold level had been exceeded by the impounded water

Image 2. Extract from local residents' video showing water levels across the wall at the downstream end at the approximate peak river level.

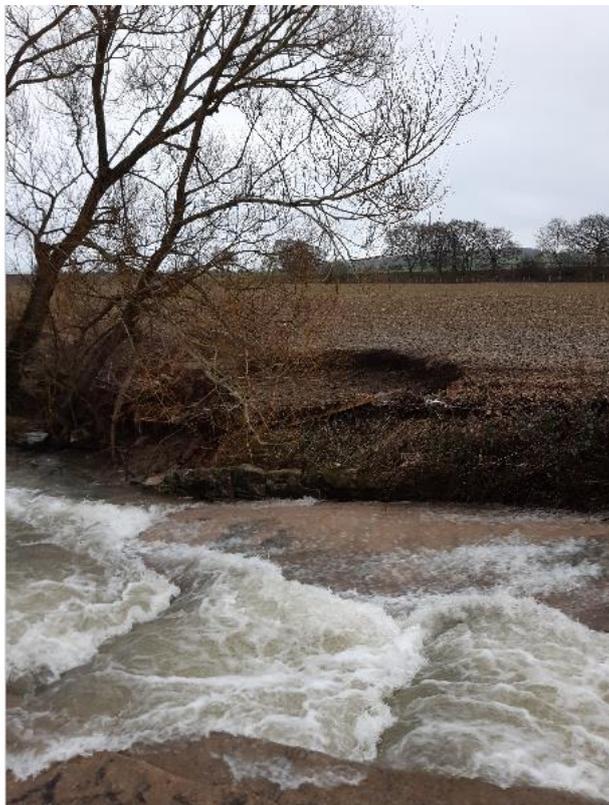
A notable area of scour was observed adjacent to the weir on the right bank of the watercourse, assumed to have been caused by out of bank flows returning to the channel downstream of the weir.

Image 3. Area of scour on right bank adjacent to weir.
