**Cyfoeth
Naturiol**
Cymru
**Natural
Resources**
Wales

Flood Investigation Report Ruthin 20 January 2021

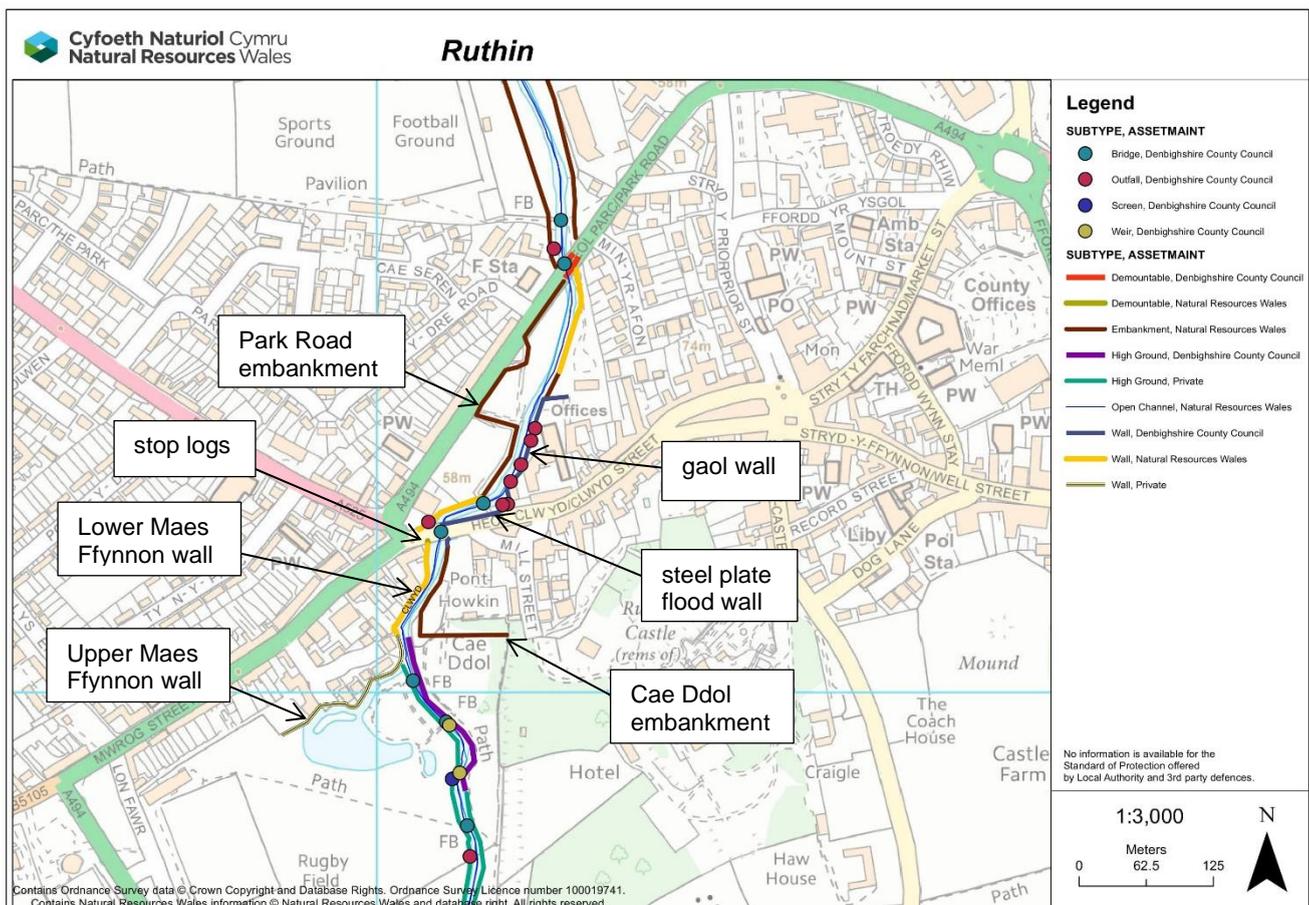
Figure 3: Ruthin flood risk management assets

All raised defences in the Ruthin area are visually inspected on a 6-month schedule. All assets have a condition score allocated in reference to the 2012 Condition Assessment Manual². At the time of the January 2021 storm event, majority of NRW maintained flood risk management assets in Ruthin were performing at or above their target condition with only the lower Maes Ffynnon wall slightly below its target condition.

The most recent asset inspection of the Cae Ddol embankment did identify a localised defect with the condition of the embankment adjacent to the castle wall. Whilst not sufficient to decrease the overall condition assessment of the embankment the defect was raised with the Operations team and a repair was due to be undertaken this summer when conditions allowed.

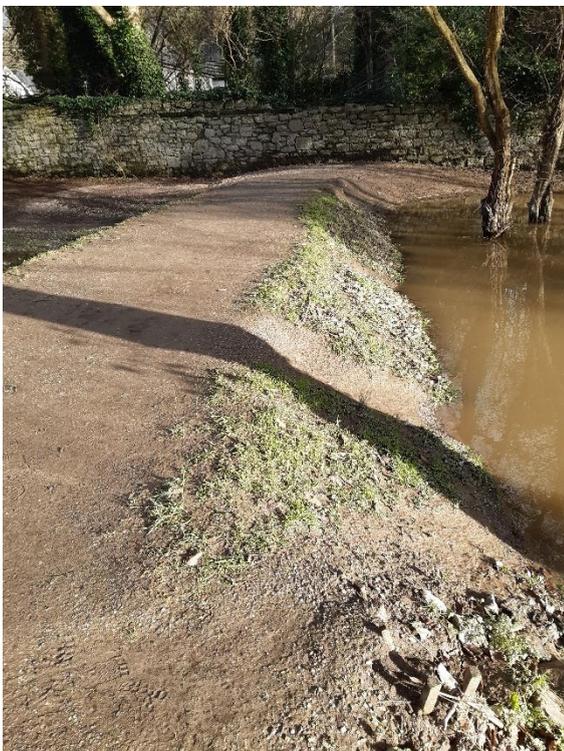
Residents detailed that around 3-4 pm, the Clwyd began to inundate the park areas around Cae Ddol. As the Clwyd continued to rise, the Cae Ddol embankment near the skatepark (see Figure 4) overtopped and floodwater began to fill the Crispin Yard Car Park and the public conveniences.

The location of overtopping of the Cae Ddol embankment was similar to that which overtopped during the 2012 flood event. According to residents, in February 2020, sandbags were placed along the crest of the Cae Ddol embankment which stopped the Clwyd from overtopping to the car park, it is presumed that Denbighshire CC undertook this work as NRW has no knowledge of this.

Figure 4: Cae Ddol embankment near skatepark (source: NRW staff)

1. Temporarily raised the Cae Ddol embankment through the use of sandbags to increase the standard of protection for the properties on Mill and Clwyd streets.
2. Undertaken a full topographic survey of the Ruthin flood alleviation scheme.
3. Undertaken an asset condition walk through to check on any post flood defects.

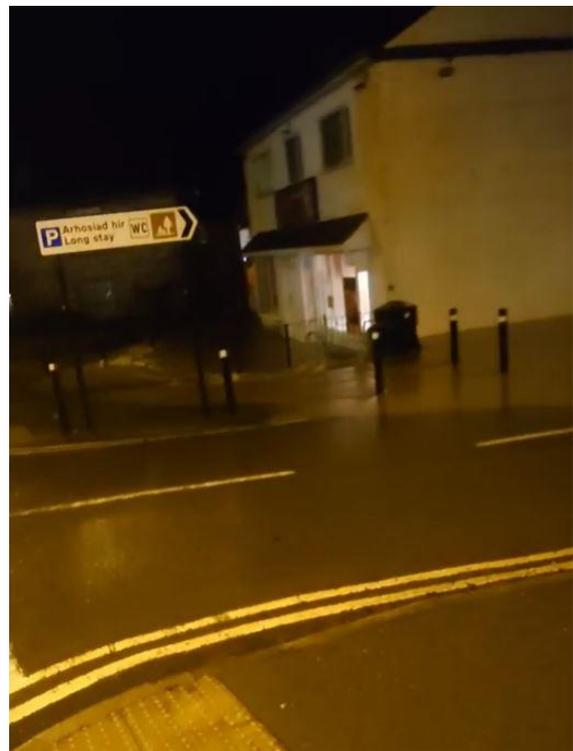
Around the same time (6:30 pm), floodwater entered 'Ty Carrog'. The floodwater had flowed north from the car park (south of 'Crispin'), towards the car park entrance on Clwyd Street and into Mill Street (see Figure 5). The properties along Mill Street were flooded not long after, with 1 Mill Street reporting internal flooding at about 7:15 pm.

Figure 5: Floodwater at the car park entrance (Source: Real Fans of Ruthin Facebook page)

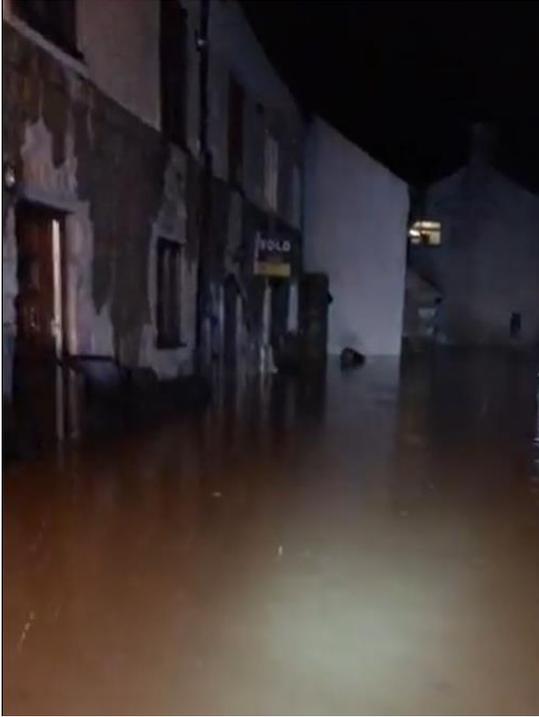
The Clwyd floodwater ponded on Clwyd and Mill streets (Figure 6 and Figure 7) as it was unable to drain back into the river due to the steel plate flood wall (see Figure 9) along Clwyd Street, designed to stop the Clwyd downstream of Pont Howkin overtopping to Clwyd Street. The masonry wall alongside the gaol also trapped the floodwater from returning to the Clwyd.

The roadside gullies along Clwyd and Mill streets were overwhelmed by the volume of water (as they are designed for local runoff) and anecdotal evidence from residents suggested some needed unblocking, so were unable to drain the ponded water efficiently.

**Figure 6: Flooding on Mill Street
(Source: Real Fans of Ruthin
Facebook page)**

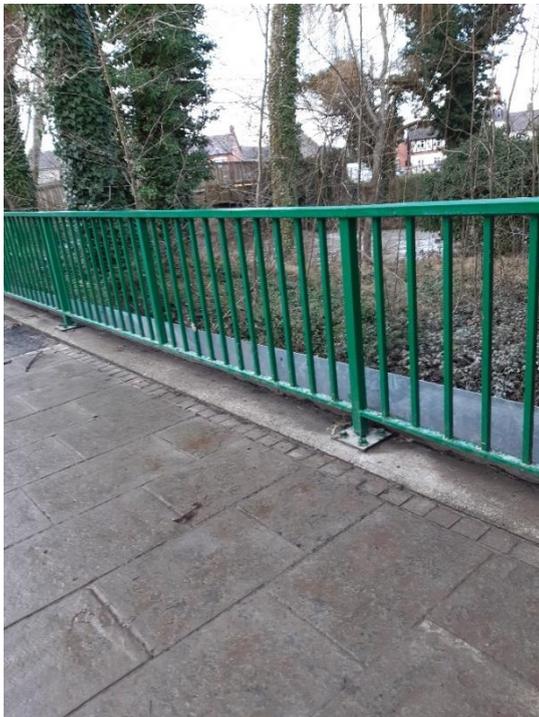
**Figure 9: Steel plate flood wall along
Clwyd Street (source: NRW staff)**

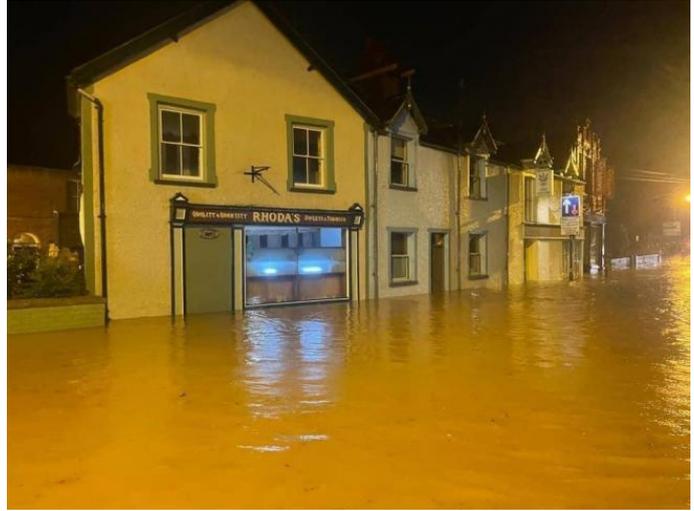
The floodwater on Clwyd Street peaked at about 9:30-10 pm, reaching the front step (did not enter) of 'Royal Oak' on Clwyd Street.

**Figure 7: Flooding on Clwyd Street (Source:
NWP Rural Crime Team twitter page)**

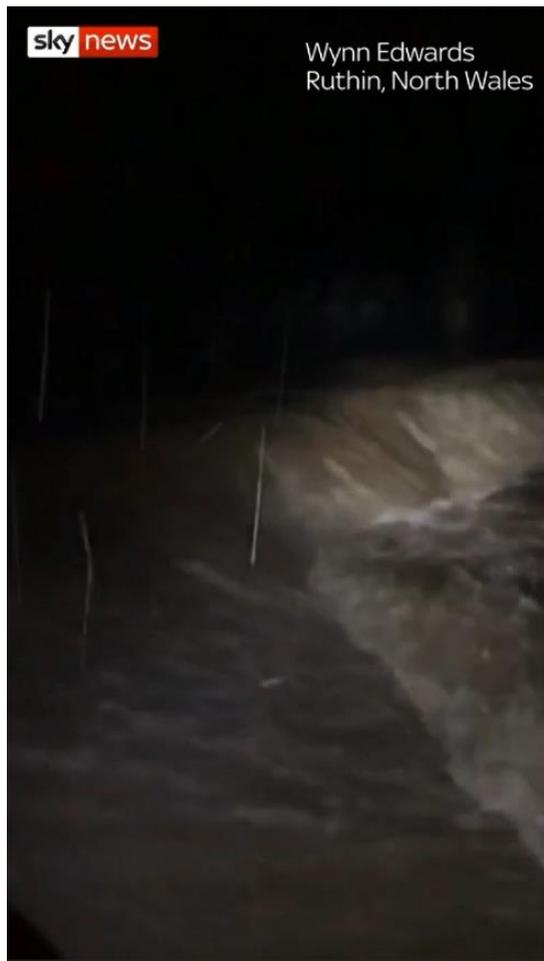
As a result of the rising river level, the Afon Clwyd overtopped the Cae Ddol flood defence embankment and flooded areas of Mill Street and Clwyd Street in Ruthin. Areas around Maes Ffynnon estate and outside of 1 Mwrog Street were also affected by Clwyd floodwater.

**Figure 8: Overtopping of the Cae Ddol
embankment (source: Sky News³)**

The significant nature of the event and the extent of defences overtopped indicates that the flooding was caused by an exceedance event, in that the flood event was bigger than the defences were designed to protect against.

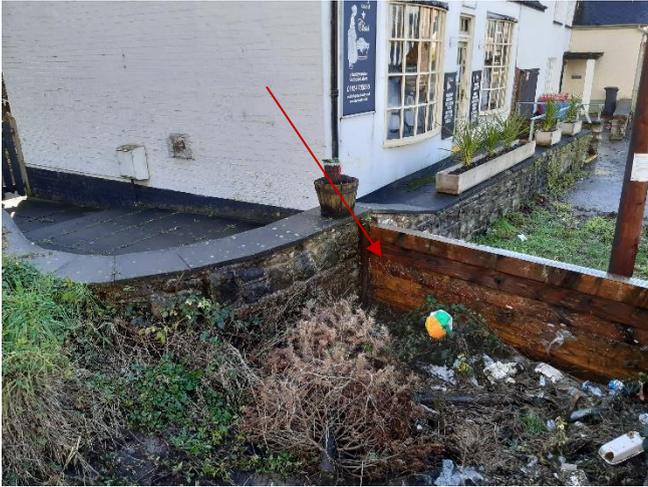
According to observations from Waterco staff, the floodwater from the Clwyd was seeping between the stop logs (Figure 10) immediately upstream of Pont Howkin bridge. This water was flowing towards properties (Figure 11), however there was no reported internal flooding in this area.

Figure 10: Wrack mark at stop logs (Source: NRW staff)

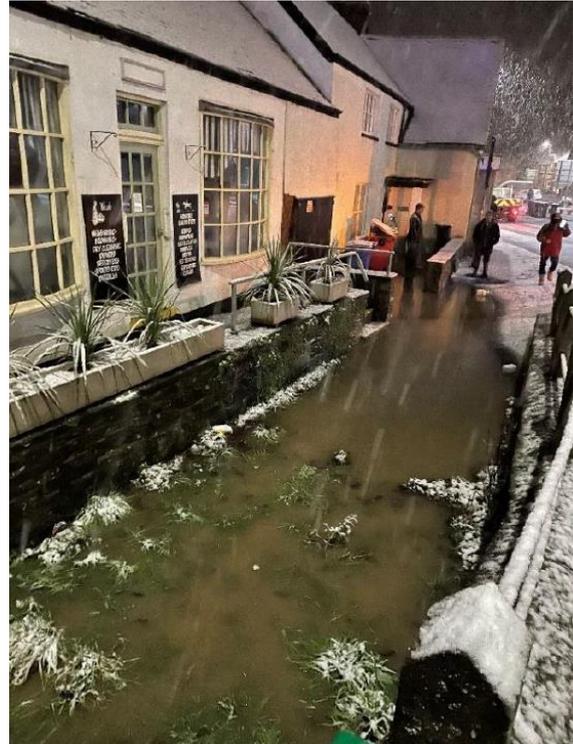
Figure 11: 1 Mwrog Street (Source: Waterco)

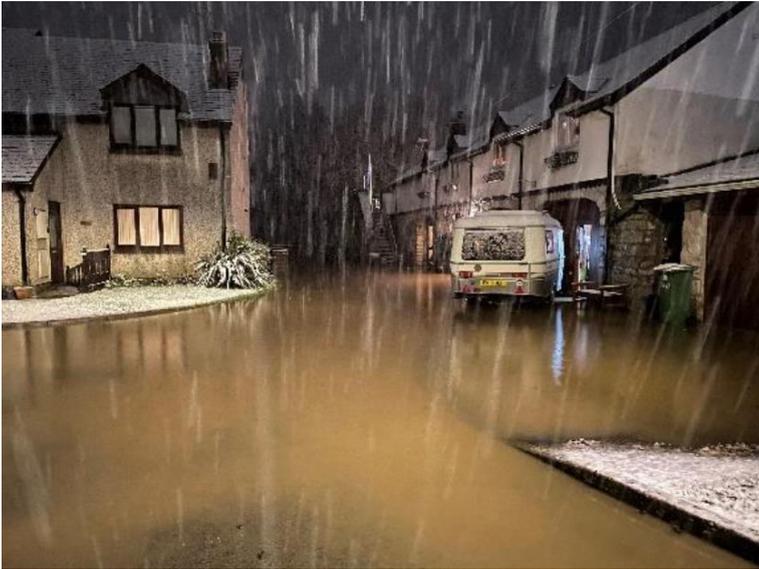
Denbighshire CC have confirmed there was internal flooding at 24 Maes Ffynnon, which was caused by water coming up through the ground outside once the Clwyd levels had reached a height above ground level. This was also the case for 15 to 19 Maes Ffynnon, with water coming up through the back gardens/patio over a period of 3-4 hours, accumulating in approximately 8-9 inches of water, but not enough to enter through conservatory/back doors. Levels started to drop around 8-9 pm.

The Clwyd did not overtop the Maes Ffynnon wall, peaking about 0.3 m below the top. Nor was water observed to be seeping through the stone wall. Instead, floodwater was coming up through the manhole and roadside gullies.

Figure 12: Maes Ffynnon estate (source: Waterco)

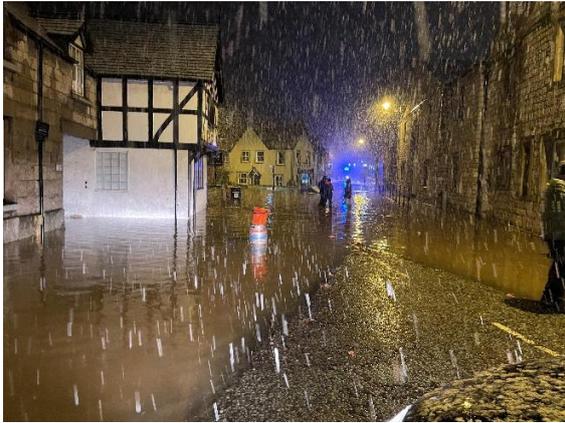
During the site visit, we observed the flood water extent to be from approximately 10m short of the local chip shop, Finns, to the eastern side of the BP Garage road bridge. Due to the depth of the flood water, we were unable to inspect further than the extent of the flood extent.

View from the chip shop towards Mill Lane

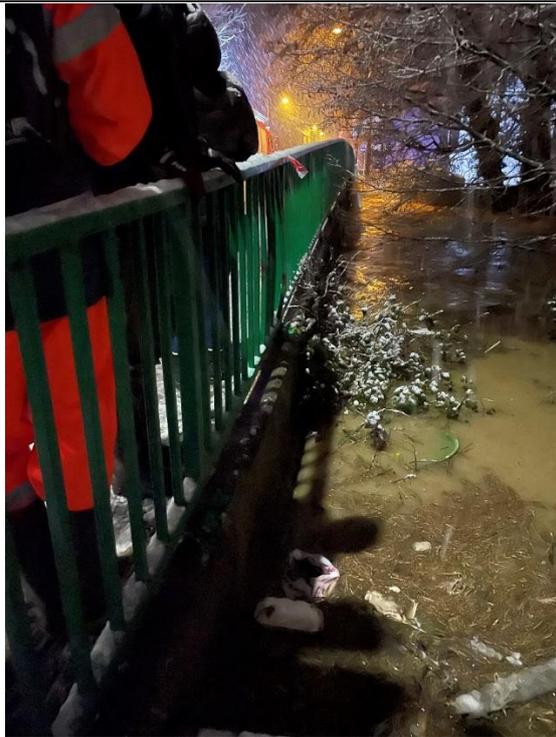
The road bridge allows the River Clwyd to pass under the road (Clwyd Street), with the Llanfwrog watercourse discharging into the River Clwyd immediately downstream of the bridge. The road bridge appeared to be at full capacity with water up to the soffit. To the east and west of the road bridge demountable stop logs (wood) were deployed. Water was observed to be flowing/seeping slowly between each stop log. The result to the western demountable was that water was slowly flowing towards a shop and at least one property, with a low door threshold. The owners were attempting to block the water at their doors, but it was unclear if internal flooding had occurred.

Upstream view across road bridge from western demountable

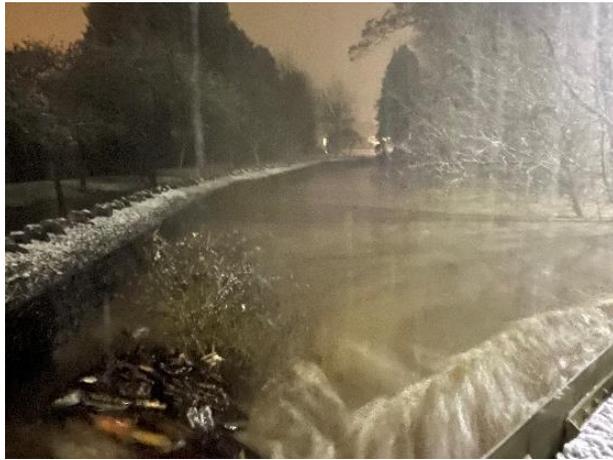
The road crossing at the fire station appeared to be at full capacity, with an imminent risk of overtopping. This could have caused flooding to the fire station and the properties along Park Road and into Parc-y-Dre and Cae Seren.

View upstream from fire station road crossing

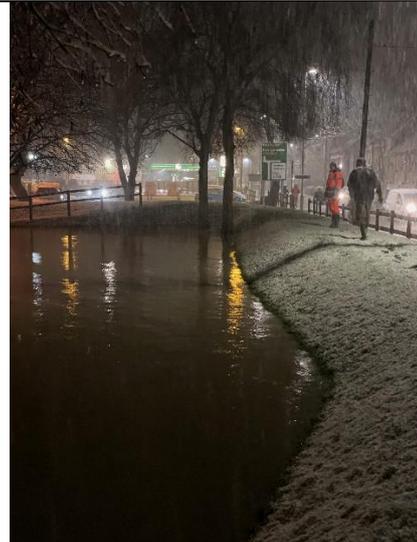
A potential low spot in the flood defences was observed at the fire station road crossing. The parapet threshold appears to be some 300mm lower than the top of the earth bunds. The water level in the bunded area was approximately 500mm lower than the top of the bunds.

View showing available capacity within the bunded storage area

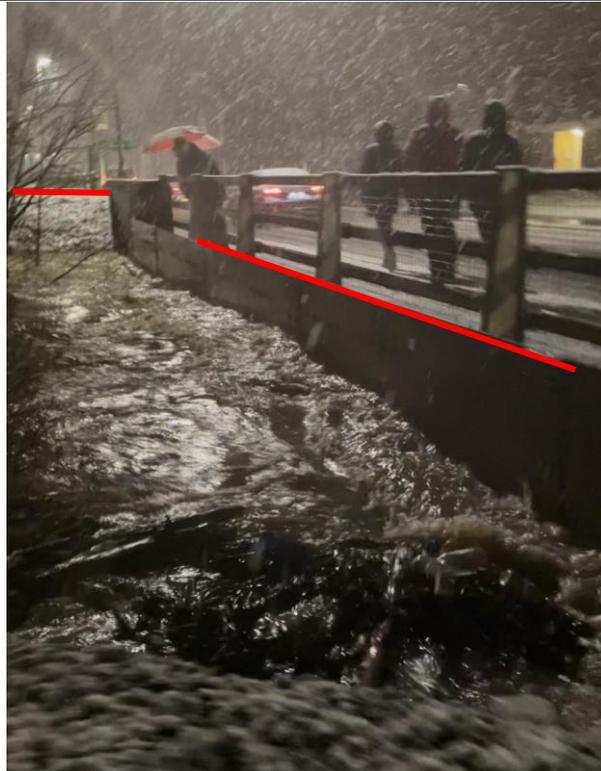
View of the fire station road crossing and bunded area.
Note the difference in level (shown in red) between the top of bund and bridge threshold

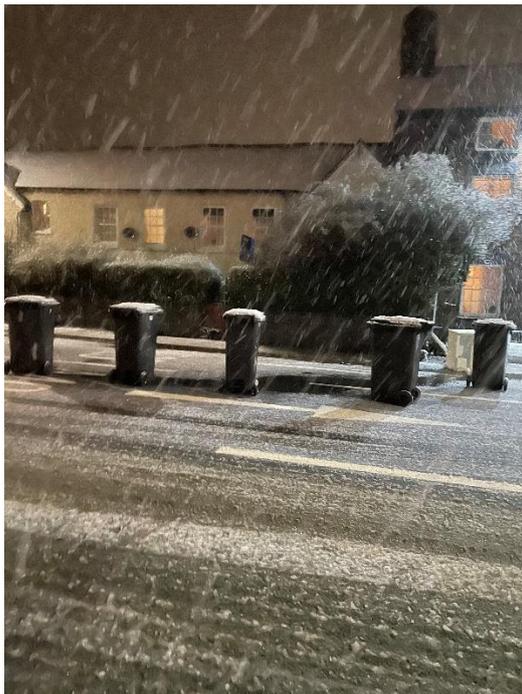
The outfall at the BP Garage appeared to be discharging at full bore. The first upstream manhole in the highway (next to the Park Place public house) had been fenced off by residents. It was assumed that this action had been taken in advance of the manhole cover potentially blowing. We visited the manhole twice and observed minimal surcharging onto the road.

Surcharging manhole adjacent to Park Place pub

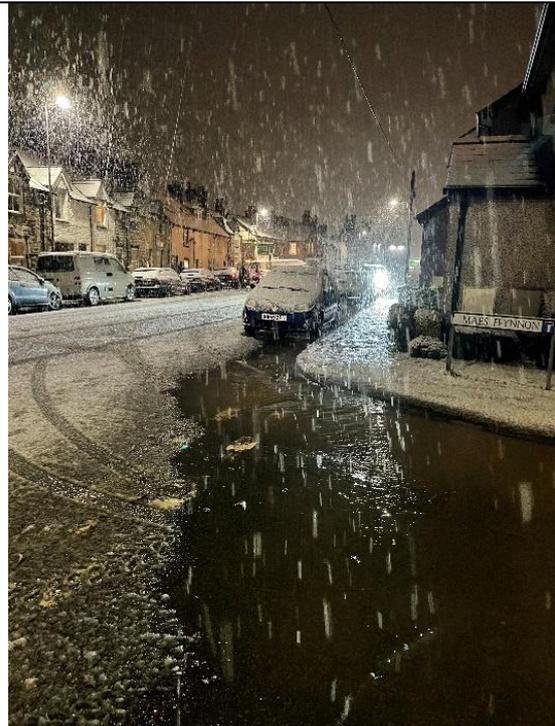
Approximately 200m upstream of the outfall, highway gullies were observed to be surcharging and flooding towards Maes Ffynnon. It is assumed that the gullies discharge into the culvert. The cul-de-sac appeared flooded, but no properties appeared to be affected internally.

Entrance to Maes Ffynnon cul-de-sac

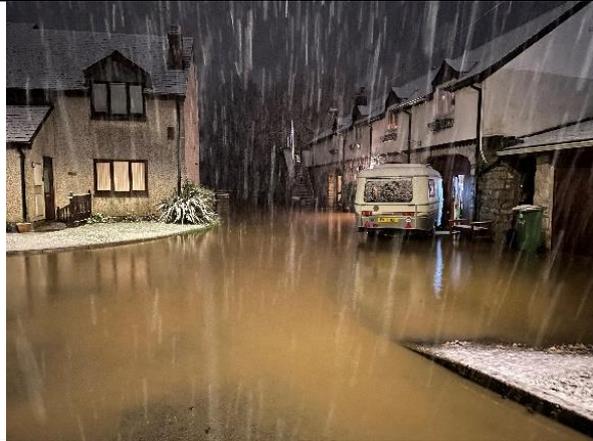
View into Maes Ffynnon cul-de-sac
