PROJECT	Addendum to Brookhouse Flood Investigation Report
PURPOSE OF NOTE	Additional investigation following flooding of property during Storm Christoph (20 th January 2021)
WATERCOURSE	Afon Ystrad
FILE NOTE PRODUCED BY	Neil Taunt
DATE	05/03/2021

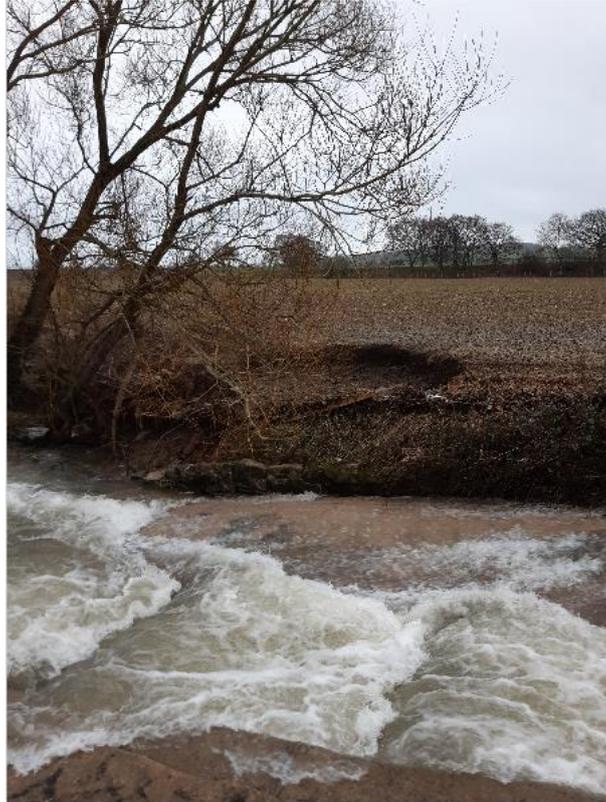
A notable area of scour was observed adjacent to the weir on the right bank of the watercourse, assumed to have been caused by out of bank flows returning to the channel downstream of the weir.

Image 3. Area of scour on right bank adjacent to weir.
