SECTION 19 FLOOD INVESTIGATION REPORT

**20th OCTOBER 2023
FLOOD EVENT**

LOCATION: DENBIGHSHIRE

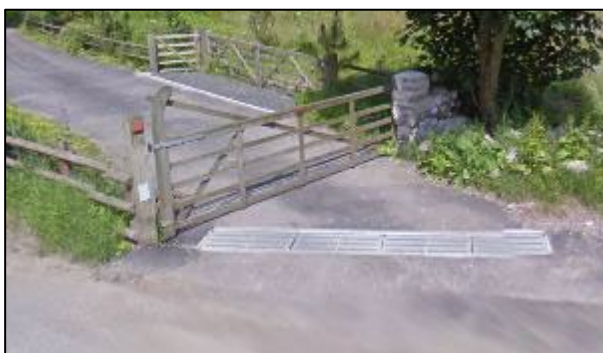
Photo 1: Bespoke highway drainage at Llanarmon Yn Ial flood investigation area

For the Property at Llanarmon Yn Ial, historically surface water highway drainage has caused issues, so much so that in 2007 DCC undertook work to install bespoke highway drains in front of the Property, as shown In photo 1.

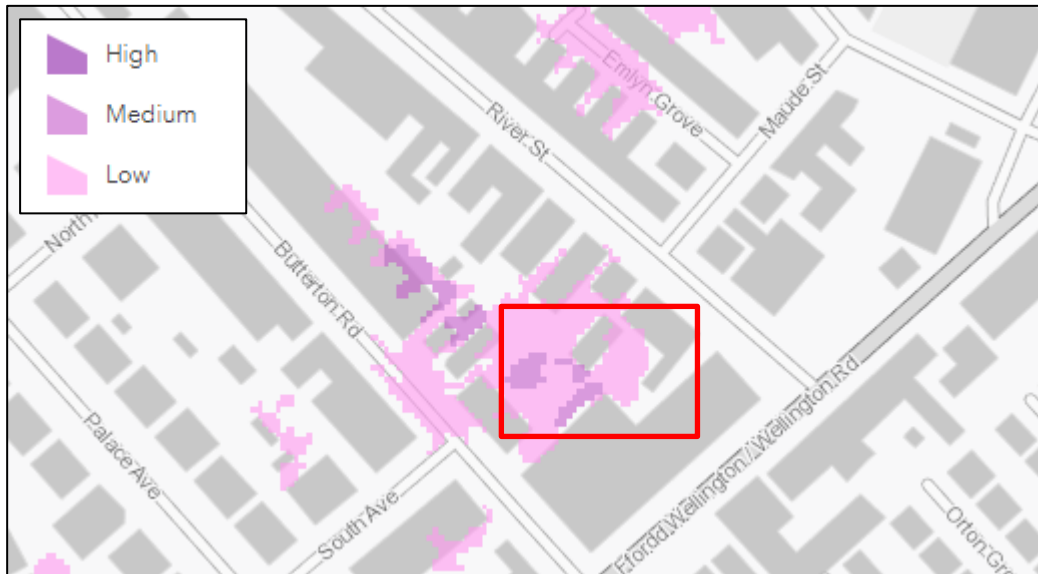
Figure 26: NRW Surface Flood and Coastal Risk Maps for surface water and small watercourses.

Figure 26 from the NRW Flood and Coastal Erosion Risk Maps surface water and small watercourses flood map shows that the two properties have a low to medium risk of flooding from surface water and small watercourses.

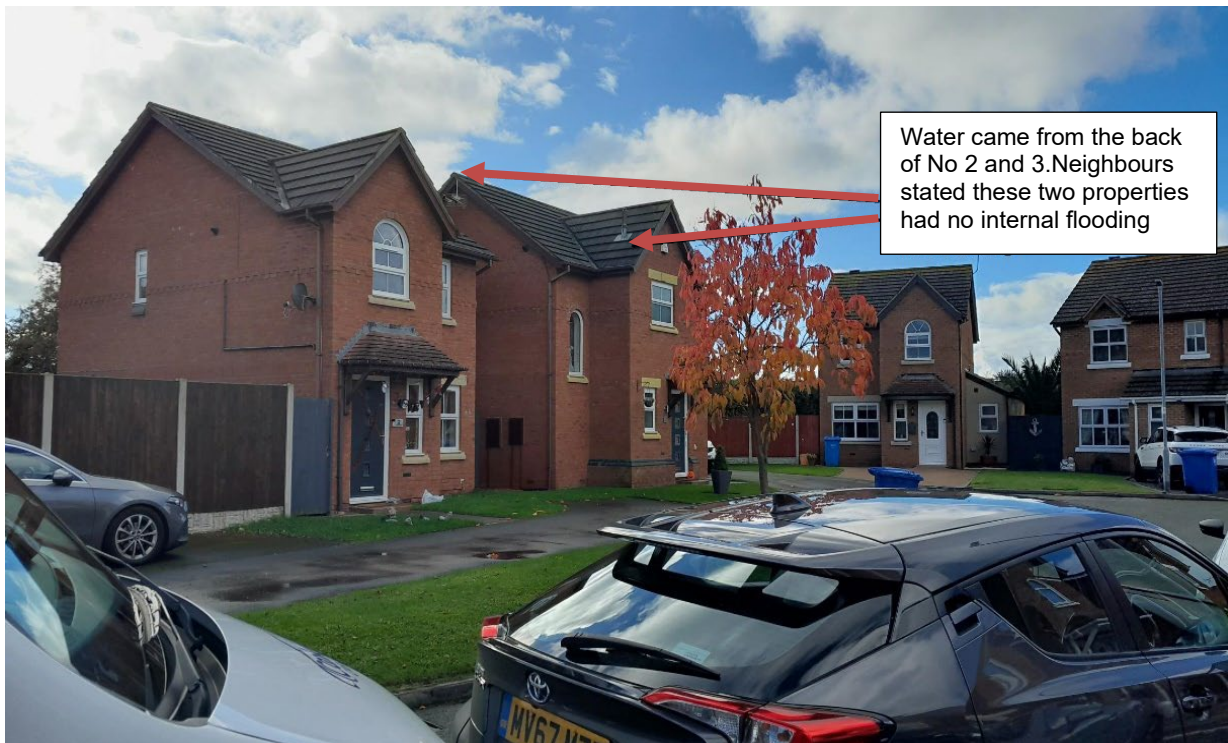
This action by some of the residents at Maes y Gog inevitably sent water down towards Llys Gwennol and merged with flood waters from the Maes Gwilym Drain, which according to residents had entered Llys Gwennol from the back of Nos 2 and 3, as shown in Photo 2 below, which has been supplied by NRW

Photo 2 showing the direction water came from the Maes Gwilym Drain into Llys Gwennol.

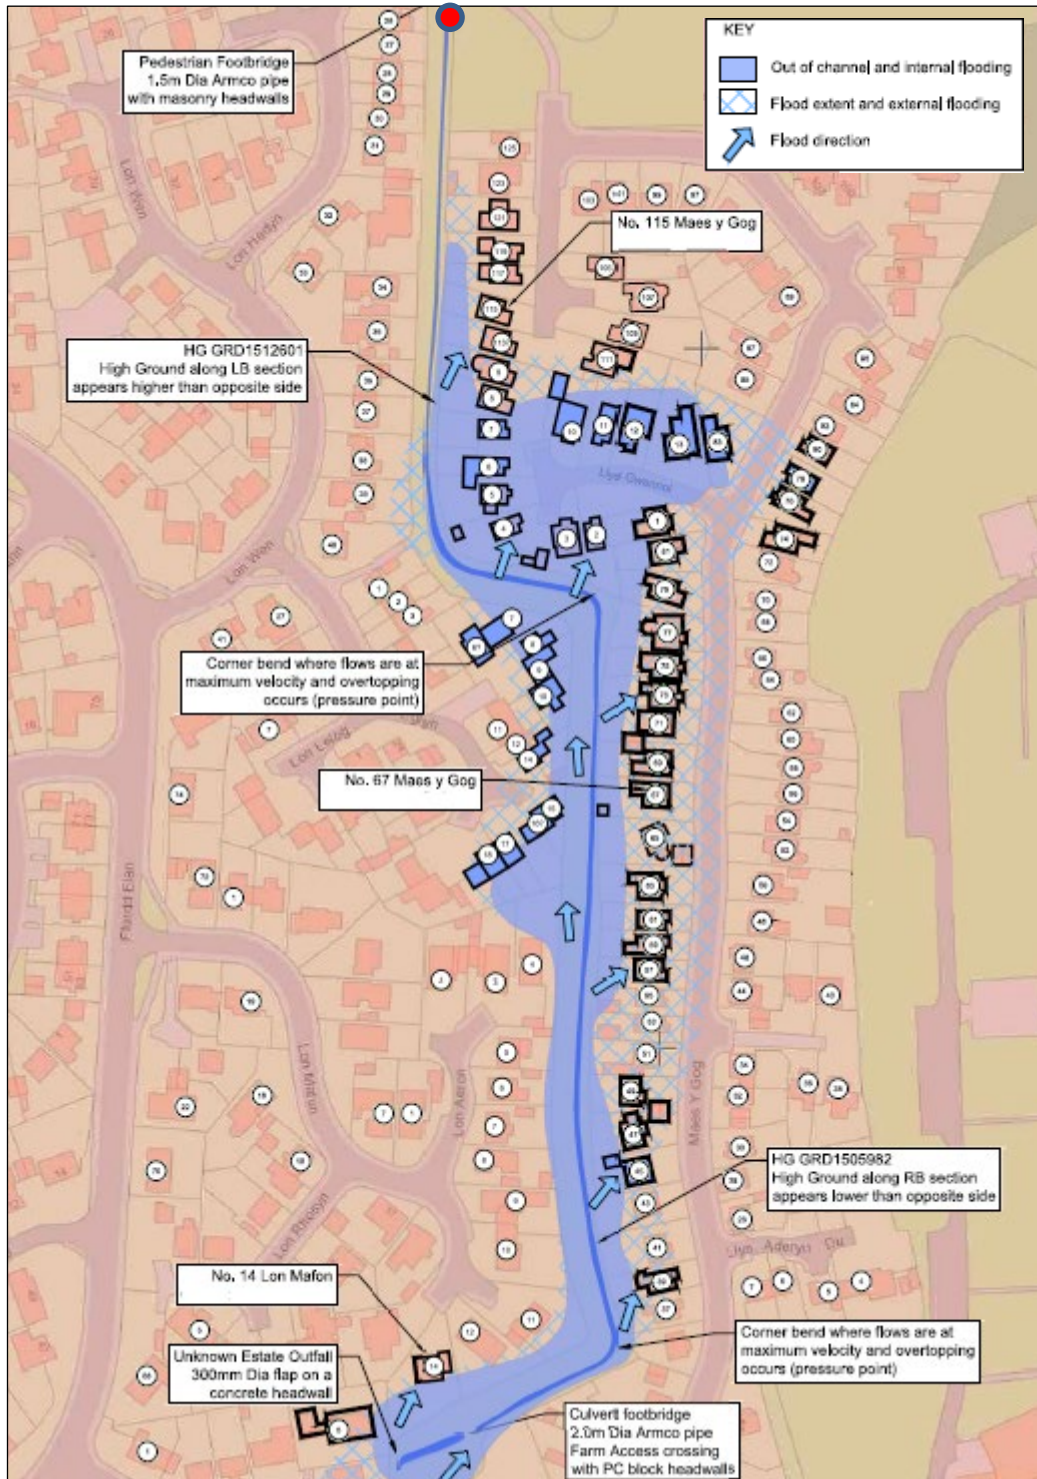
Figure 27: Flood source map from the Maes Gwilym Drain, courtesy of NRW

Nos 2 & 3 suffered no internal flooding, but unfortunately this flow, coupled with the brushed/pumped water from Maes Y Gog, caused internal flooding to Nos 7, 8, 9, 11, 12, 13 at Llys y Gwennol and 83 Maes Y Gog, as shown in figure 27

From NRW's on site investigation, it was evident that the watercourse had come out of channel where there were two sharp almost 90 degree changes in direction of the channel. Figure 27 shows the location of these bends along with the flood flow direction. Water in the Maes Gwilym Drain is at maximum velocity at these two bends and overtopping occurs.

From the above Figure (27), the first bend is located behind No 39 Maes Y Gog and No 14 Lon Mafon. Here the water overtops and enters the back of properties at Maes Y Gog. Water also overtopped the left bank as witnessed by the resident of No 14 Lon Mafon who stated that the small culvert footbridge marked in the figure also restricted flows further and caused overtopping into the resident’s back garden. The second bend is directly behind Nos 2 & 3 Llys Gwennol which would explain the anecdotal evidence from

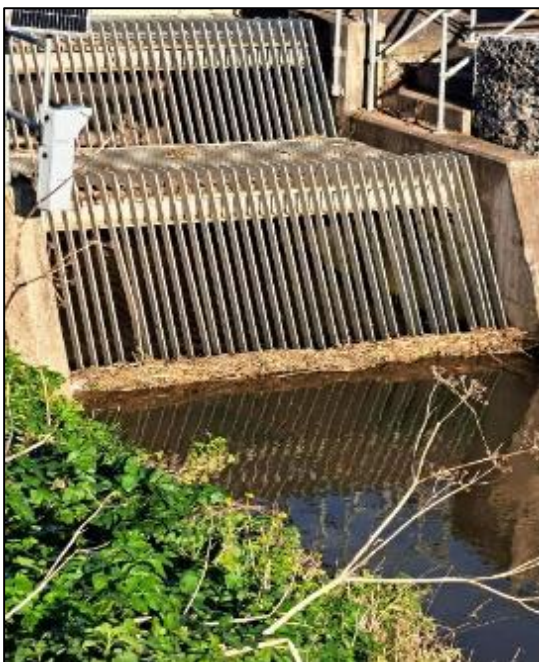
Photo 3: Lyons Culvert

No other blockages were observed in the watercourse itself, although it might be that the footbridge culvert further down-stream of Llys y Gwennol (see red circle in figure 27 for location) may have restricted flows further, but there was no evidence of over-topping here. According to a resident of Maes Y Gog, there is also a possibility that the upstream culvert at the railway crossing and Lyons Holiday Park caused water to back-up to the Maes Gwilym Drain as both were allegedly blocked with debris on the day of the flooding, Photo 3 and 4 show both culverts respectively, but were not taken on the day of the flooding.

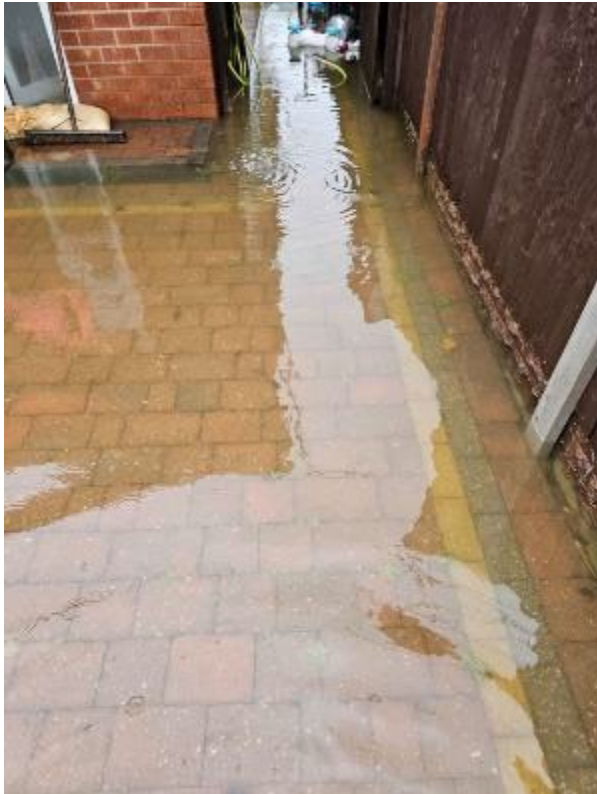
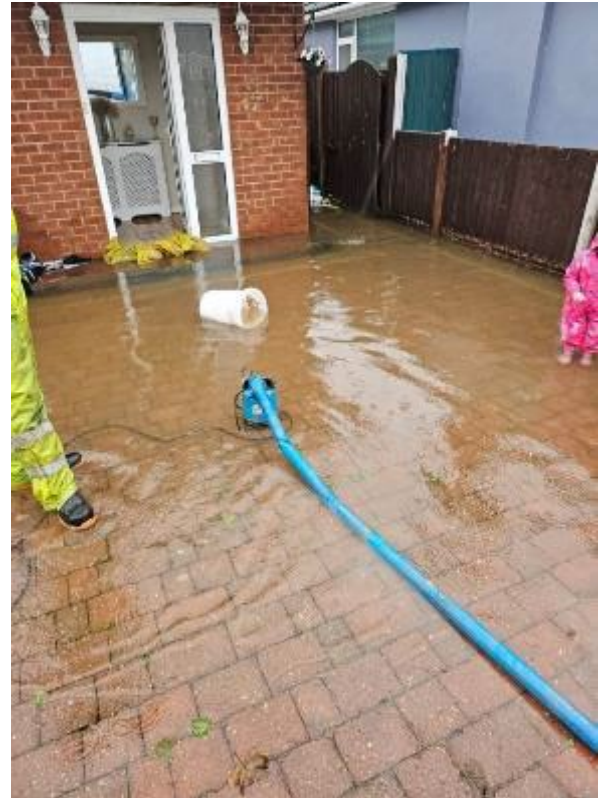
Residents of Property number 1 were visited to discuss the flooding, which had caused severe internal damage to the Property. Photos 5 and 6 below show the extent of the flood at this Property.

Photo 5 – Flooding at No 1 Winchester Drive

Photo 6 – Flooding at No 1 Winchester Drive

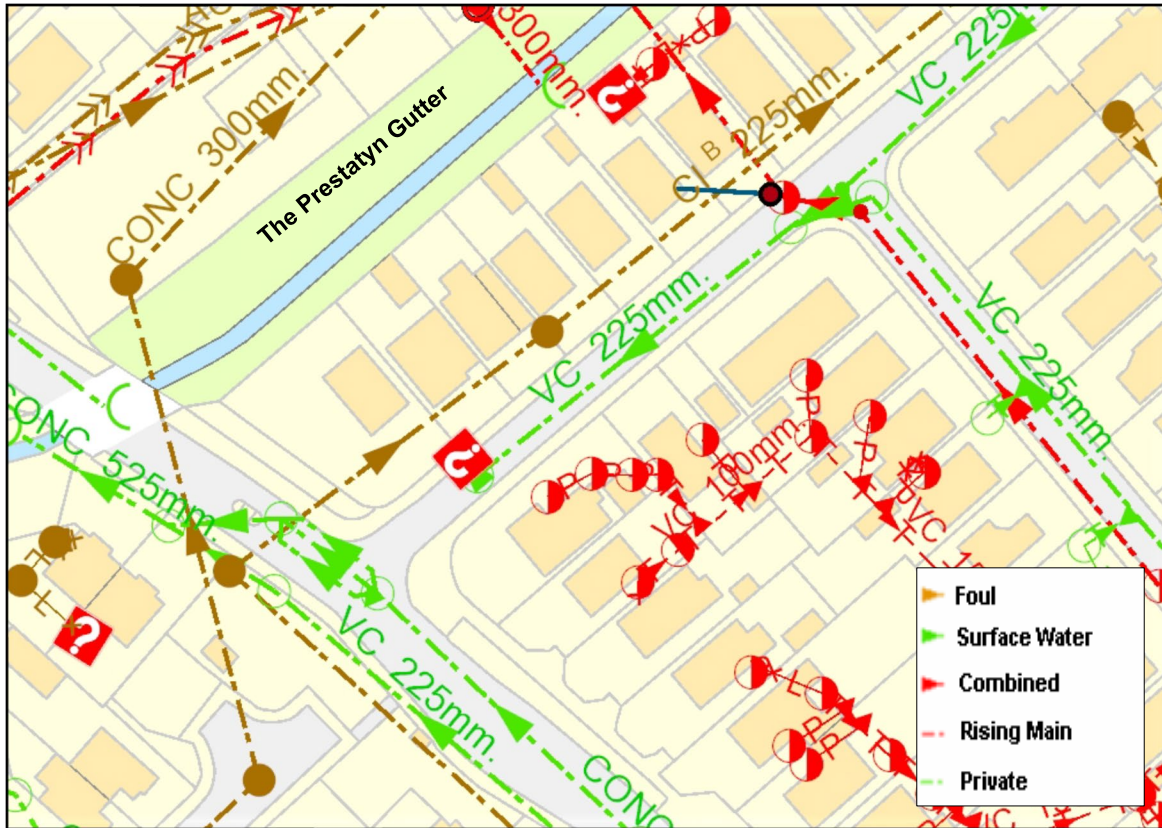
Figure 34: DCWW drainage apparatus map for Winchester Drive

Welsh Water are responsible for the sewerage infrastructure at Winchester Drive. Figure 34 shows the the network at this location to area be combined, which drains to the main Marine Park Pumping Station (see figure 5 for the location). This pumping station also has a storm overflow facility that discharges to the Prestatyn Cut during storm conditions.

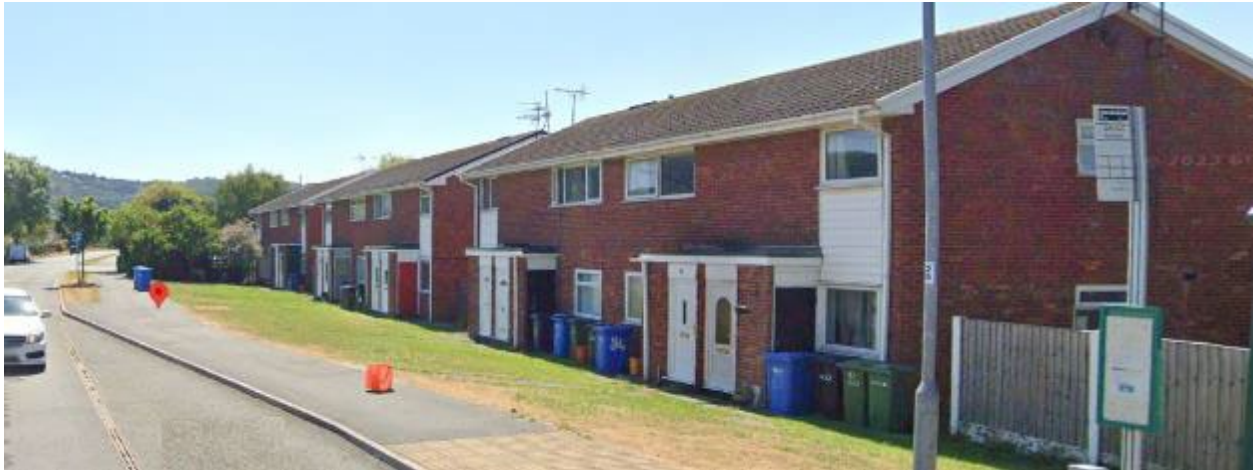
Photo 7: Photo showing the drop in gradient in front of the flooded ground floor flats at Ffordd Penwhylfa

- To engage with all relevant stake-holders to understand how the drainage systems work and what can be done to improve the flood risk issue
- DCC strongly recommend residents investigate PLP

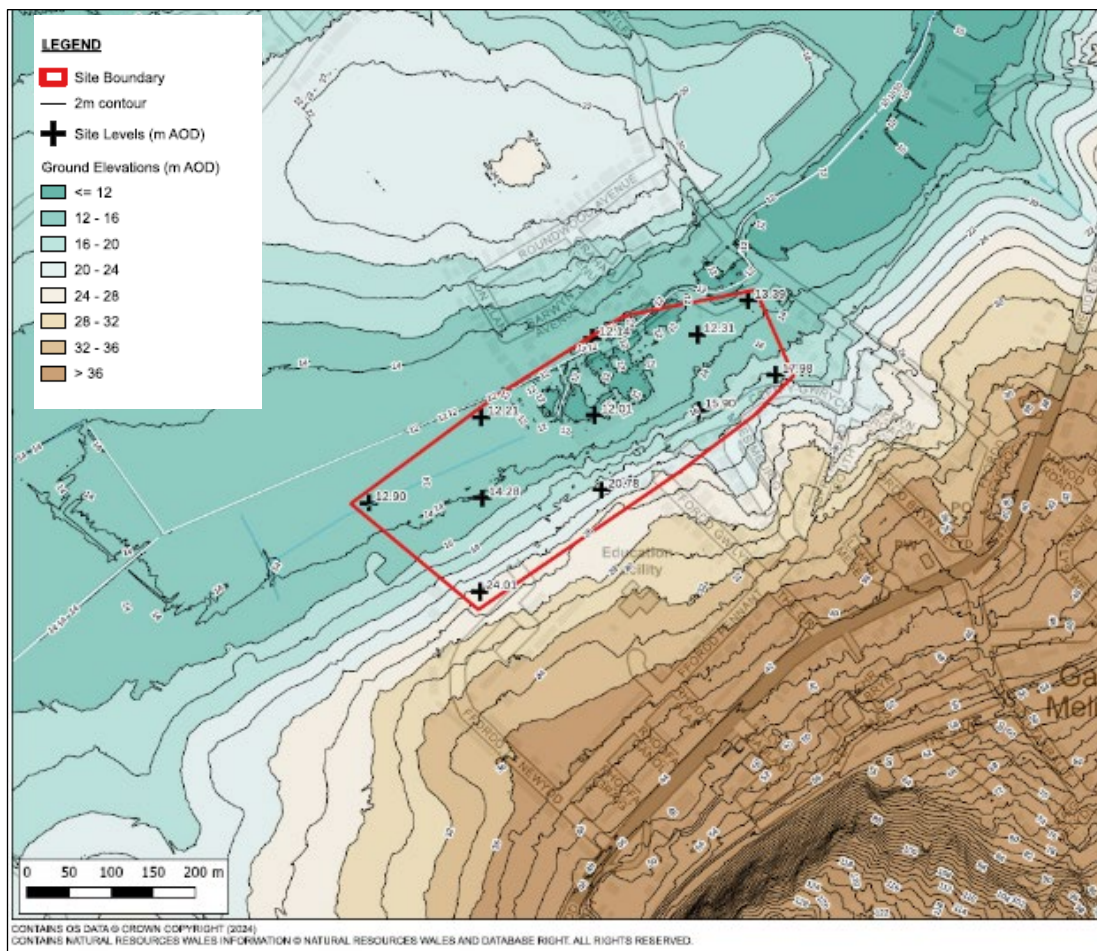
Figure 39: Ground elevations in relation to the flood investigation area at Pwll y Bont

Hence, it is likely that surface water inflow upstream of the site from ditches (minor watercourses) and runoff from the upland area flowing towards Prestatyn Gutter caused and contributed to the internal flooding of 5 properties at Pwll y Bont.

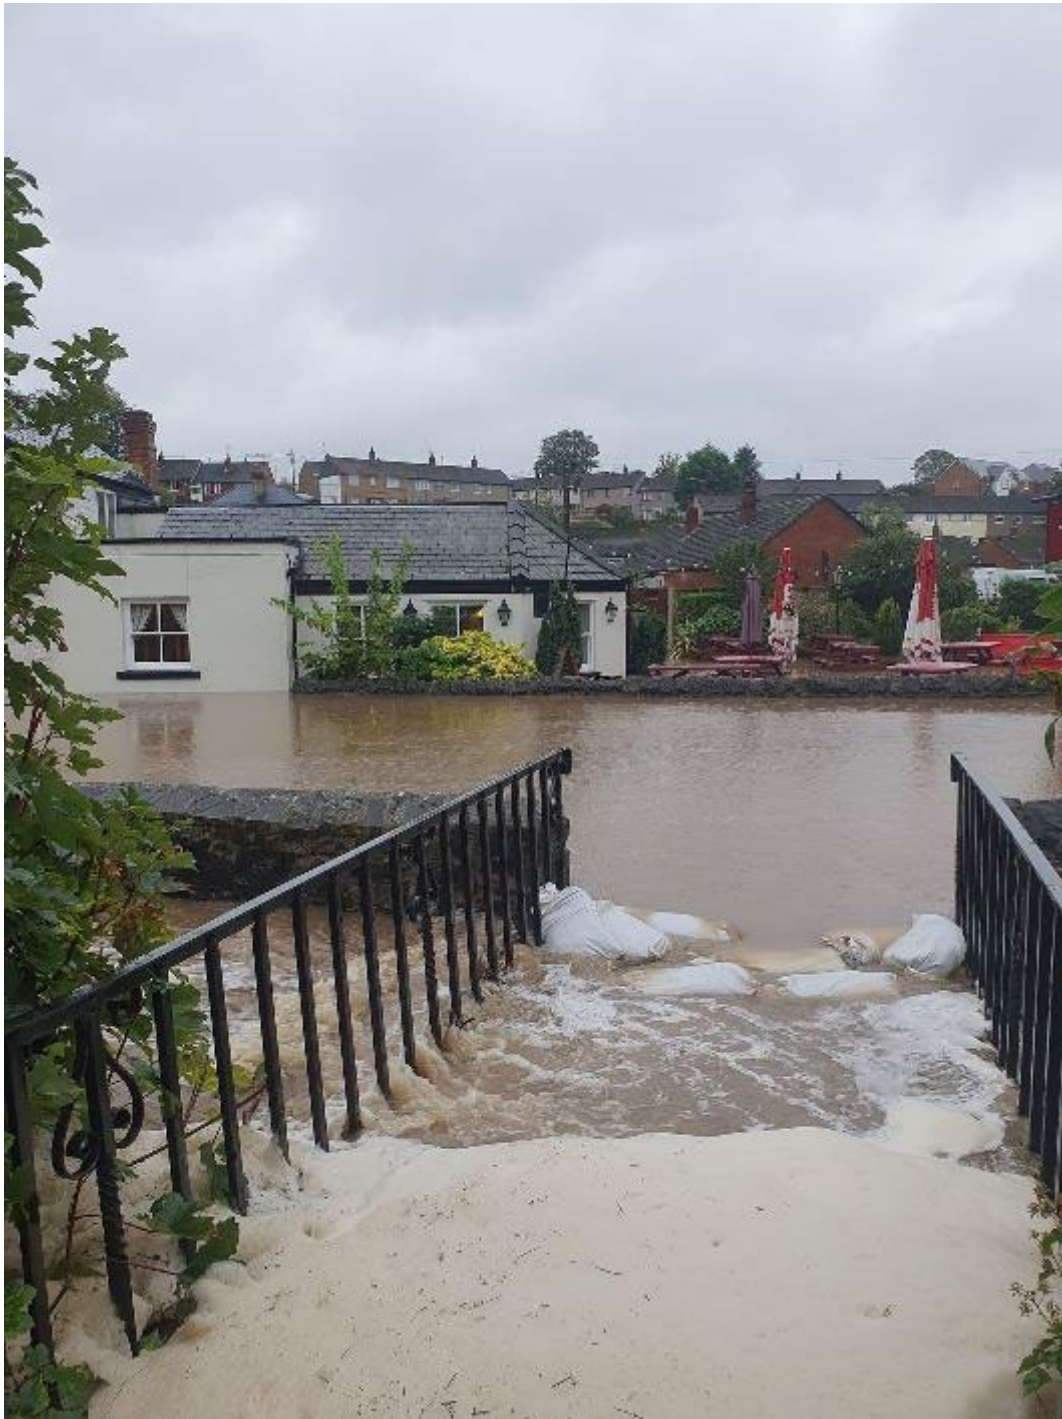
flooding is lack of capacity within the channel to cope, as well as crossings/culverts along this section restricting flows further. Therefore, on the 20th October, this scenario played out, which caused the Afon Ffyddion to over-top onto Waterfall Road and consequently cause internal flooding to 3 properties and 1 business.

Photo 8: Flooding from the Afon Ffyddion onto Waterfall Road

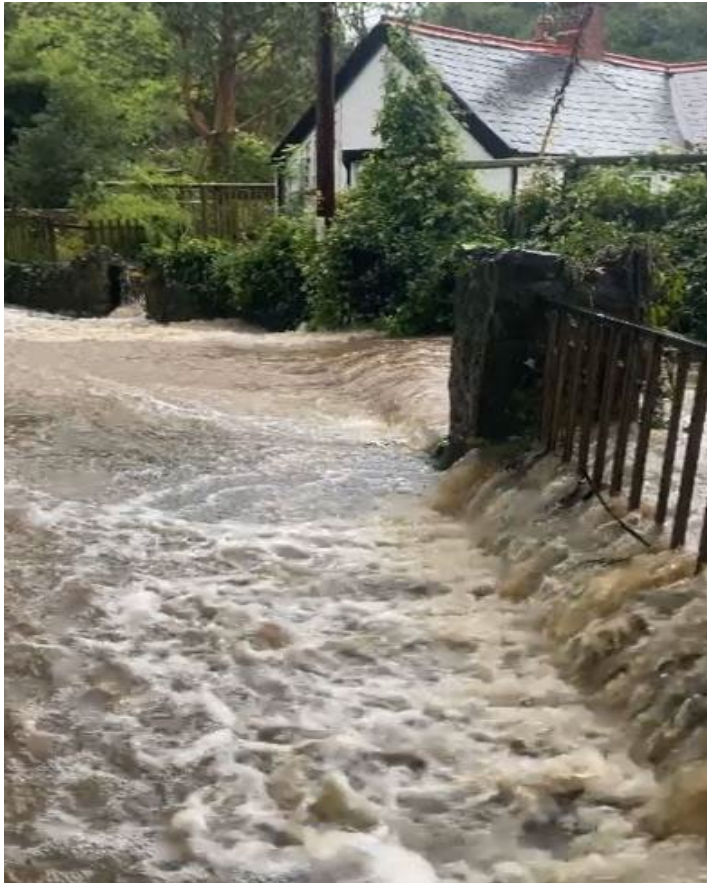
Glan y Afon Cottage on Pandy lane suffered internal flooding due to the Afon Ffyddion overtopping as a result of the storm conditions, as shown in photo 9

Photo 9: Flooding from the Afon Ffyddion at Glan y Afon Cottage

The floodwater flowed out of the river bank and made its way around Glan y Afon Cottage before being impounded by the garden wall, which may have caused the flood water to back-up and increase the depth of flooding. This however will need further investigation via modelling to confirm the flood outlines.

There was also debris build up at the highway bridge adjacent to the Cottage, caused mainly by fallen trees which had washed down from the heavily wooded catchment as a result of the Storm. DCC operatives cleared debris build-up during the morning of the Storm.

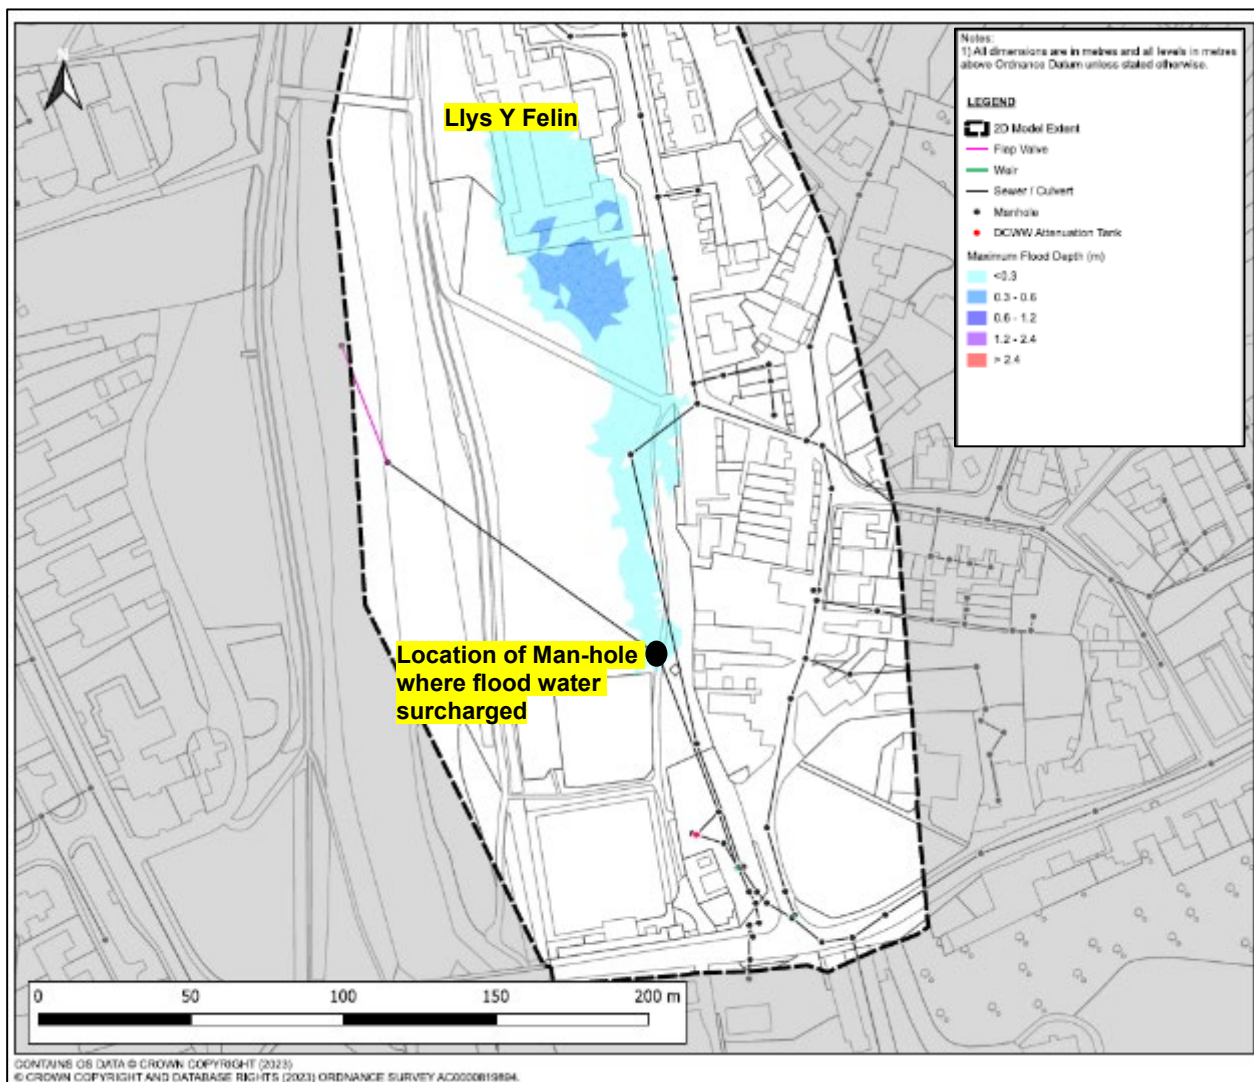
Figure 44. Maximum Flood Depth during Storm Babet at Llys y Felin

The Intense rainfall experienced during Storm Babet, caused spilling from the DCWW tank (CSO) into the system which outfalls into the Elwy via a non return flapvalve. However, the River Elwy was high, that is, showing a maximum level of 4.44 metres²,

which consequently caused water to back-up in the system and eventually surcharge out through a man-hole. The floodwater then flowed in a northerly direction towards the DCC owned flats at Llys y Felin and caused internal flooding to 6 flats.

Following flood modelling done by flood consultants, minimal input is shown into the gullies along St.Asaph High Street and therefore, it is the incapacity of the DCWW sewer system and tank (CSO) which caused the flooding.

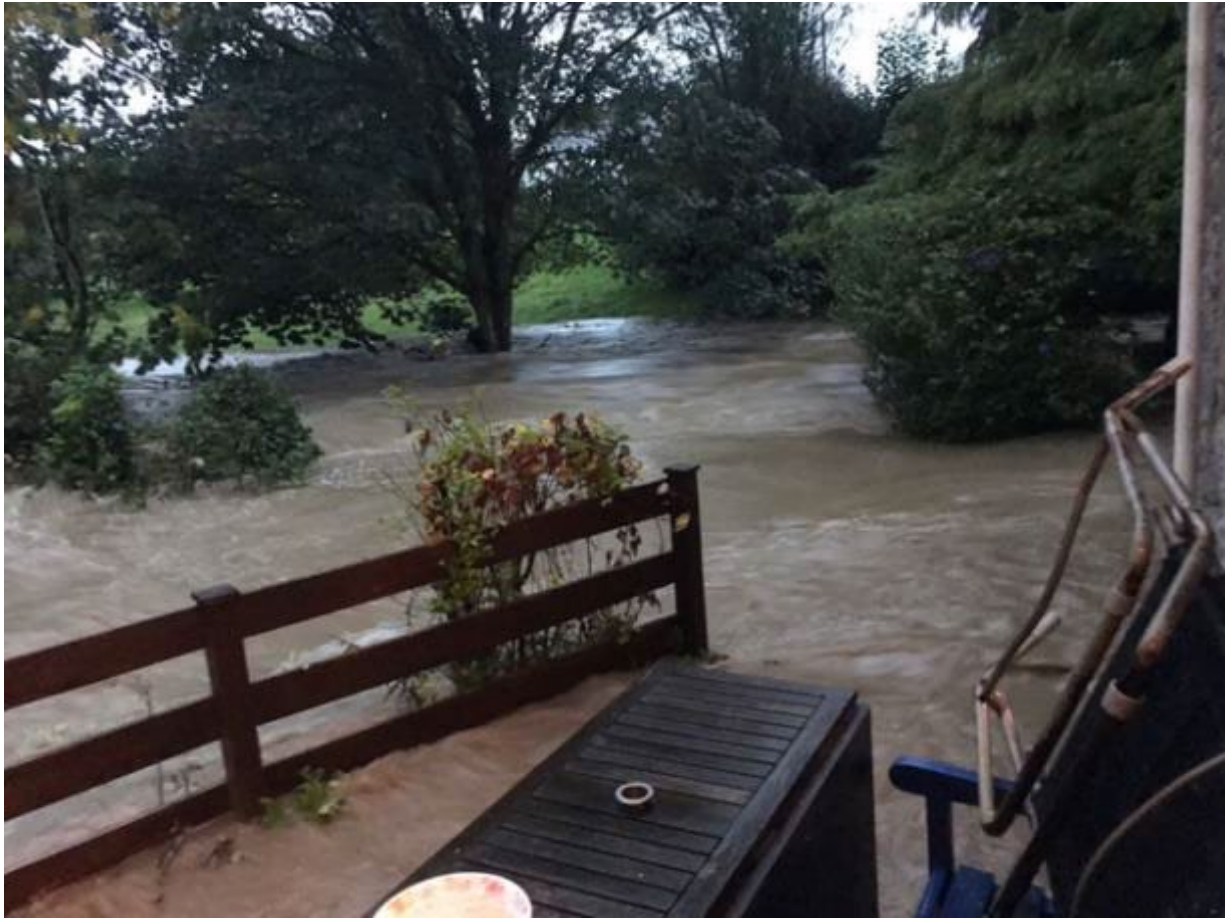
Photo 10: Flooding from the Afon Ystrad at Segrwyd Mill, Nantglyn

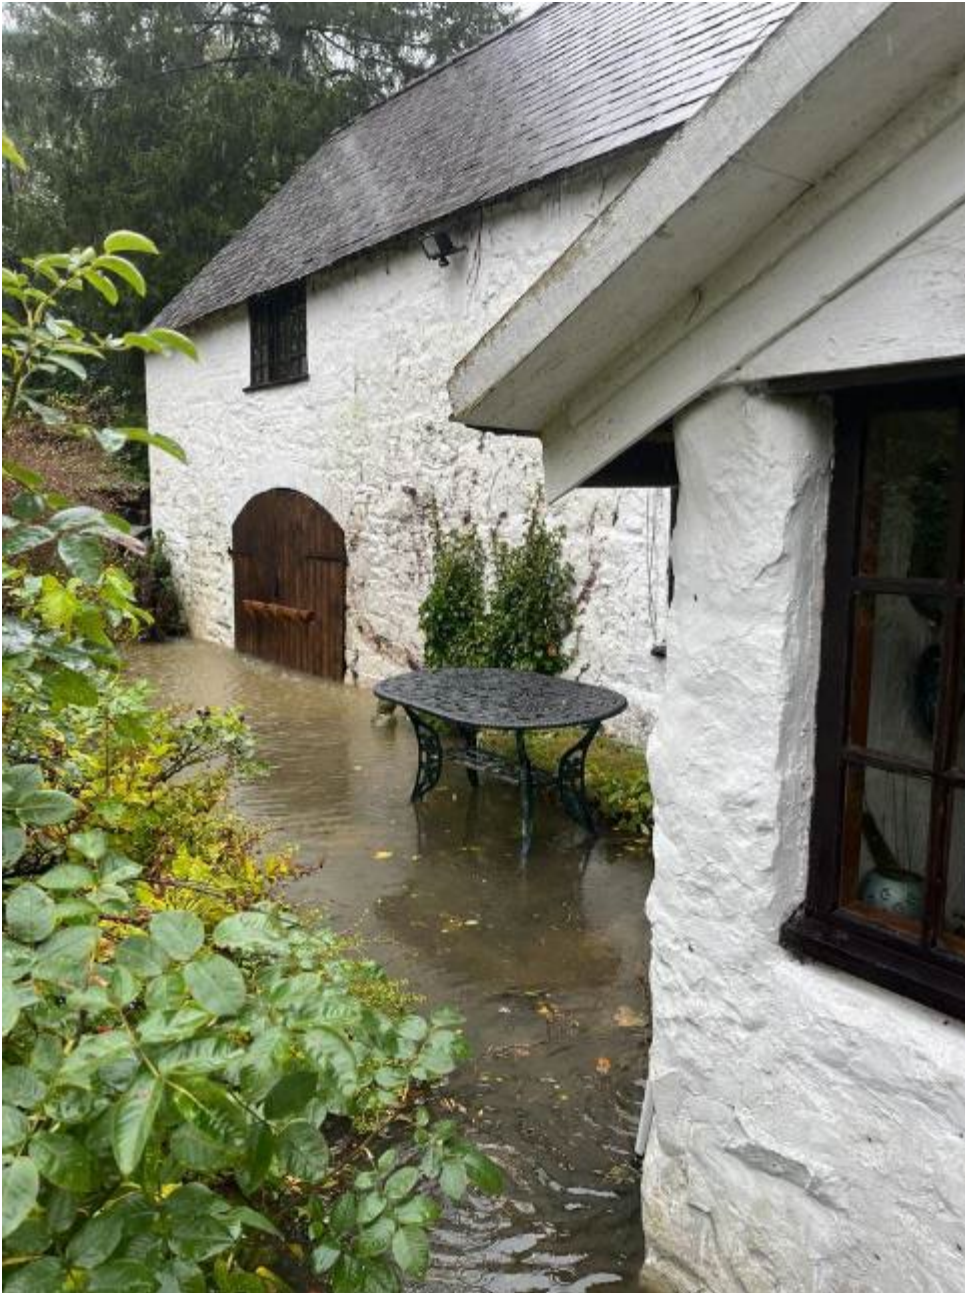
Flood water entered the Property from the front via a low sitting floor, as shown in photo 11 below

Photo 11 showing flood waters at the front door of Plas Isaf
