**Cyfoeth
Naturiol
Cymru**
**Natural
Resources
Wales**

Llantysilio Mountain Fire Preliminary Assessment and SSSI Management Recommendations

Katharine Longden
Penny Anderson Associates Ltd

Report No 372

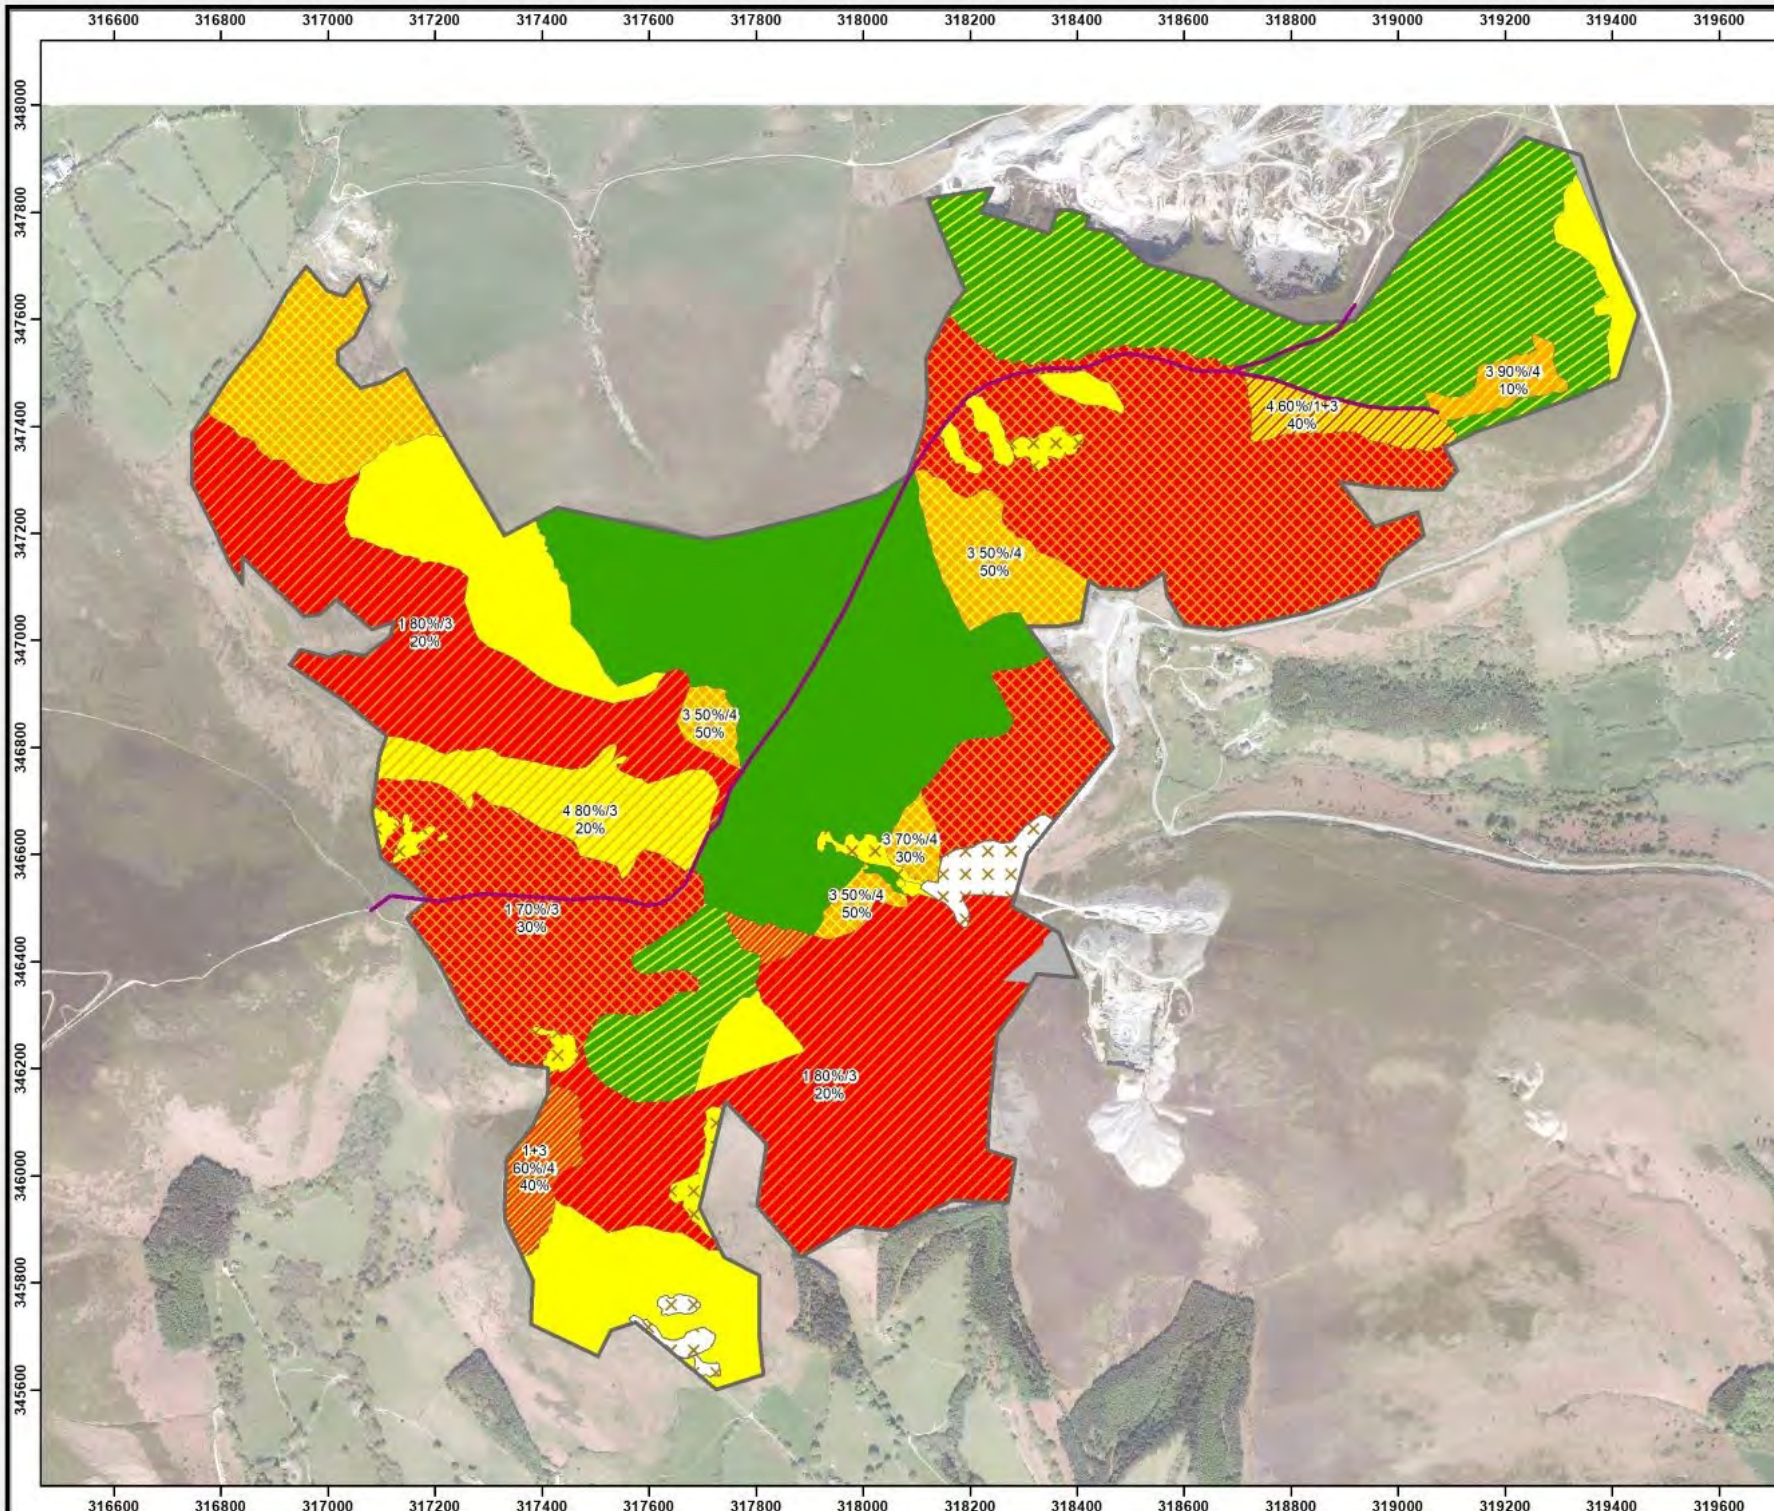
Figure 3 presents the mapped polygons and the allocated burn category. The red and orange colours represent burn Categories 1 and 3 respectively. Category 2 was found to occur in small areas, generally within the more damaged zones, but it was also occasionally found as small areas in the less damaged zones. At this stage of the project these Category 2 areas have not been individually plotted as that level of detailed mapping has not been undertaken.

The yellow areas indicate areas dominated by plates of intact peat and root mat (Category 4) but there could still be many smaller areas of higher damage categories scattered within the boundary. The green areas represent mainly intact areas that have relatively minor damage from the fire (Category 5).

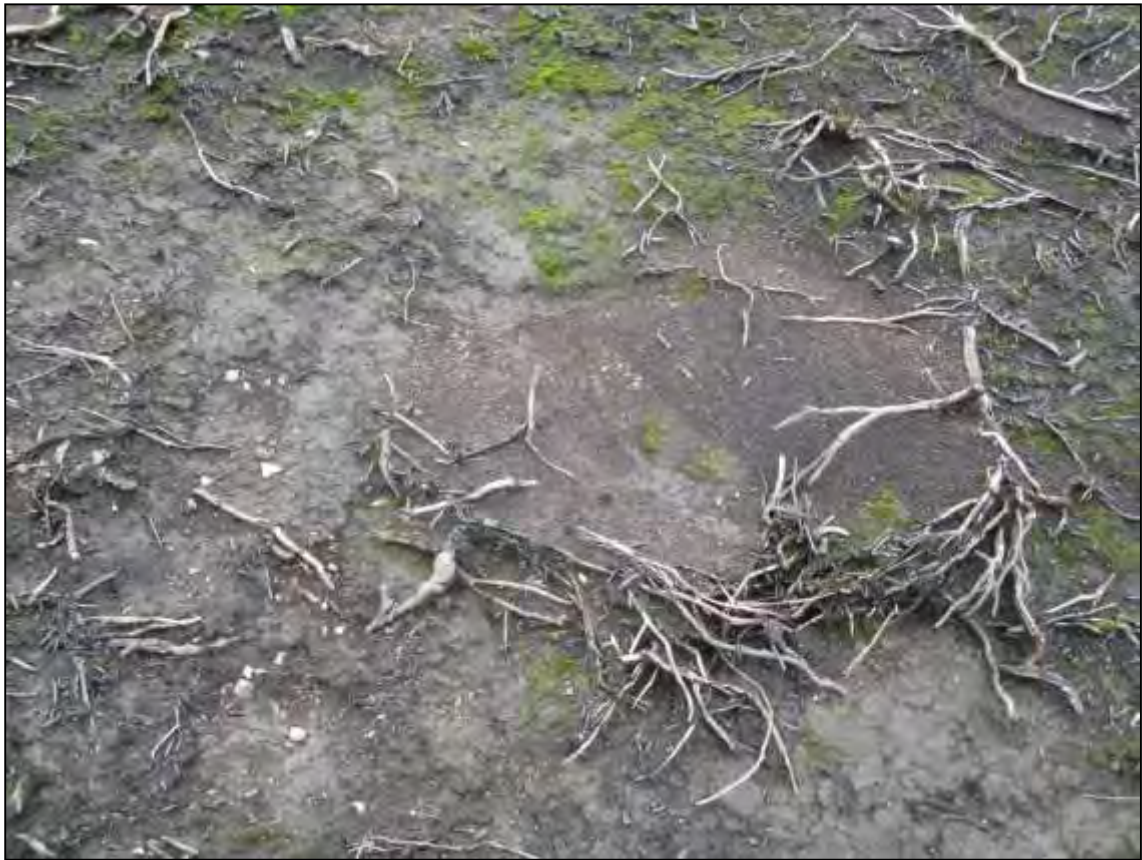
Plate 1

Category 1 Fire Damage

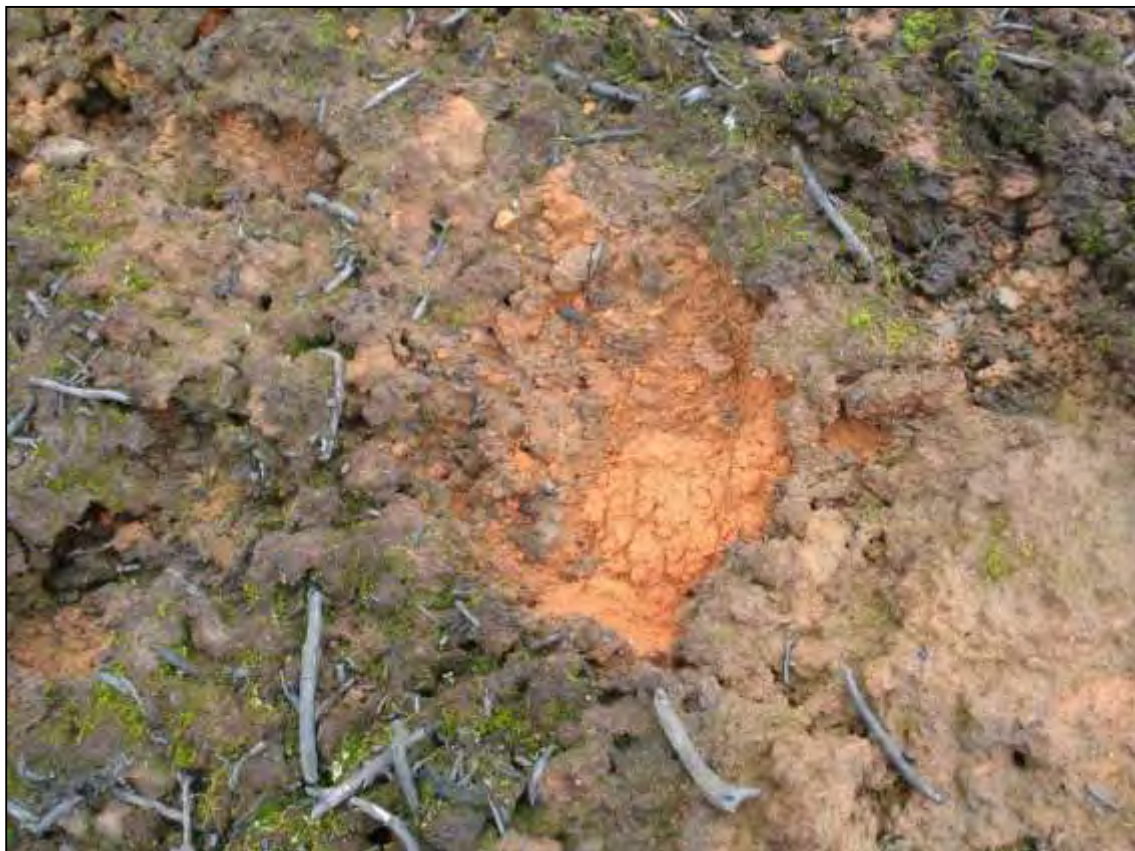
Plate 3

2.	As 1. above, but with a very soft surface where the peat has been ashed completely. The orange surface of this is hidden under superficial burnt peat or ash material. Vascular plants are rare (<5% cover)

Category 2 Fire Damage

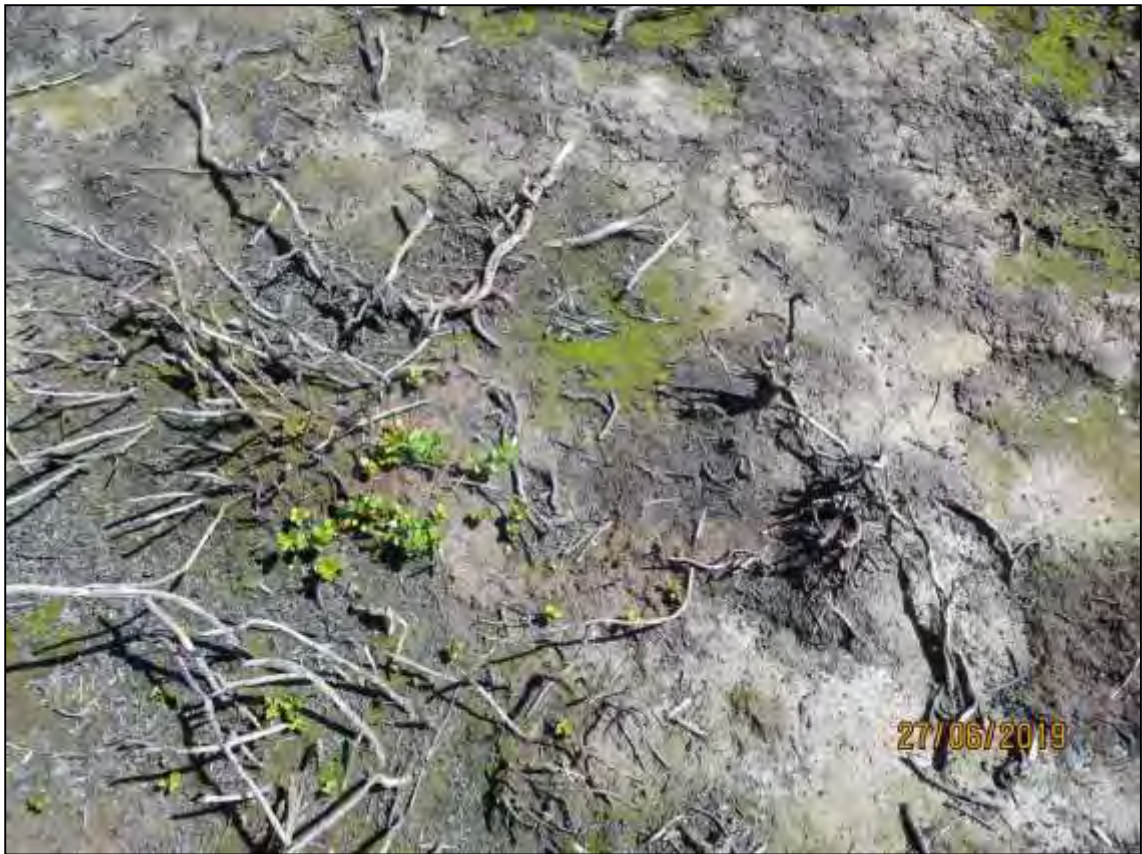
Plate 5

Category 3 Fire Damage

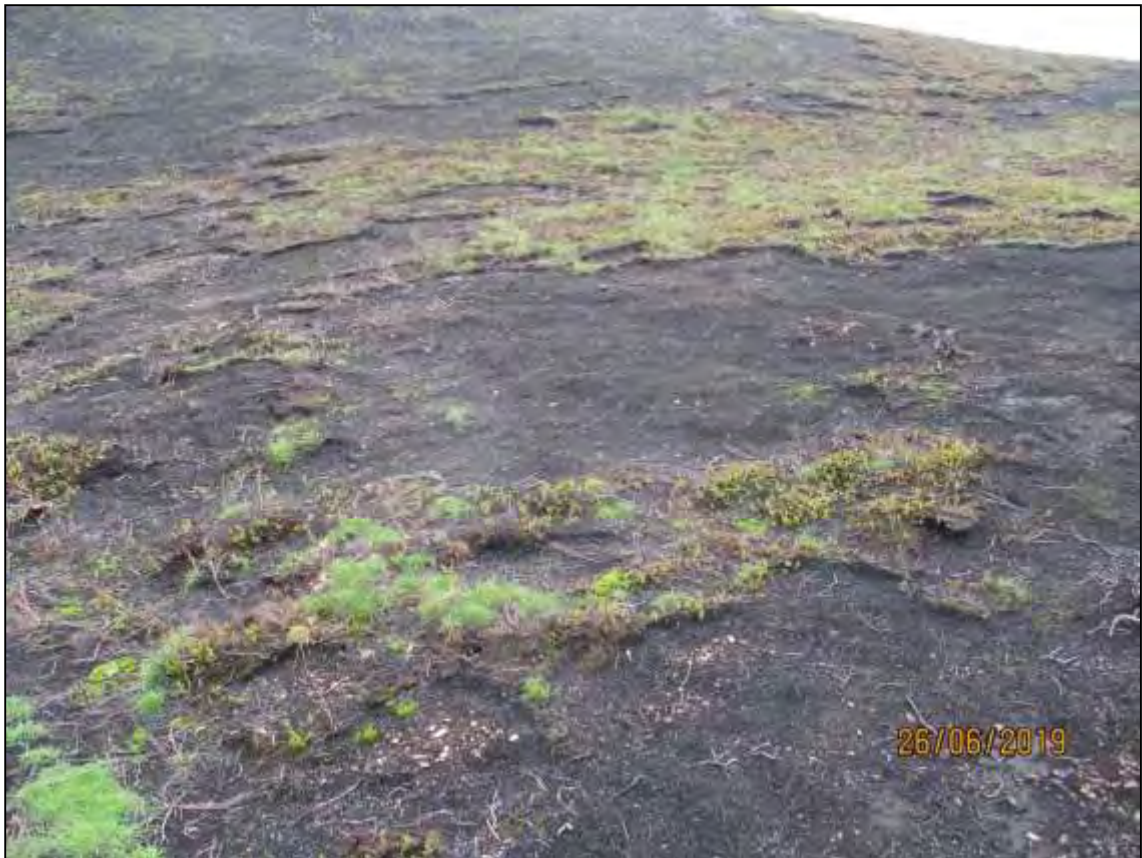
Plate 7

4.	Areas where there are many burnt heather or gorse stumps with a good root mat still in place, but showing loss of peat in between plants, but not throughout the whole area. More frequently there are 'plates' of peat present with good intact root mats and significantly more bilberry and heather regeneration interspersed with barer areas typical of the 1-3 categories above. Vascular plants are frequent (25-50% cover). The plate depths vary from 2-10cm deep.

Category 4 Fire Damage

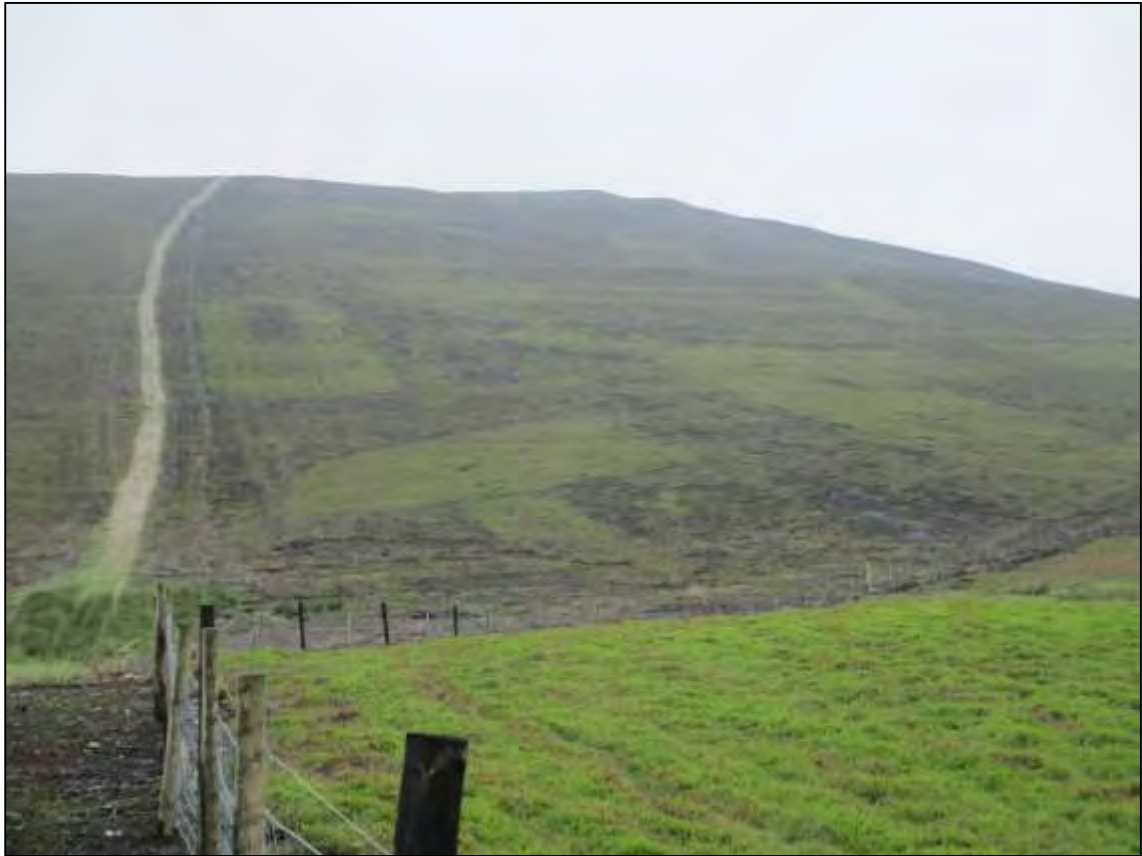
5.	Burnt areas where most of the surface vegetation is still present, i.e. in flushes or where the fire moved more quickly. Generally intact peat surface (<25% bare peat/soil) generally 2-10cm deep.

Plate 9 The whole hillside beyond the fenceline

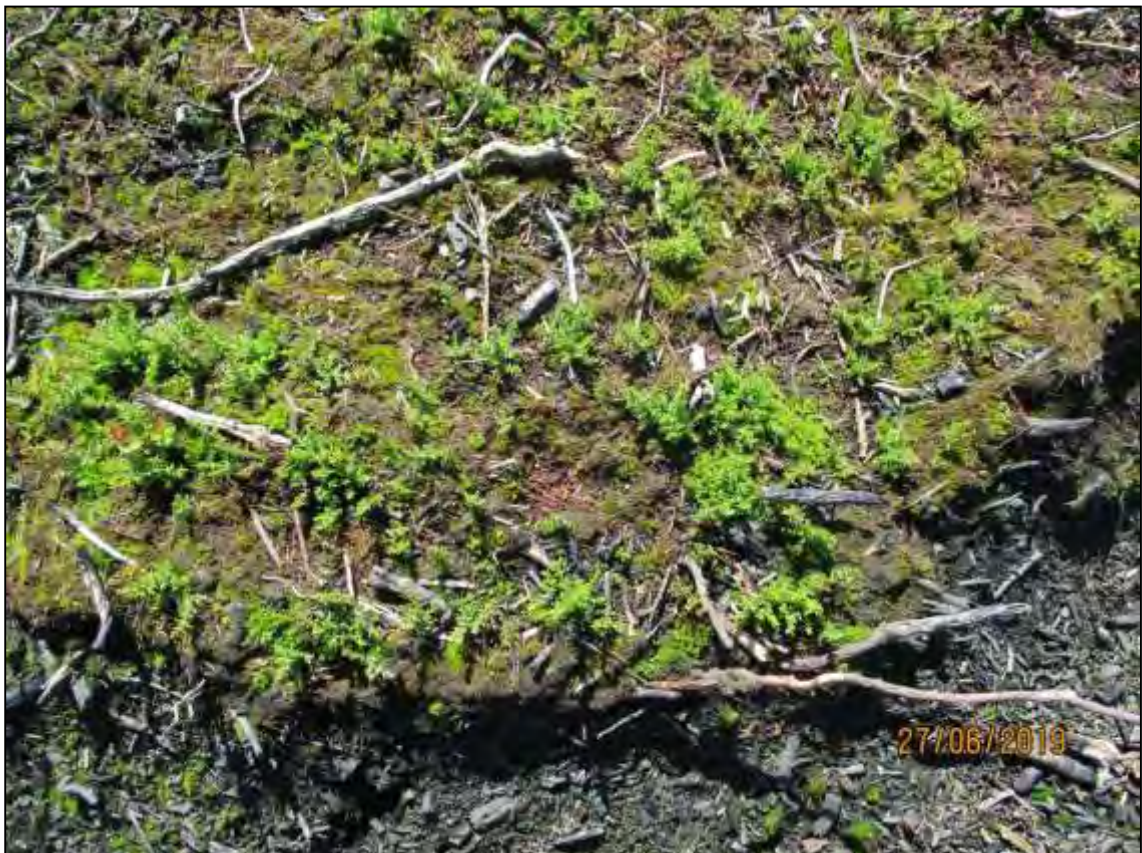
Plate 10 Close-up of good heather regeneration after the fire

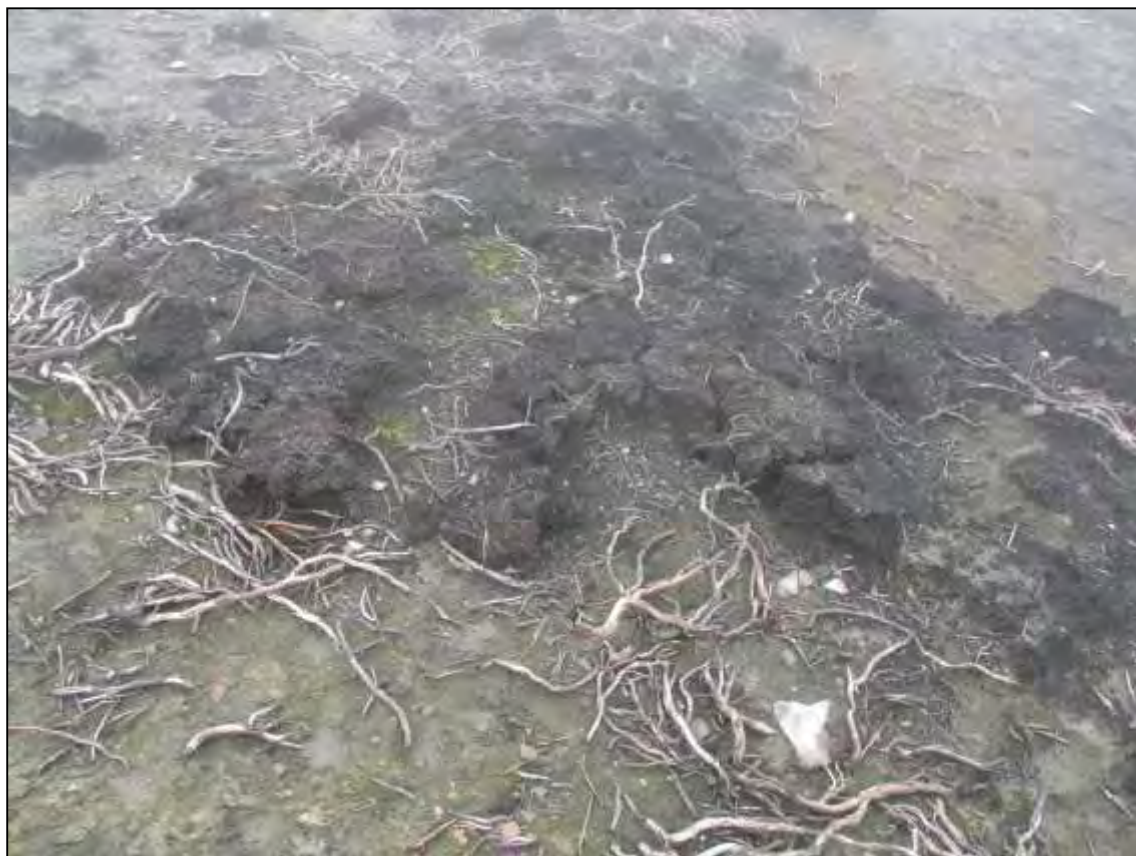
Plate 11

Photographs taken in October 2018 (the autumn after the fire) show a similar situation with large bare areas and on the deeper peats the cracked, disturbed and damaged pedestals. This suggests that the majority of the peat loss was during the actual fire and that the peat layer fuelled the fire as well as the vegetation.

Areas of Deeper, Damaged Peat

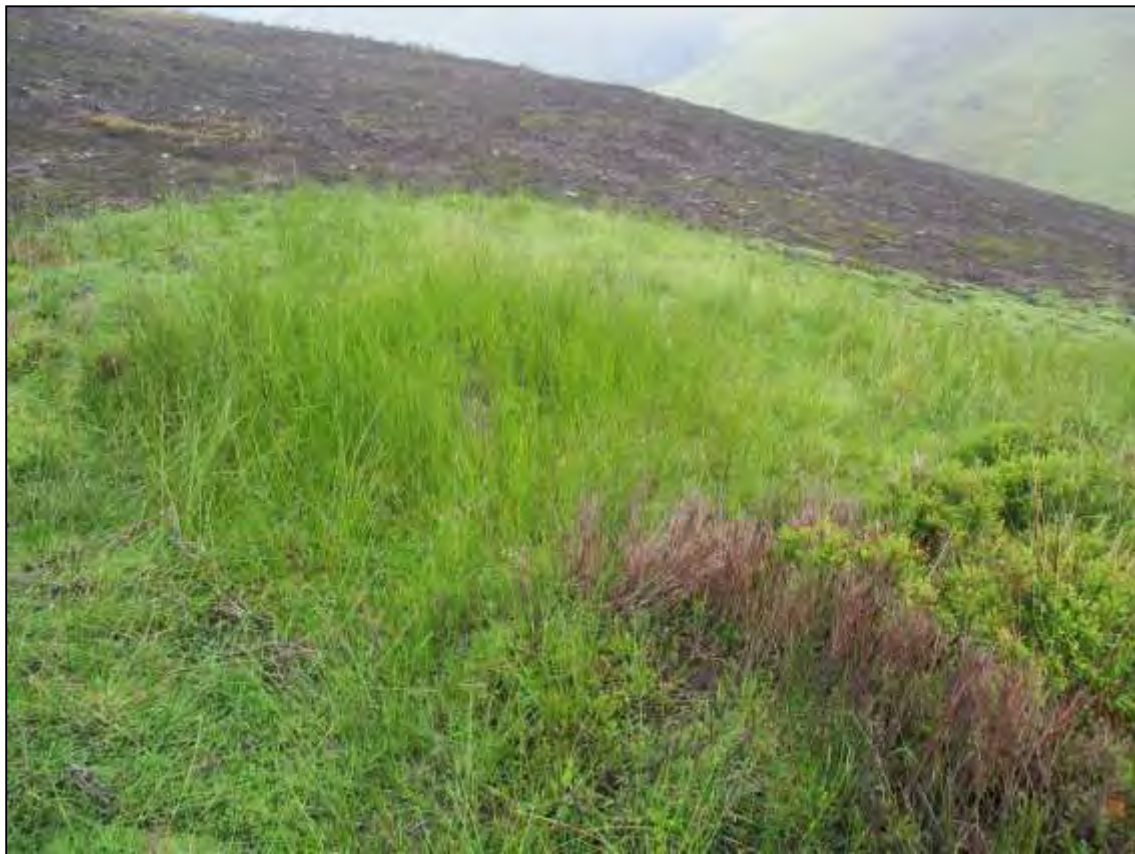
There are a few small areas of intact vegetation within the fire boundary and these are centred on flushes and stream valleys where the vegetation was wetter and provided a smaller fuel load. Detailed species lists were not compiled for these areas, but there were generally a number of common grasses such as sweet vernal-grass (*Anthoxanthum odoratum*), mat-grass (*Nardus stricta*), common bent (*Agrostis capillaris*), wavy hair-grass (*Deschampsia flexuosa*) and occasionally Yorkshire fog (*Holcus lanatus*) and tufted hair-grass (*Deschampsia caespitosa*). Several areas supported soft-rush (*Juncus effusus*), with a substantial moss layer of *Rhytidiadelphus squarrosus*, *Pleurozium schreberi* and occasional *Sphagnum* species (Plate 13). Peat depths in the flushes were not measured.

Plate 13 Flush

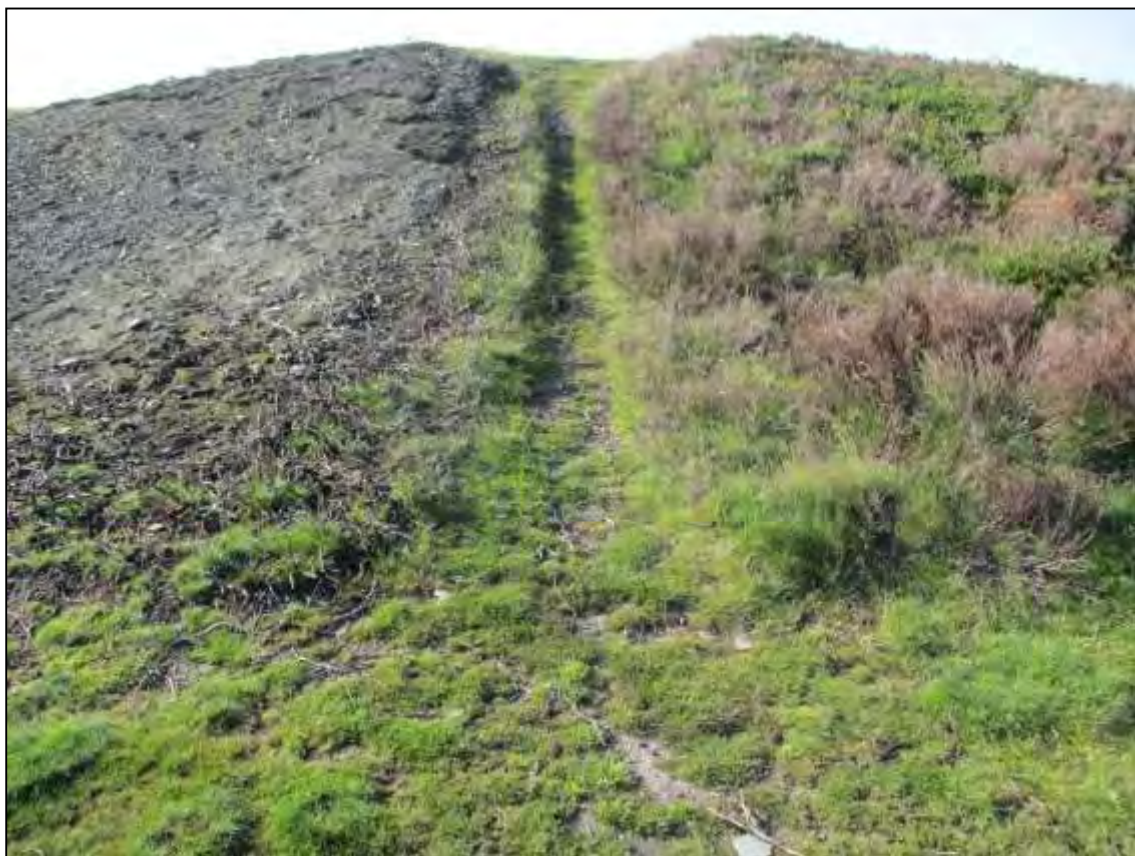
Plate 14 Dwarf Shrub Heath

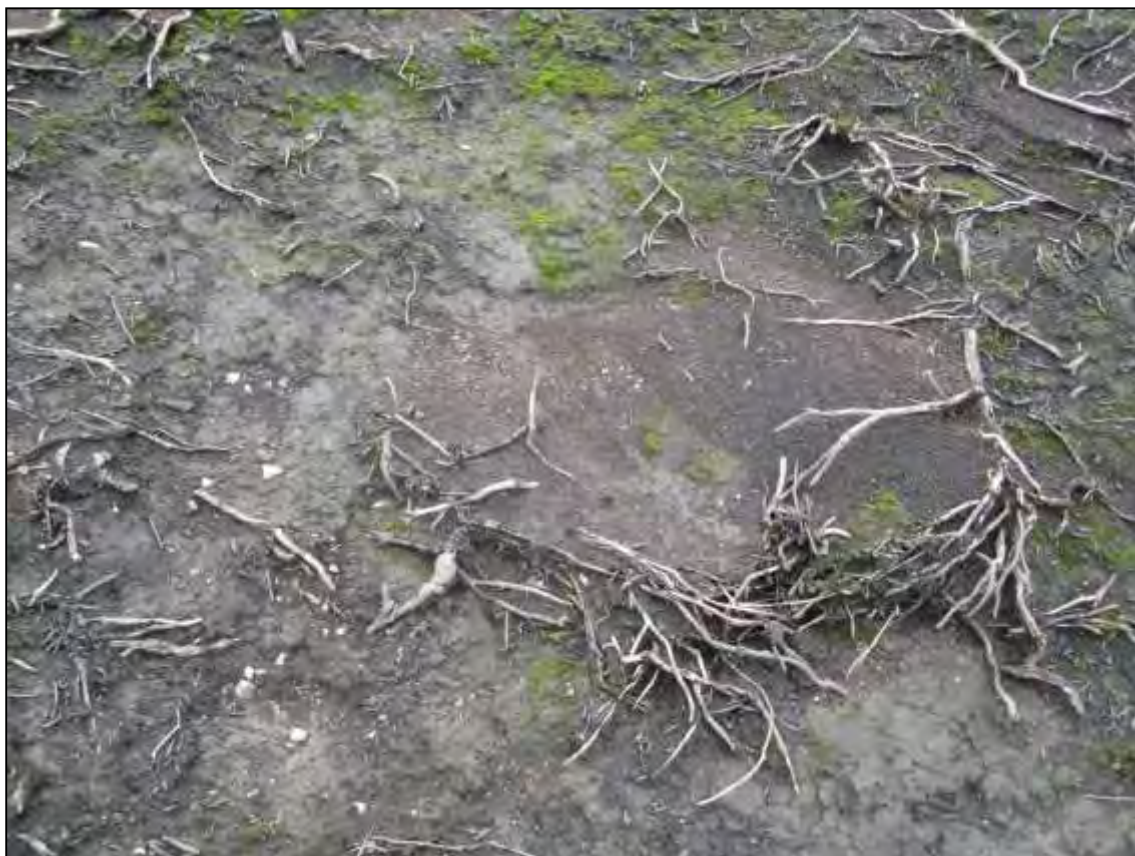
Brash strewn across the site after the fire has been blown by the wind and in several areas there is no material on the ground surface indicating those areas which are particularly windswept and, therefore, at a higher risk of further soil erosion. This broken brash is holding peat/soils in place in some places and trapping sediment within surface run-off (Plate 15).

Plate 15 Loose heather stems are holding back soils which have washed off the bare ground upslope

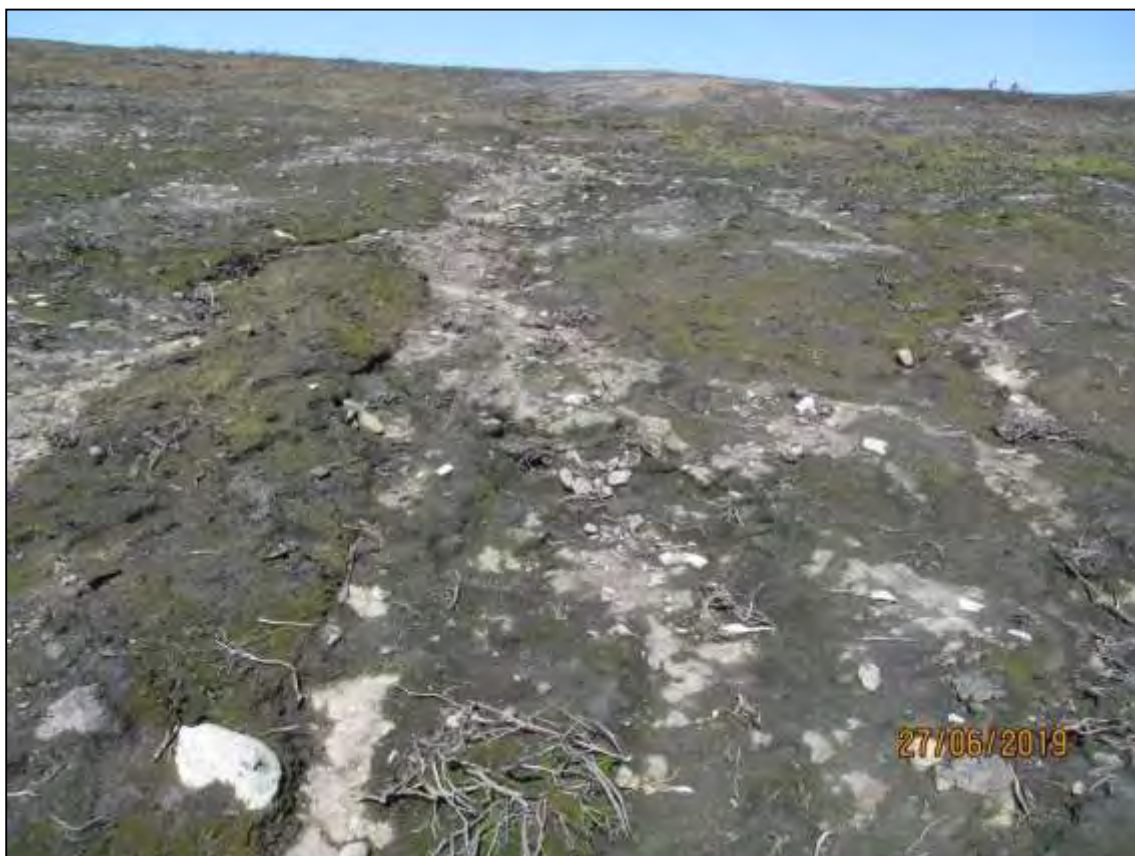
There are a number of water runnels/channels on the site - currently most are quite small with the larger ones only reaching a depth of 20cm and a width of 30-50cm (Plate 16). However, these channels are actively eroding the soil and clay subsoil. There is some incidental blocking of the channels by loose brash

Plate 16 Water runnels/channels actively eroding

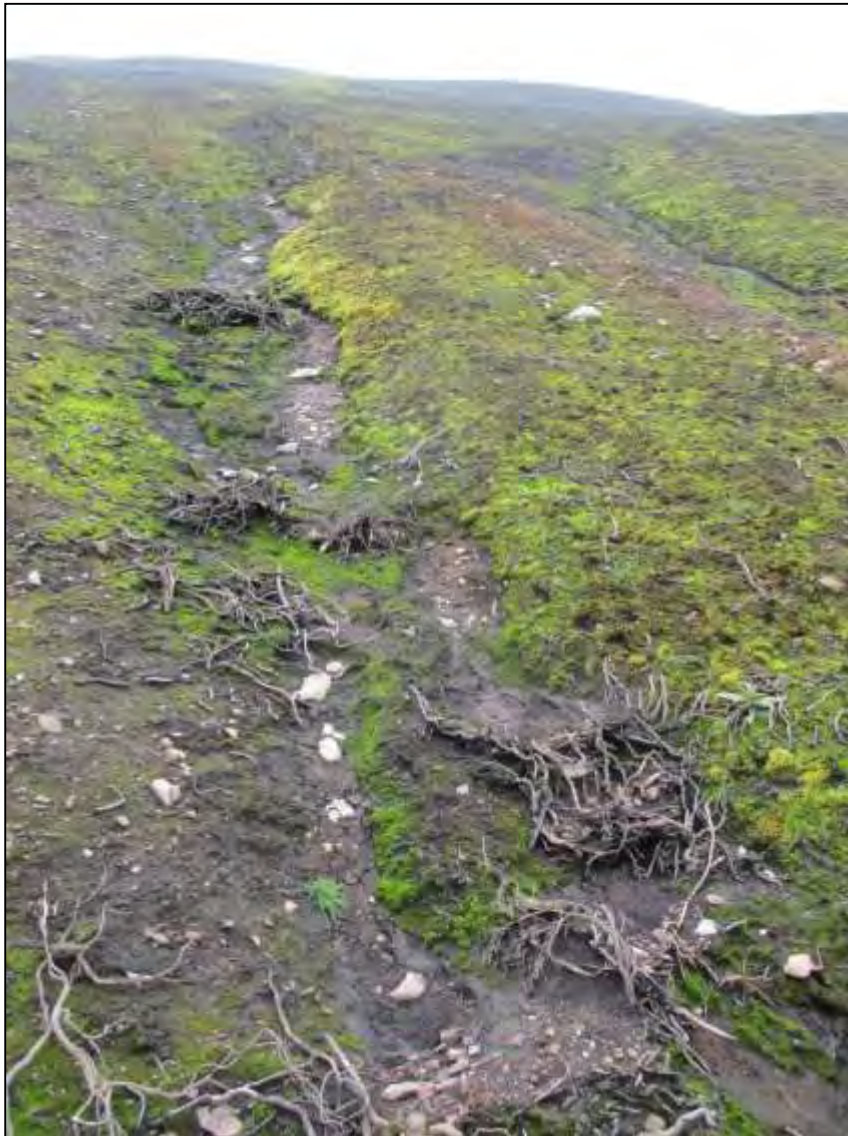
Plate 17 Natural blocking/damming of the water runnels/channels

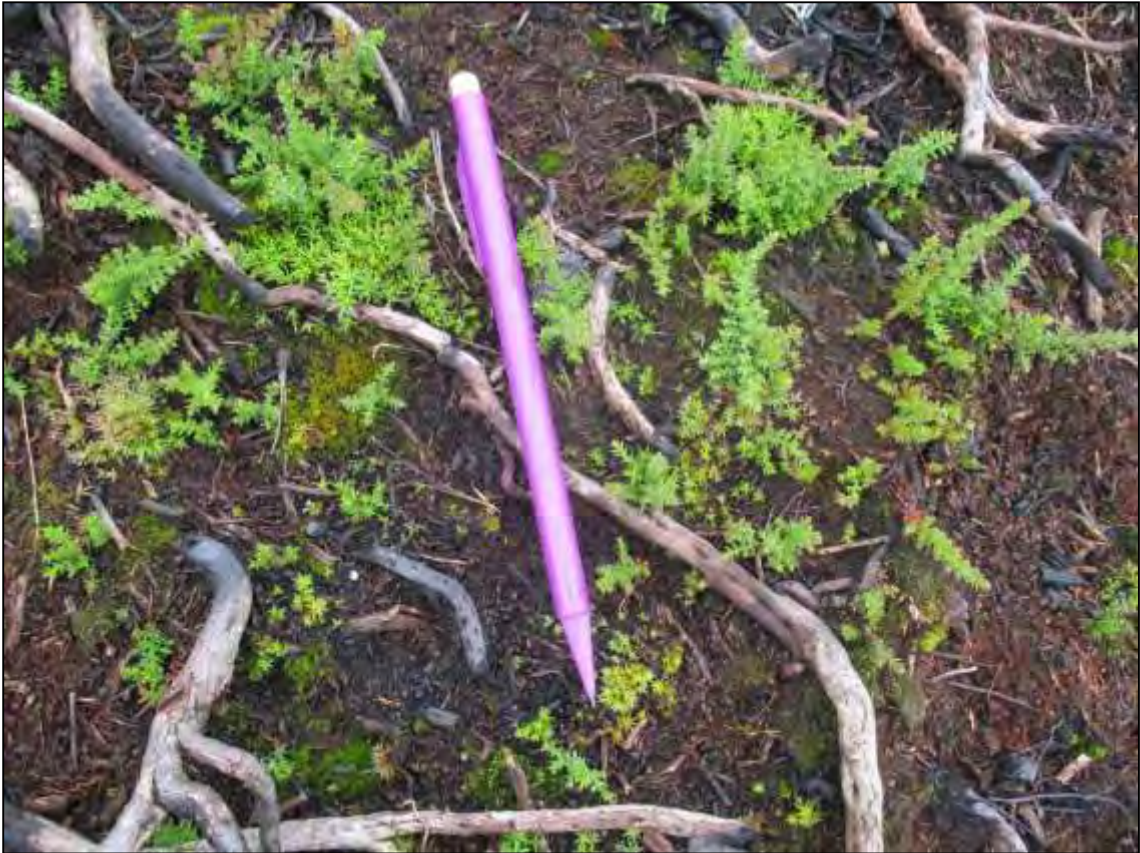
Plate 18 High density of heather seedlings

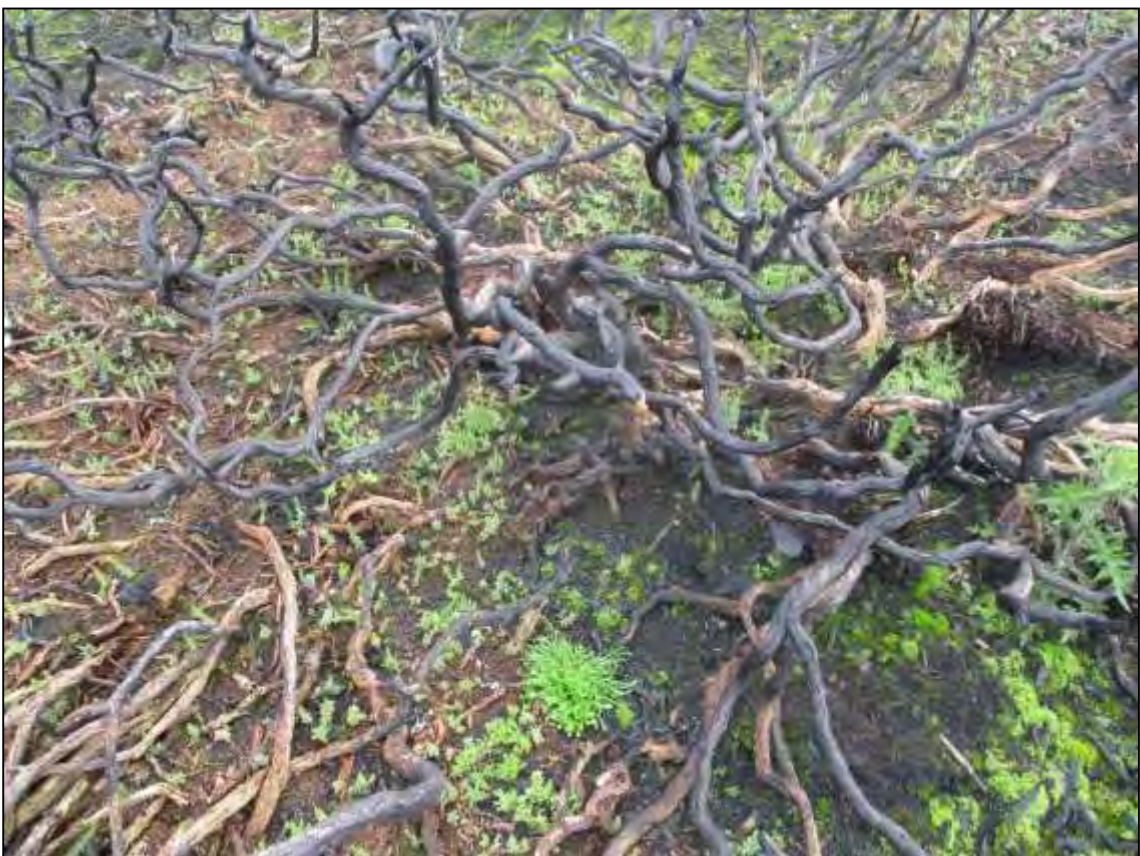
Plate 19 Abundant western gorse regeneration

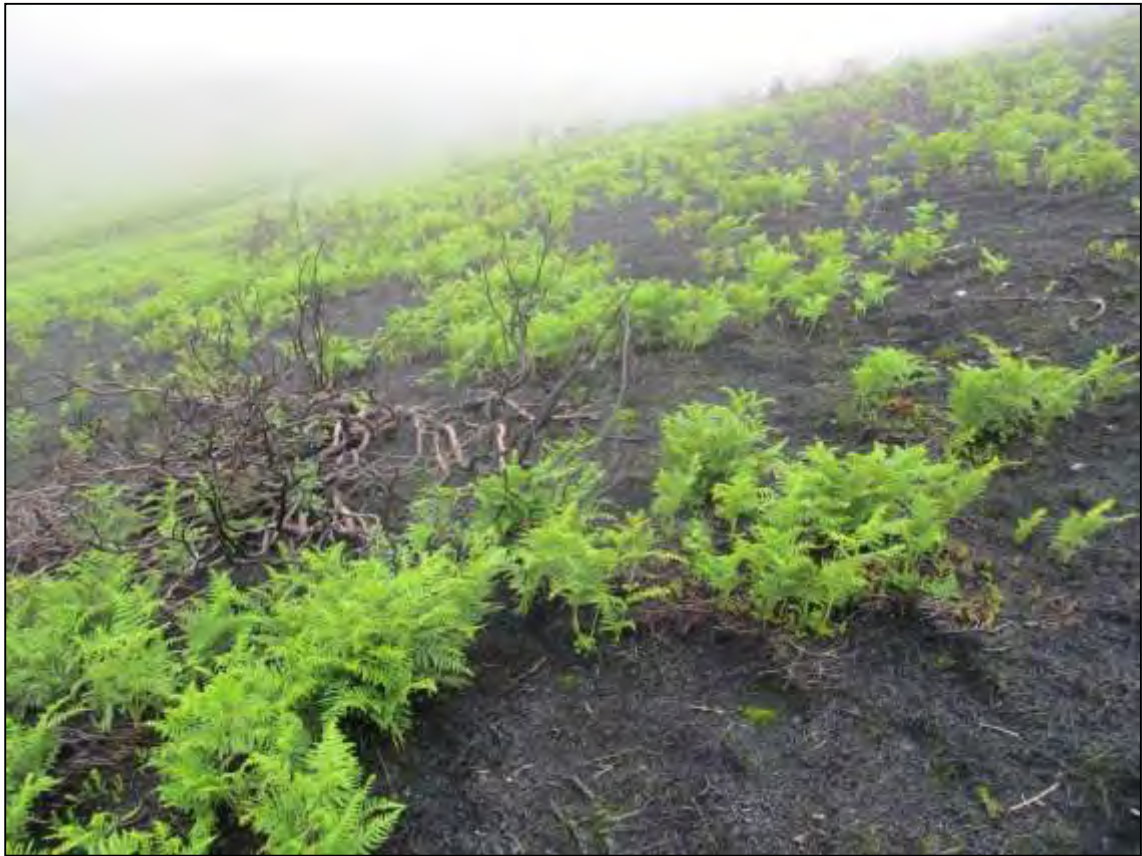
Bracken (*Pteridium aquilinum*) regeneration is significant across the site. It is recovering well from areas where it was clearly present in the past (i.e. can be seen on the 2017 pre-fire aerial photographs) and where the vegetation root mat is intact, but it is also occurring in areas where the root mat and, therefore, many of the rhizomes have been lost and in areas where it was not previously a major vegetation component. Bracken is known to ingress into heathland areas when the competing vegetation (i.e. the heath) is burnt and there is less competition for the bracken.

Plate 20 Bracken regeneration with some intact root mat and bilberry associated

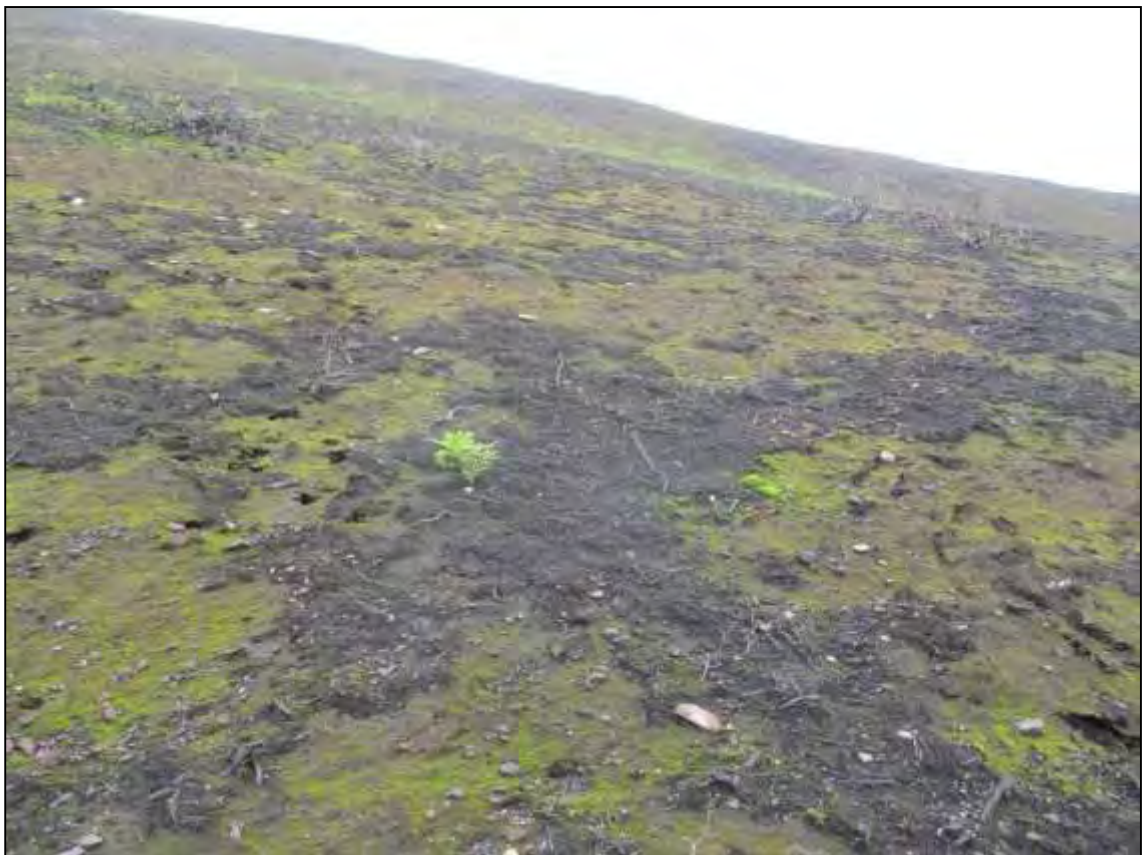
Plate 21 Isolated bracken fronds with no associated vegetation mat
