You are invited to attend a meeting of the **COMMUNITIES SCRUTINY COMMITTEE** to be held at **10.00 am** on **THURSDAY, 21 OCTOBER 2021 BY VIDEO CONFERENCE**.

### **5 SECTION 19 FLOOD INVESTIGATION REPORT INTO THE FLOOD EVENT ON 20TH JANUARY 2021** (Pages 15 - 90)

# Denbighshire County Council Investigation into the January 2021 Floods Flood Investigation Report

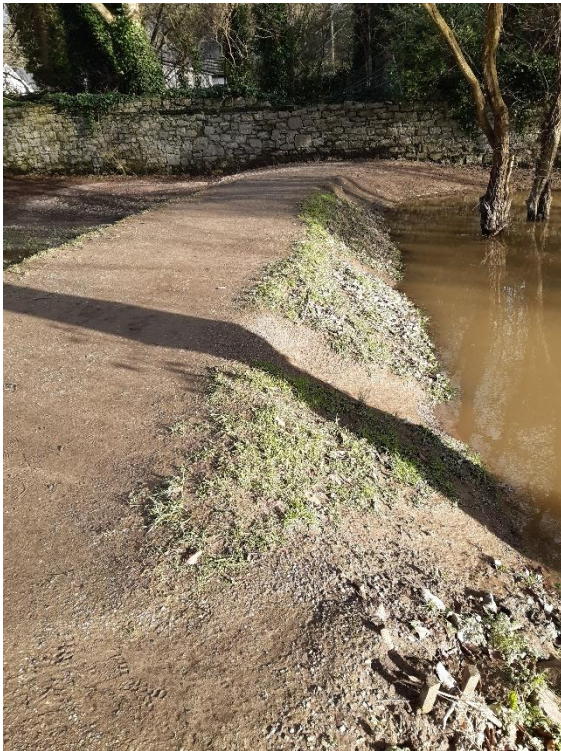
The location of overtopping of the Cae Ddol embankment was similar to that which overtopped during the 2012 flood event. According to residents, in February 2020, sandbags were placed along the crest of the Cae Ddol embankment which stopped the Clwyd from overtopping to the car park, it is presumed that Denbighshire CC undertook this work as NRW has no knowledge of this.

**Figure 4: Cae Ddol embankment near skatepark (source: NRW staff)**

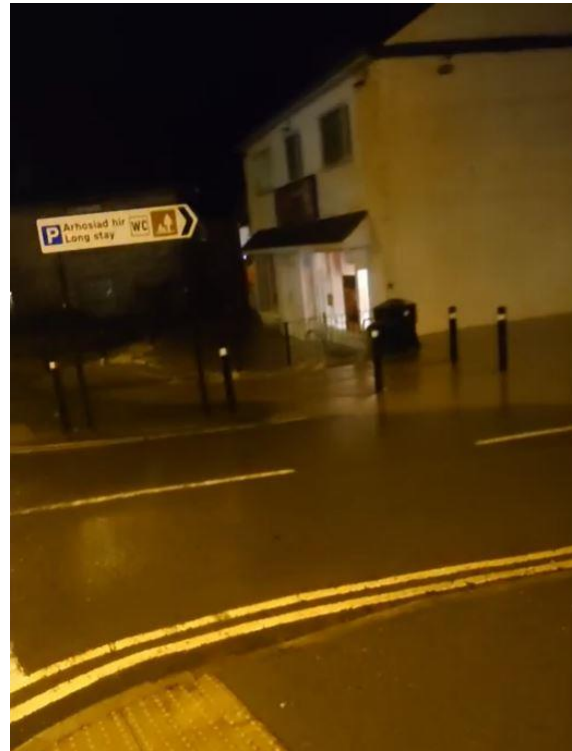
**Figure 5: Floodwater at the car park entrance (Source: Real Fans of Ruthin Facebook page)**

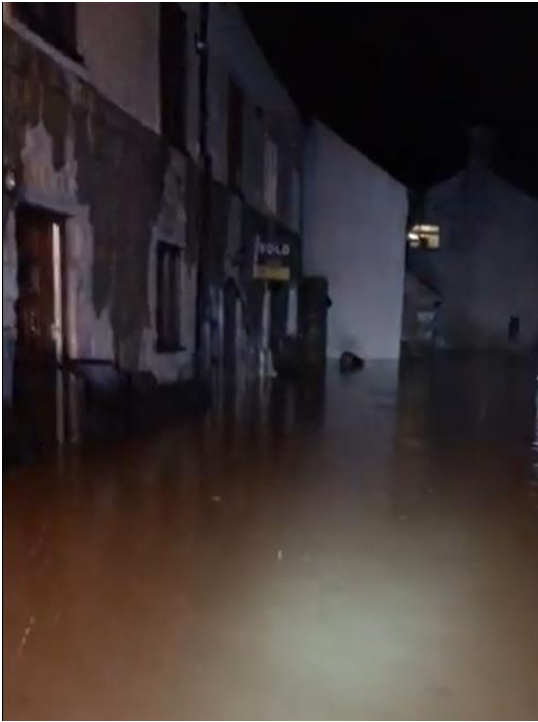
In total, there were 17 residential and 5 business properties that were flooded internally along Mill and Clwyd streets due to the Clwyd overtopping the Cae Ddol embankment.

**Figure 6: Flooding on Mill Street  
(Source: Real Fans of Ruthin  
Facebook page)**

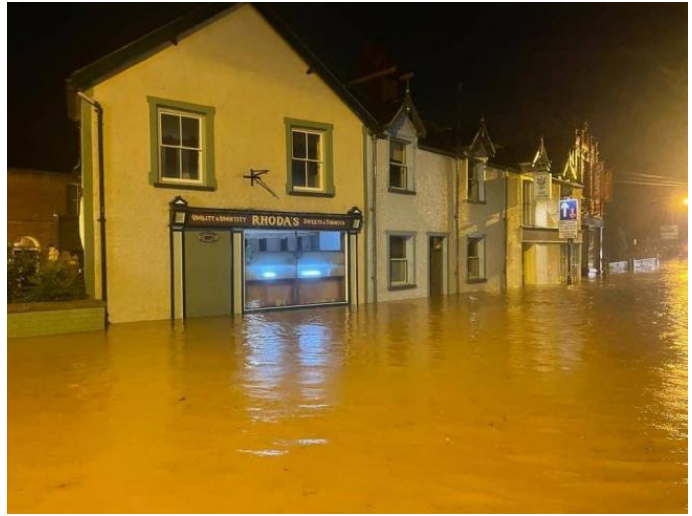
**Figure 7: Flooding on Clwyd Street (Source:  
NWP Rural Crime Team twitter page)**

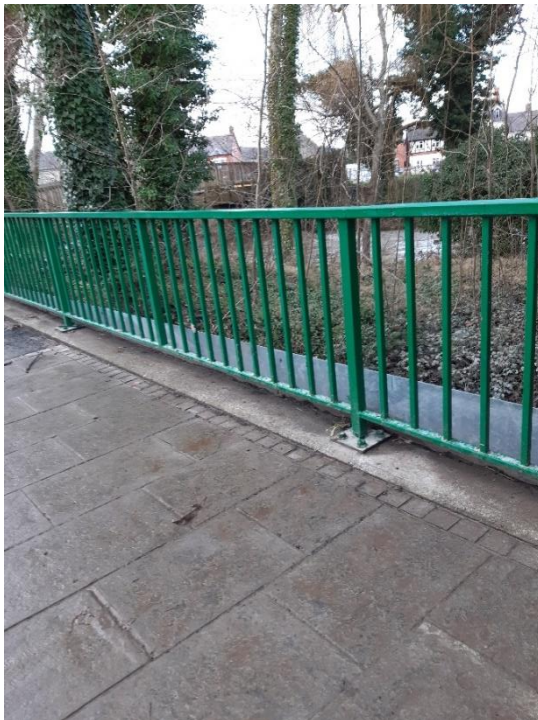
**Figure 9: Steel plate flood wall along  
Clwyd Street (source: NRW staff)**

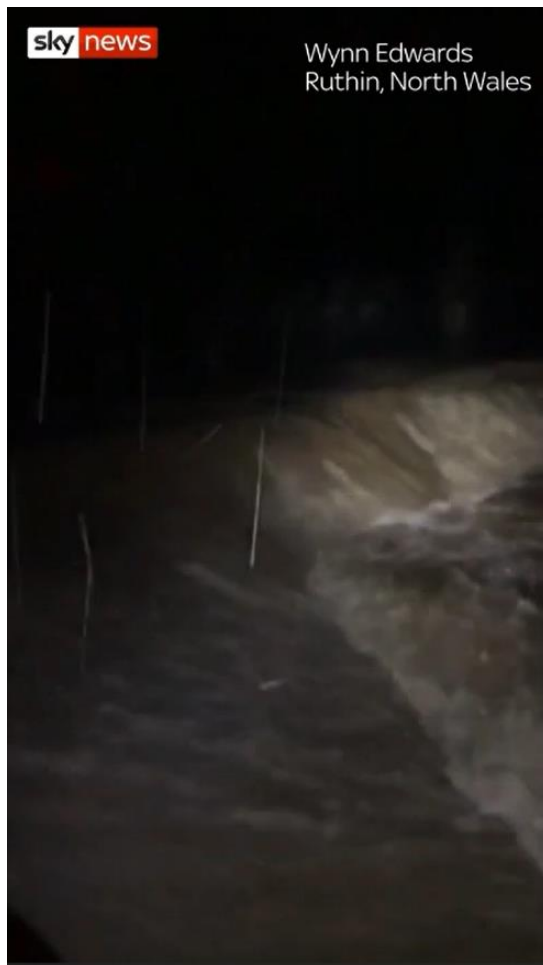
**Figure 8: Overtopping of the Cae Ddol  
embankment (source: Sky News<sup>3</sup>)**

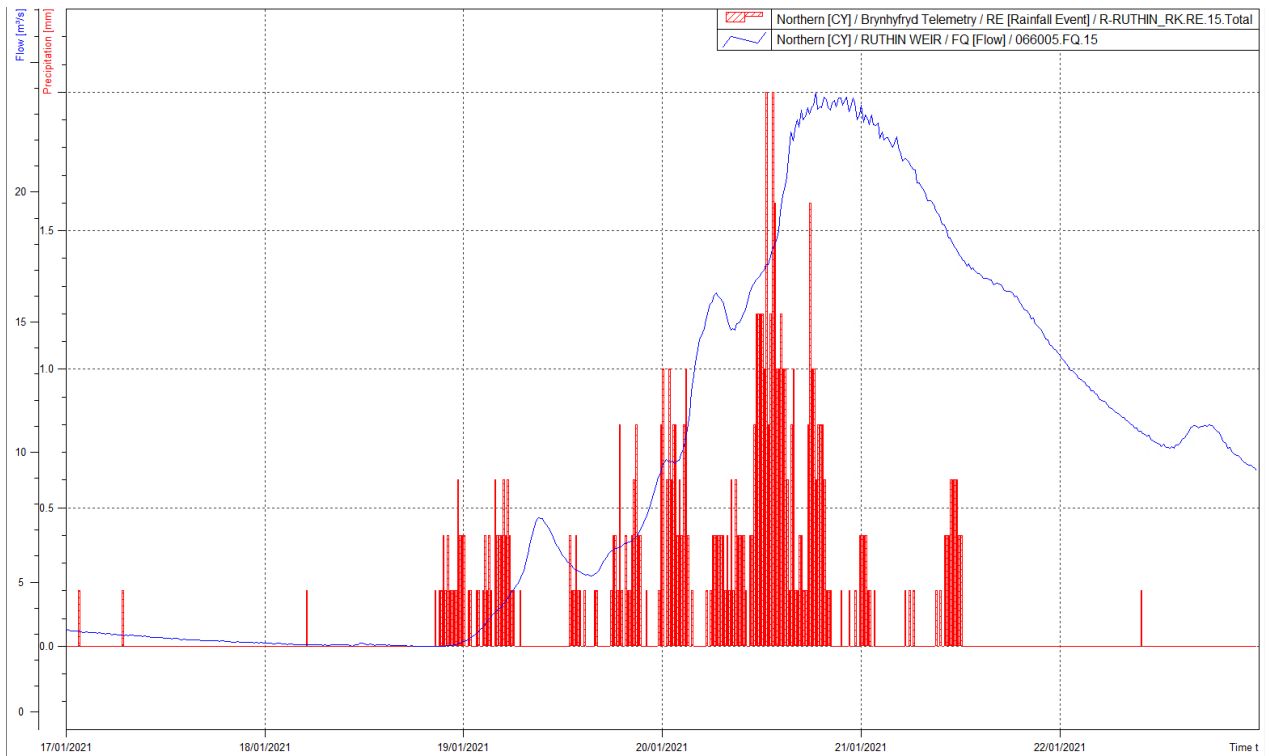
The maximum return period recorded at Brynhyfryd raingauge was 1 in 10 years over a duration of 66 hours between 18:30 on 18 January until 12:30 on 21 January. Figure 2 below shows the rainfall recorded every 15 minutes at Brynhydfyd raingauge compared to the flow measured at Ruthin Weir Gauging station. The peak at Ruthin Weir can be seen at 18:30 on 20/01/2021. Rainfall return periods for shorter durations were less significant. At Brynhyfryd all rainfall with a duration below 24 hours had a return period less than 1 in 5 years.

**Figure 2.** Hydrograph showing rainfall at Brynhyfyd raingauge compared to flow at Ruthin Weir gauging station during Storm Christoph.

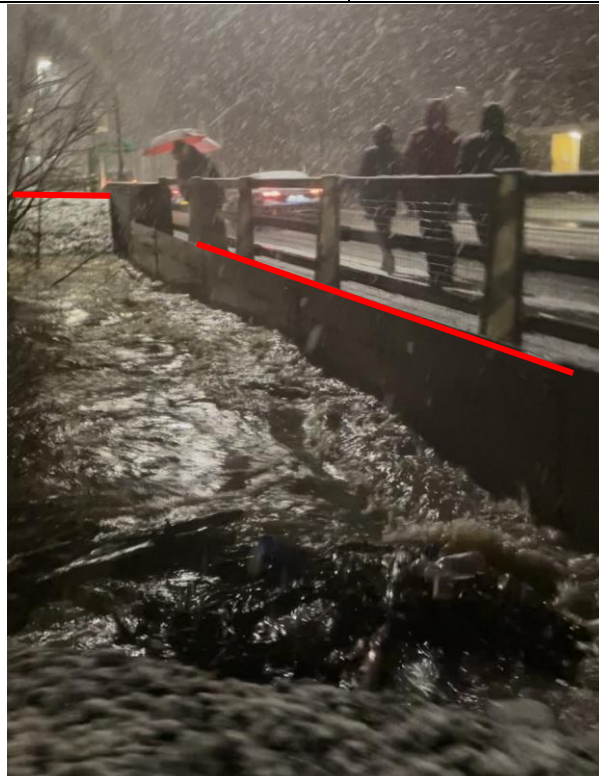
View of the fire station road crossing and bunded area.  
Note the difference in level (shown in red) between the top of bund and bridge threshold

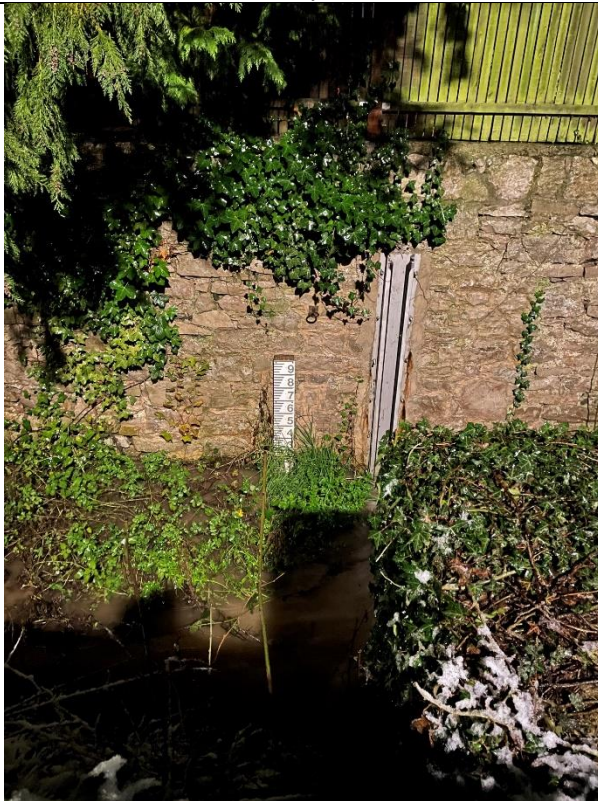
Llanfwrog open channel water level

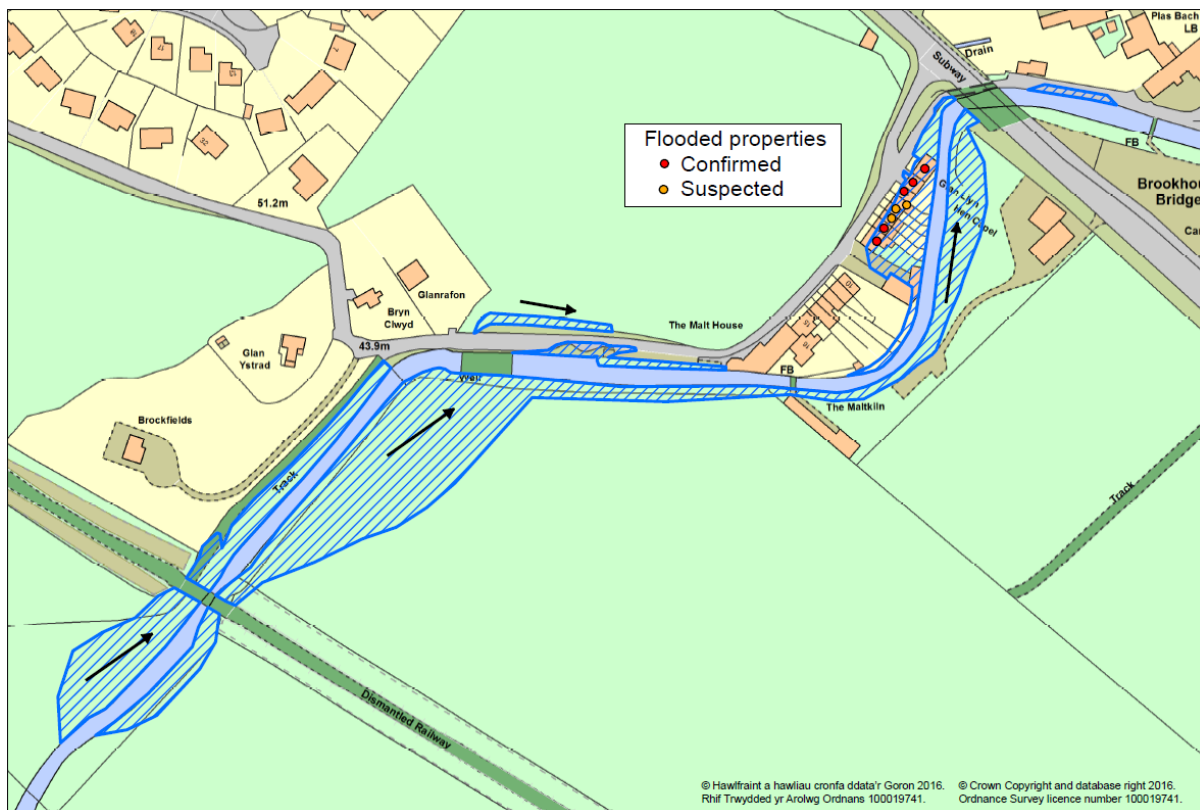
**Figure 2:** Storm Christoph flood extent, indicative flow routes and impacted properties.

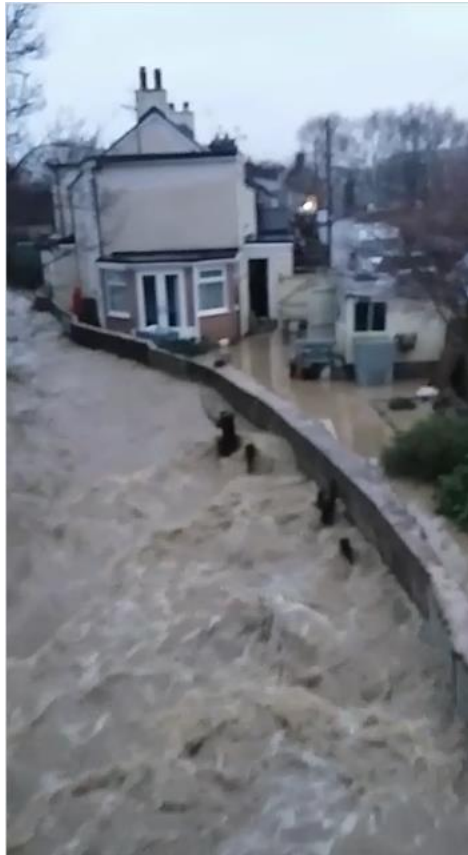
Image 1. Extract from local residents' video at the approximate peak river level.

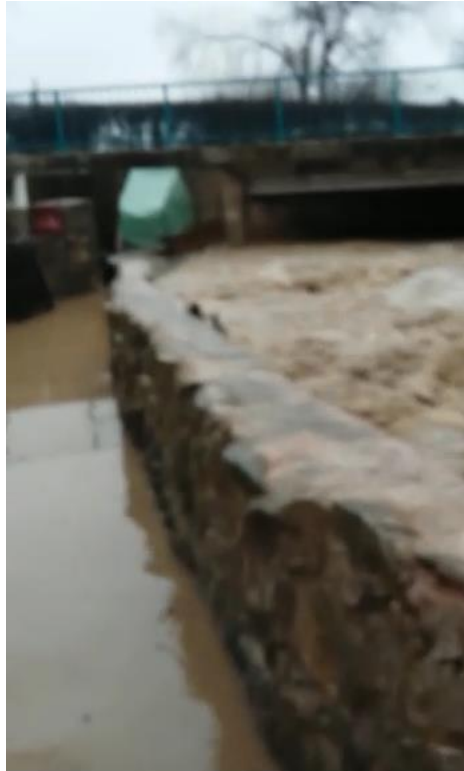
Image 2. Extract from local residents' video showing water levels across the wall at the downstream end at the approximate peak river level.

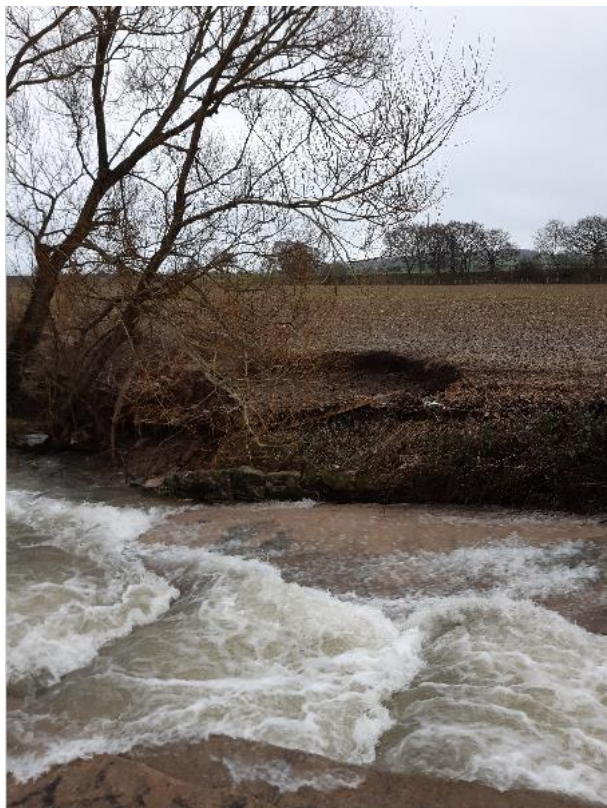
Image 3. Area of scour on right bank adjacent to weir.
