Appendix D

Flood Investigation Report Llandrillo 9 February 2020

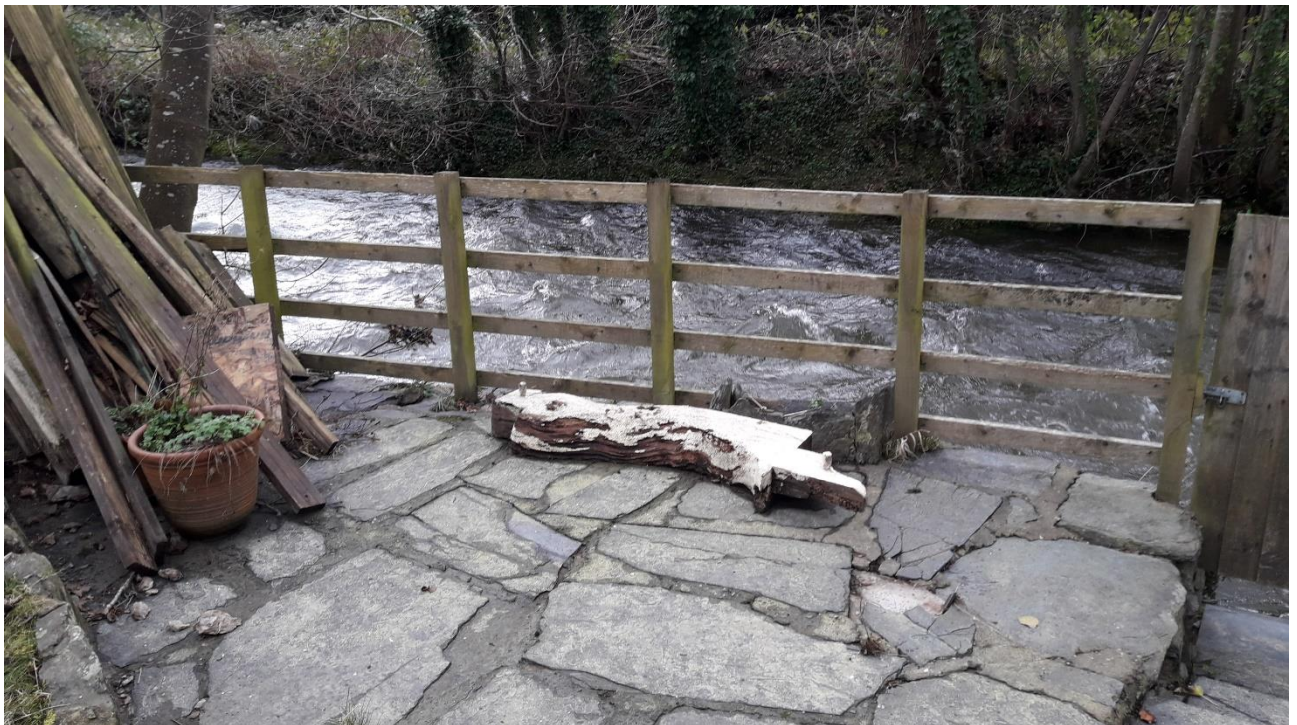
Figure 4: Afon Ceidiog from Tegfan. Source: NRW staff

During a site visit by NRW staff on the 17th February 2020, one resident confirmed that a rear room of their property (Tegfan) suffered internal flooding from the Afon Ceidiog. The resident stated water overtopped from the river into the garden (see Figure 4) and entered through the wall at the side of the house. Water did not enter through the door at the rear of the property as an IPP floodgate was deployed here.

The IPP measures used at 'Tegfan' during this event were effective to the extent that they reduced the flood depth but failed to keep the property dry as water evidently entered through a wall.

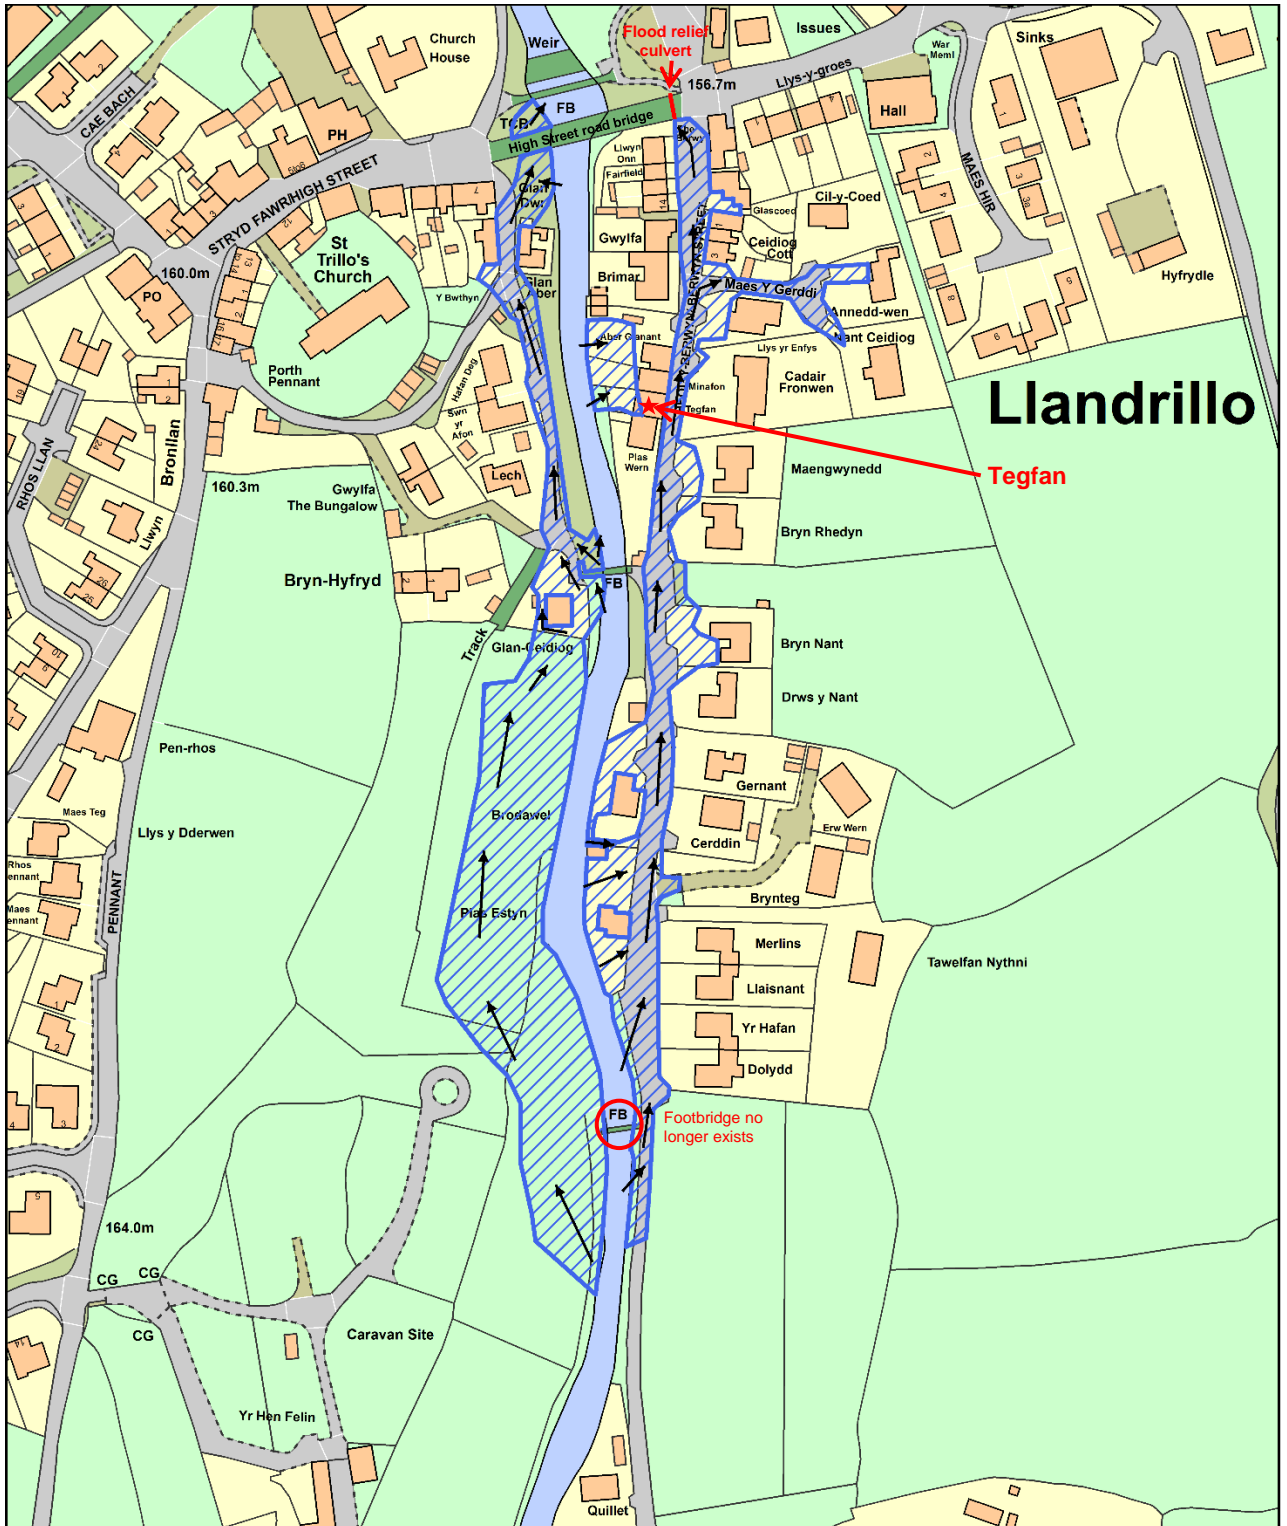
Figure 5: Outline and Route

Several other properties reported floodwater from the Afon Ceidiog reaching either the front or rear steps of their houses including 'Plas Estyn', 'Brodawel', 'Bryn Nant' and 'Glan Ceidiog'.

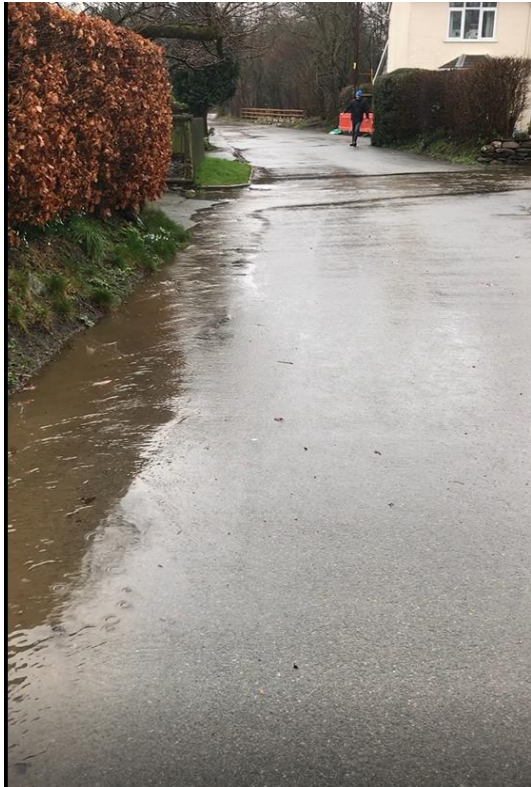
Between 8:30am and 8:44am on 9th February, the Afon Ceidiog overtopped its right bank near the property named 'Plas Estyn' (Figure 6). As the Ceidiog continued to rise, the extent of overtopping of the bank extended further upstream. The floodwater flowed north along Berwyn Street.

Figure 6: Initial floodwater overtopping from Afon Ceidiog near Plas Estyn. Source: Resident

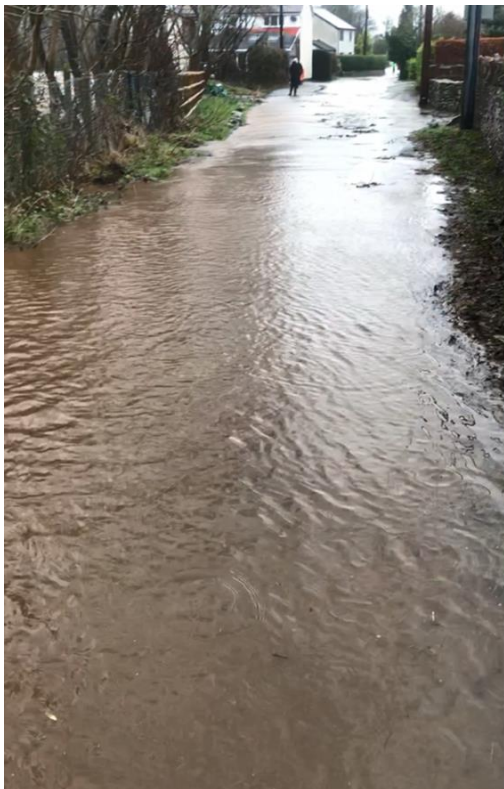
The most significant overtopping occurred over the gabion baskets, approximately 80m upstream (south) of 'Plas Estyn' (Figure 7).

Figure 7: Overtopping between Plas Estyn and Quillet. Source: Resident

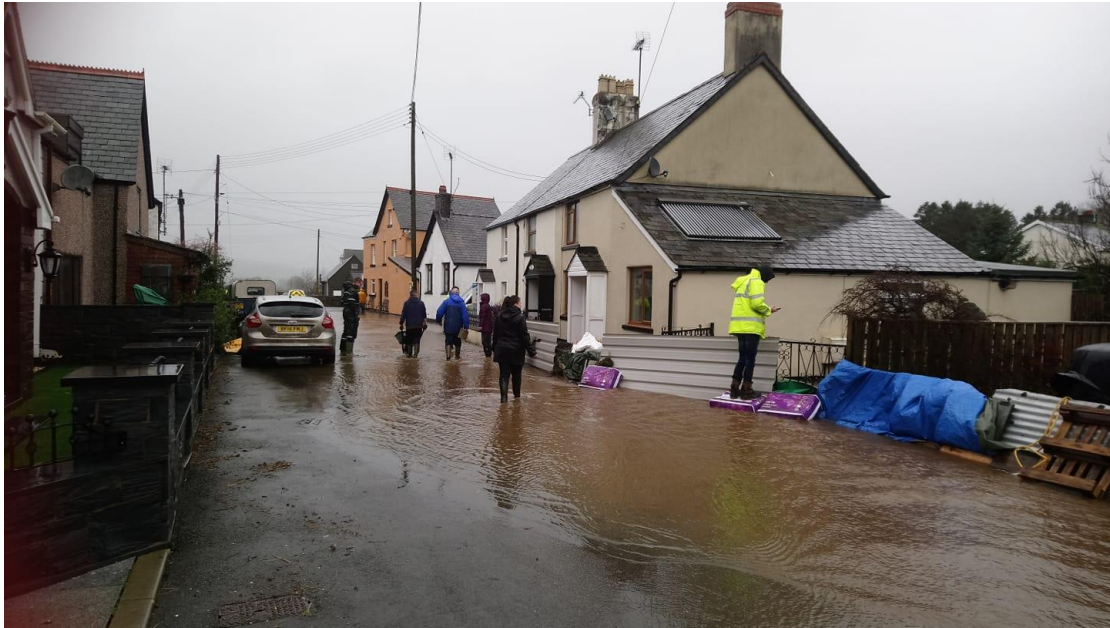
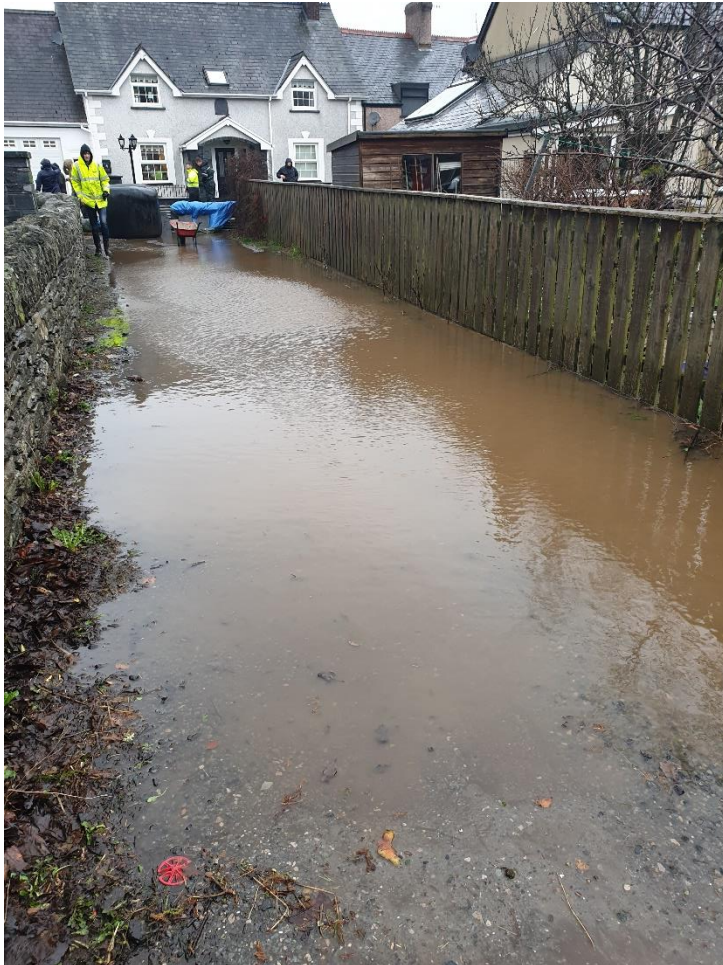
Residents implemented makeshift flood defences across drives and at strategic locations along the flood's flow path to mitigate internal flooding including across the entrance to Maes Y Gerddi (Figures 8 and 9).

Figure 8: Floodwater at the south end of Berwyn Street. Source: Llandrillo Facebook group

Figure 9: Flooding on Maes Y Gerddi, looking towards Berwyn Street. Source: Resident

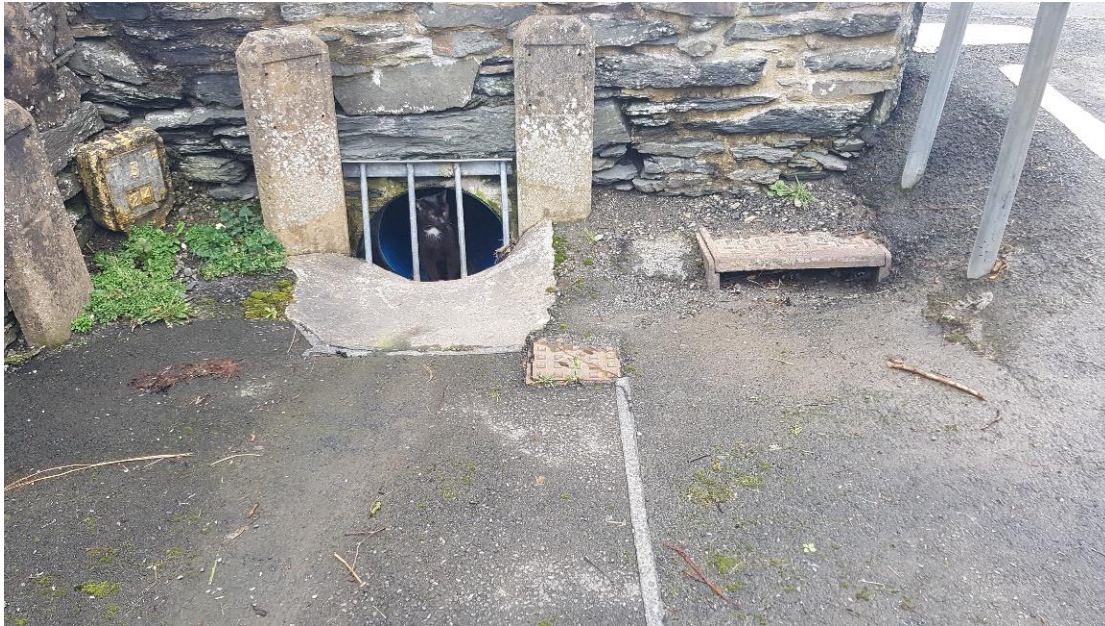
The flow along Berwyn Street drained to a flood relief culvert (a single 450 mm diameter pipe, see Figure 10) adjacent 'Llwyn Onn' which drains under Llys-y-Groes, to the east of the High Street road bridge.

According to the Senior Flood Warden for the local community, once the flood relief culvert was cleared, it worked effectively to relieve the flooding on Berwyn Street.

Figure 10: Flood relief culvert at the High Street road bridge. Source: NRW staff

Due to the extent of floodwater flowing through Llandrillo, it may be appropriate to review and update the existing flood modelling study (2008) including the underlying hydrology. This review should look at the severity of this event, the effects of structures along the system (road and foot bridges, flood relief culvert and existing defences), effectiveness of current private defences and flood warning options.

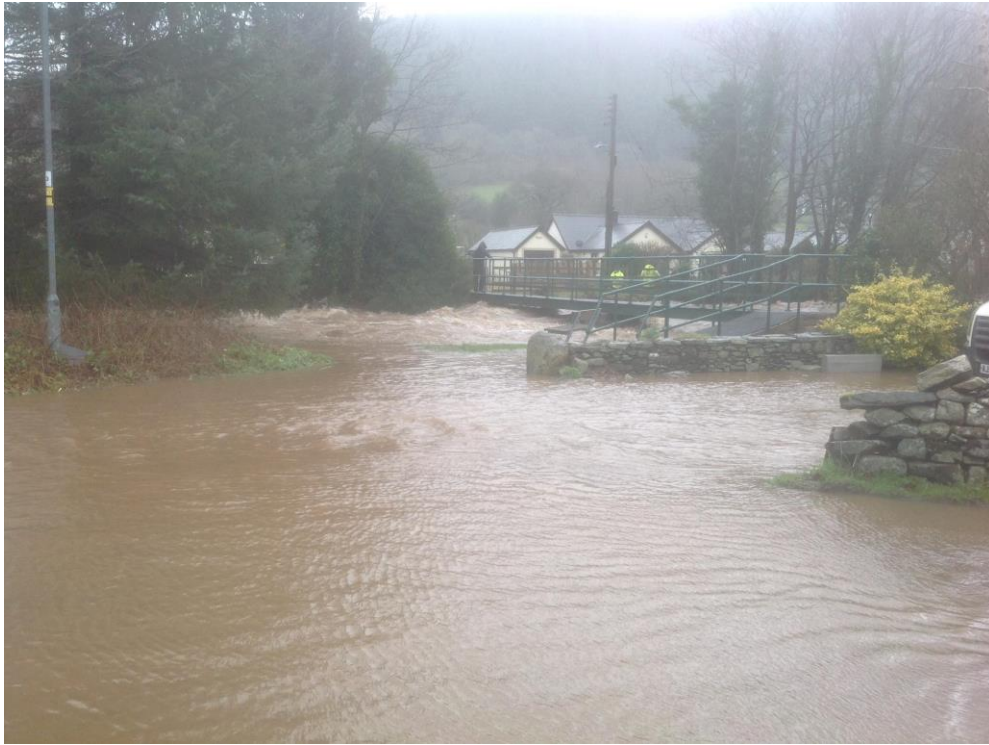
The Afon Ceidiog overtopped the left bank, later in the day than the right bank. The Ceidiog overtopped near to the caravan park and flowed north along the road between the property named 'Glan Ceidiog' and the High Street road bridge. Overtopping also occurred at the footbridge near 'Glan Ceidiog' (Figure 11).

Figure 11: Floodwater overtopping the left bank, nearby Glan Ceidiog and the adjacent footbridge. Source: Llandrillo Facebook group

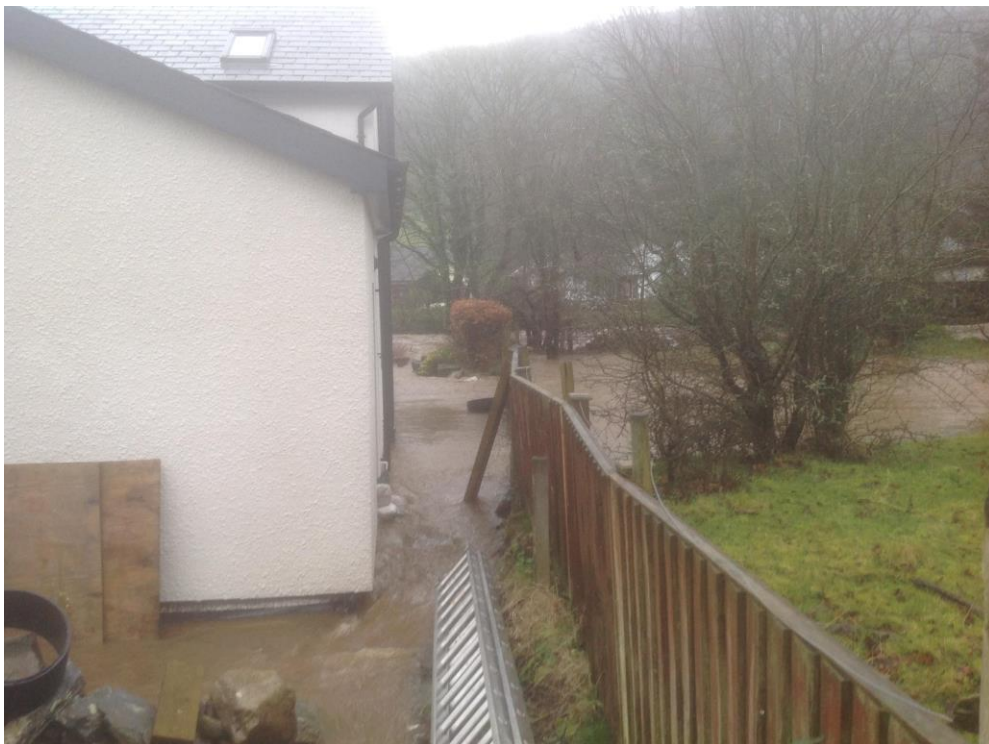
There was no reported internal flooding on the left bank floodplain. Both 'Glan Ceidiog' (Figure 12) and 'Glan Dwr' (Figure 13) were surrounded by water but did not report any internal flooding.

Figure 12: Floodwater at the rear (south) of Glan Ceidiog. Source: Llandrillo Facebook group

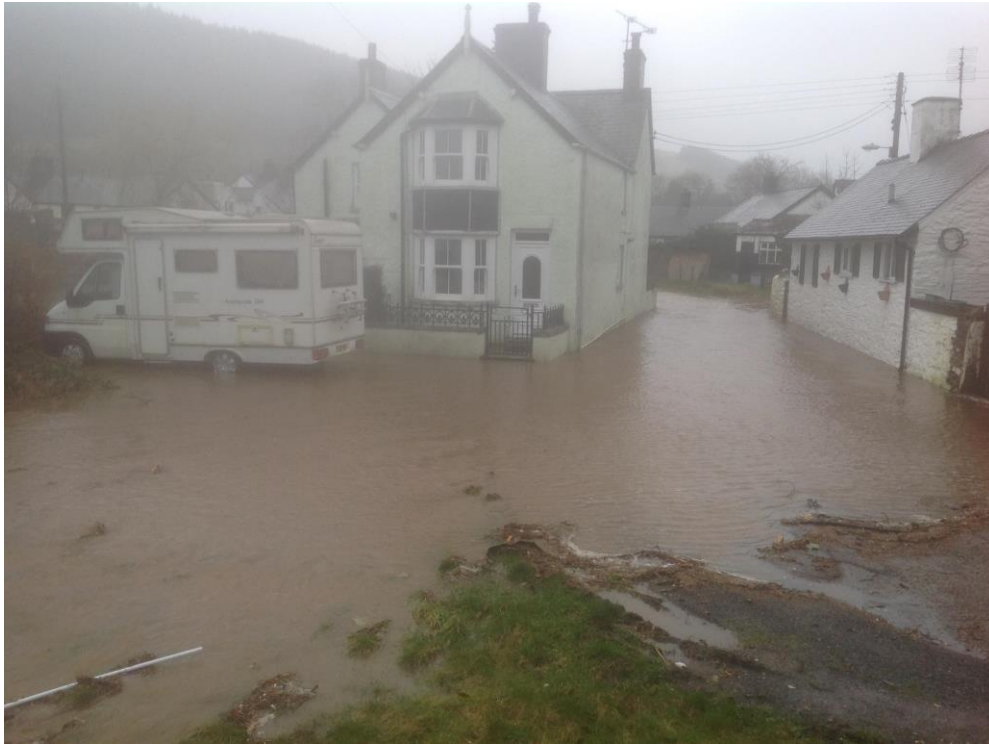
Figure 13: Floodwater around the Glan Dwr property, immediately upstream of the High Street road bridge. Source: Llandrillo Facebook group
