# Denbighshire County Council Investigation into the January 2021 Floods Flood Investigation Report

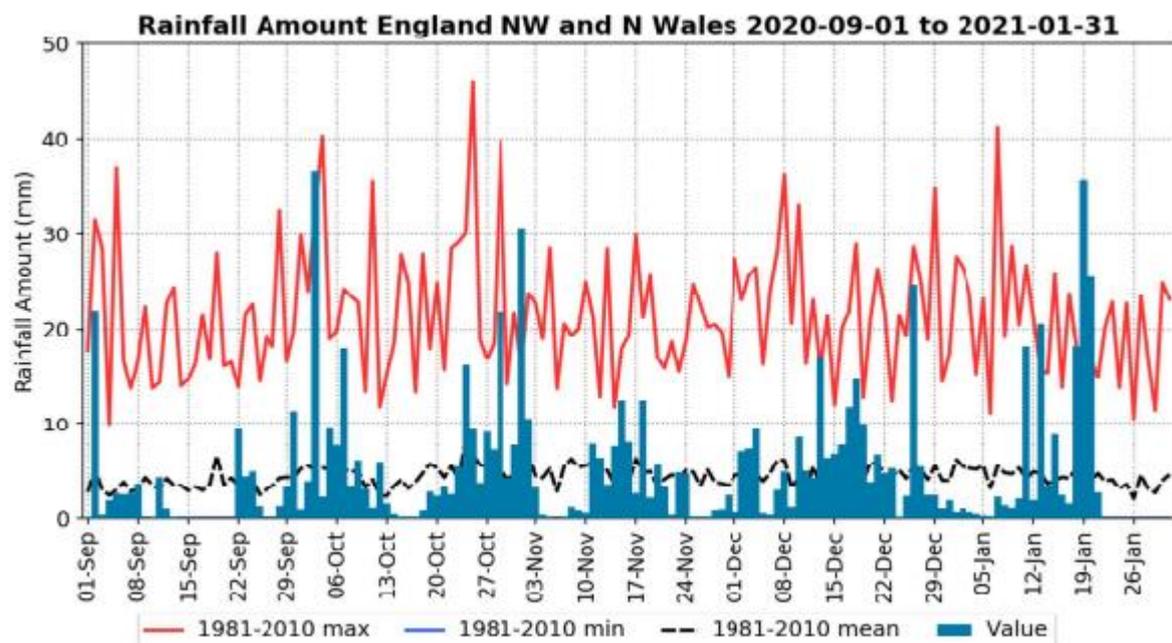
Figure 1 below shows area-average daily rainfall totals across north-west England and North Wales from September 2020 to January 2021. This region experienced three consecutive very wet days from 18 to 20 January with area-average rainfall totals of 18.2mm, 35.7mm and 25.5mm – overall 79.4mm making this provisionally the wettest 3-day period on record for this region in a series from 1891 – marginally wetter than 3 to 5 December 2015 (78.2mm) – the latter including the record-breaking rainfall from storm Desmond. (Met Office, 2021).

Figure 1: Area-average daily rainfall totals across north-west England and North Wales from September 2020 to January 2021 (Met Office, 2021)

It is in this context that the flooding that affected communities in Denbighshire on 20th January must be viewed. For example, Ruthin recorded 76.4 mm of rain over the four Days from 18<sup>th</sup> to 21<sup>st</sup> January, which is more than the long-term monthly average for that Month (*Natural Resource Wales, 2021*).
