# NOVEMBER 2012 FLOODS AT GLASDIR, RUTHIN FROM THE RIVER CLWYD

## REPORT ON THE REVIEW by the Independent Panel for the Evaluation of Hydrology, Flood Risk and Causes of Flooding

By Dr Jean Venables CBE FREng FICE  
Client Issue 2  
27 August 2013

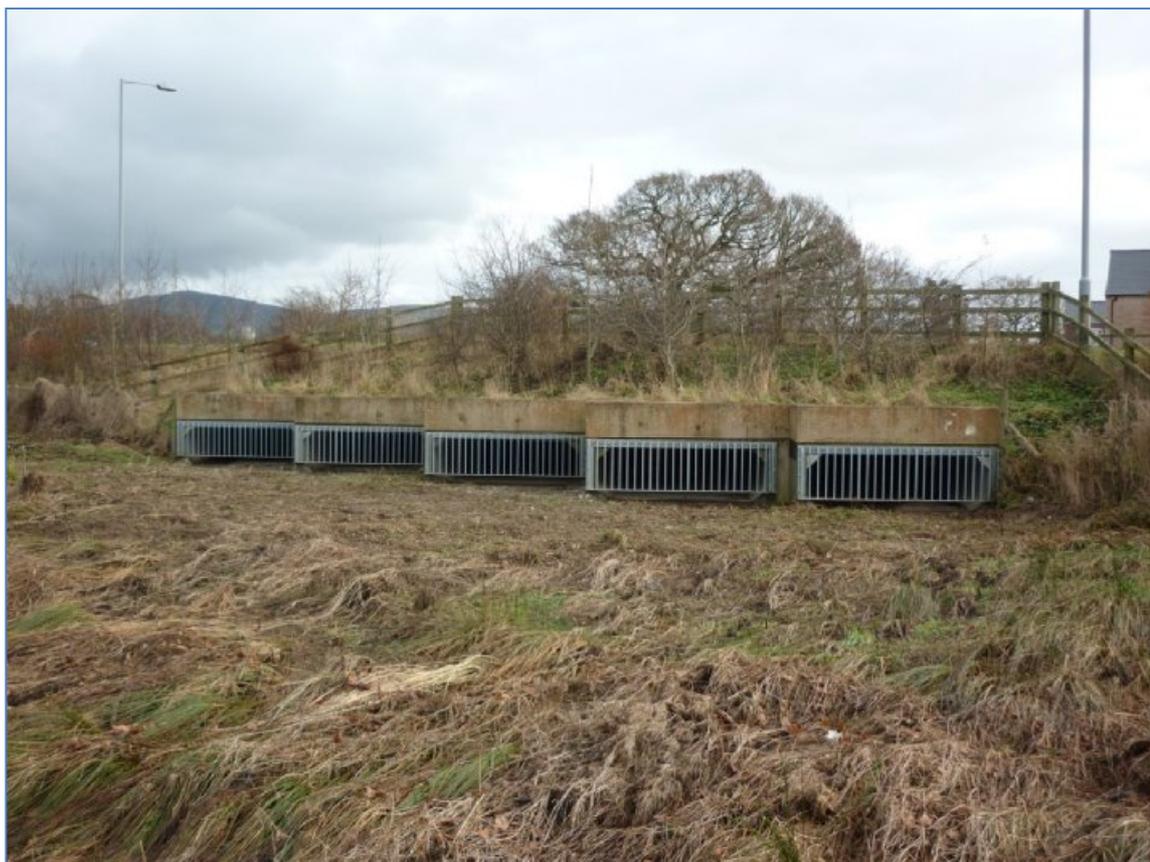
Plate 4 - Ruthin Link Road Culverts

Subsequently, five culverts were built and fitted with vertical grills at both upstream and downstream ends. These were reported as having been partially blocked by vegetation and debris, in the November 2012 event but the actual proportion of blockage during the November 2012 event is not known (see Plate 4 and Plate 5). The grills were removed shortly after the flood event.

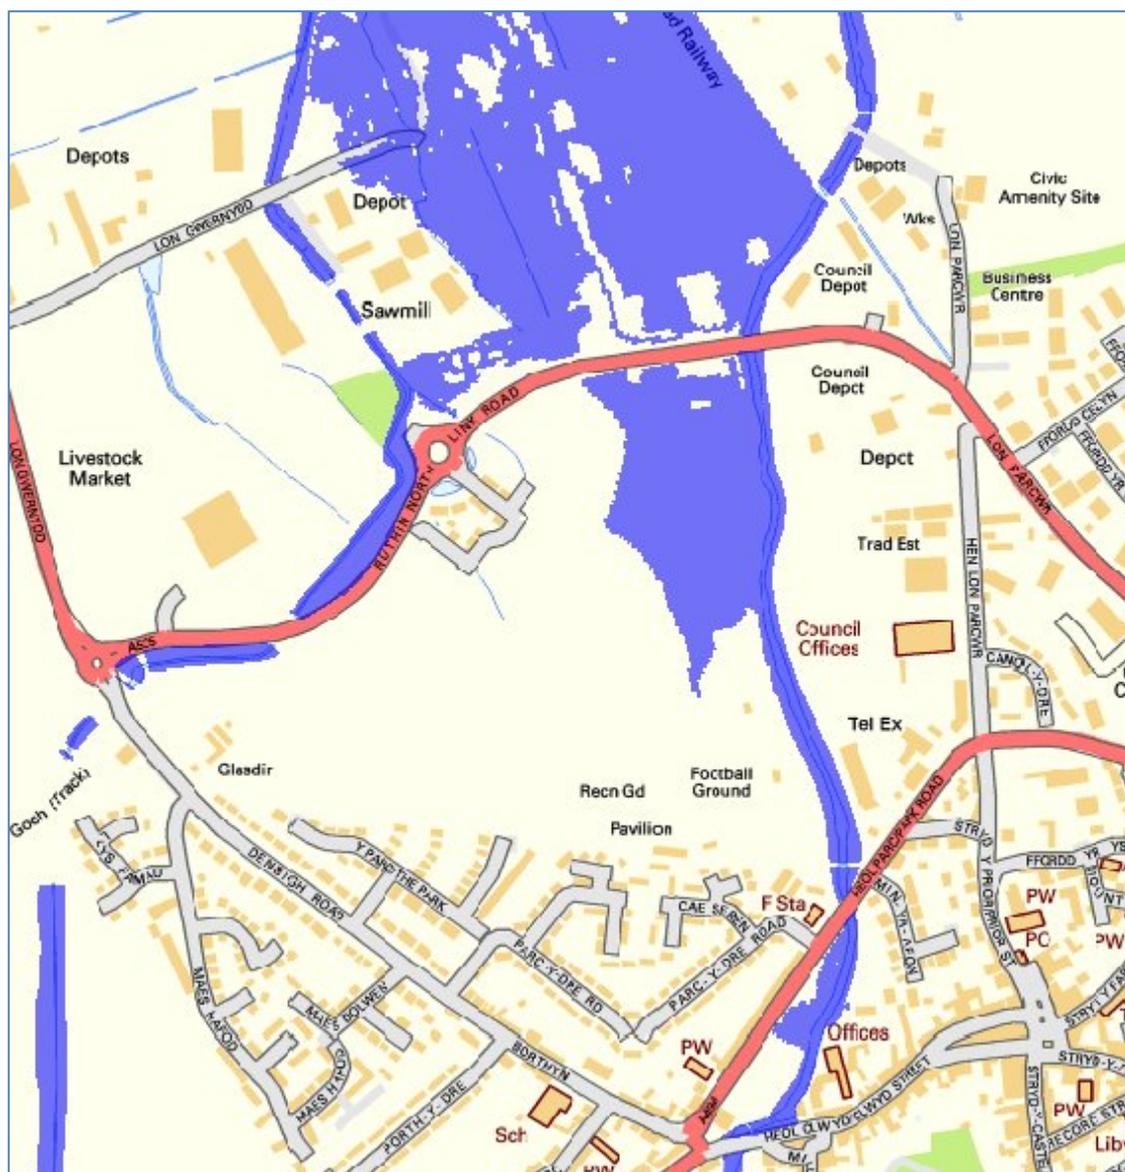
Figure 6 - Design hydrology; Q = 1 in 100 years, 35.2 m<sup>3</sup>/s Blockage = 0%: (Scenario B)

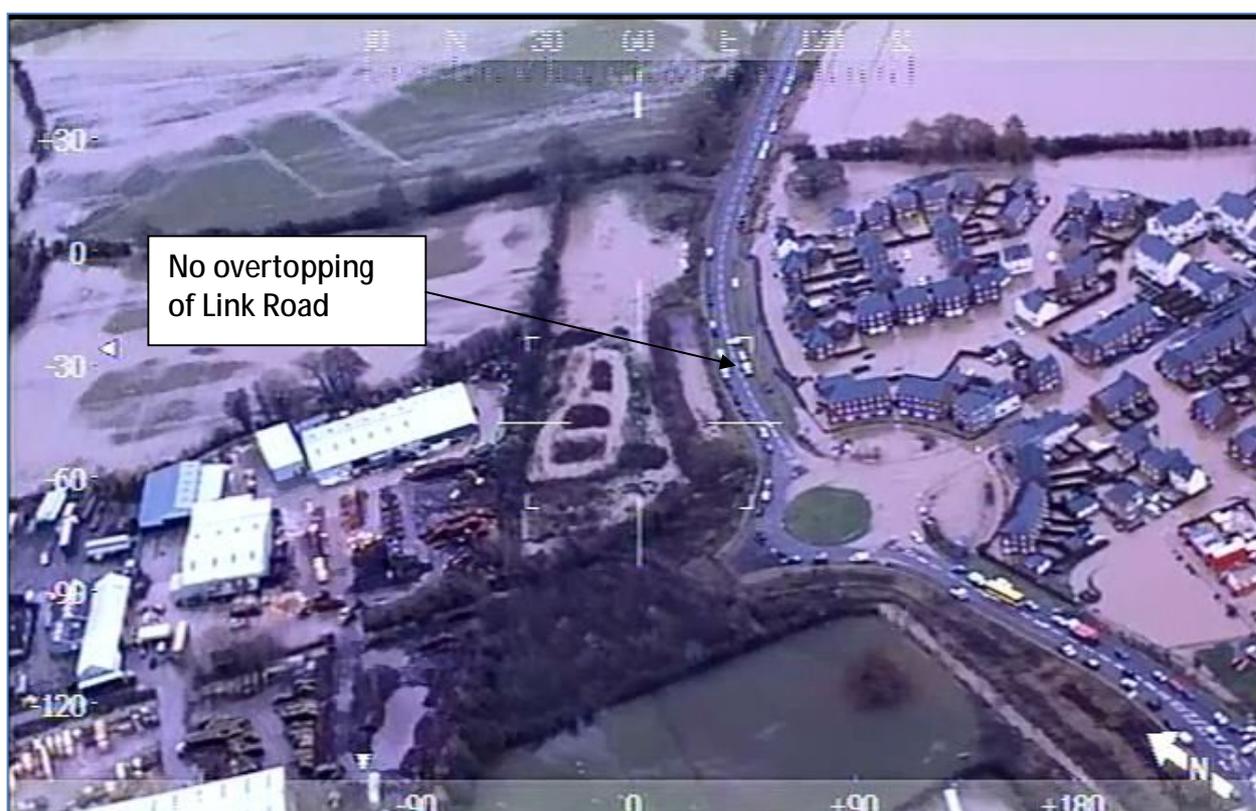
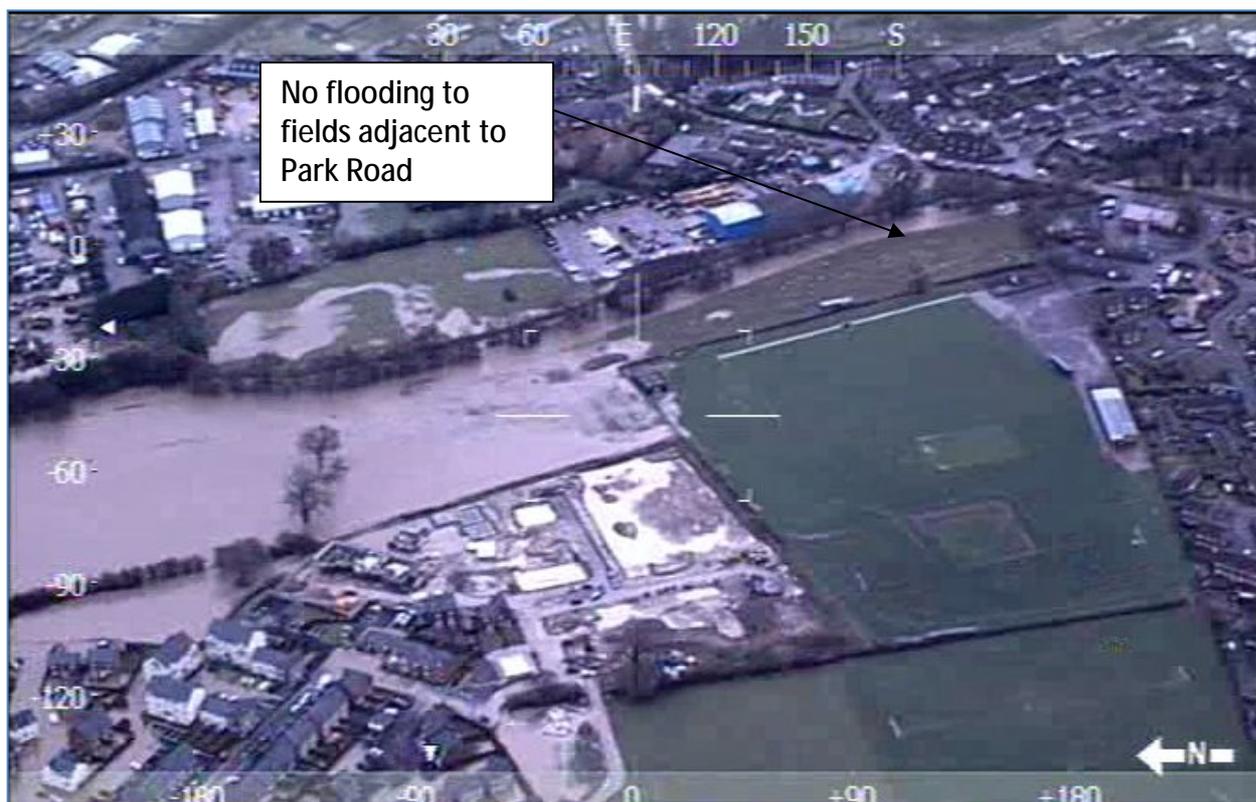
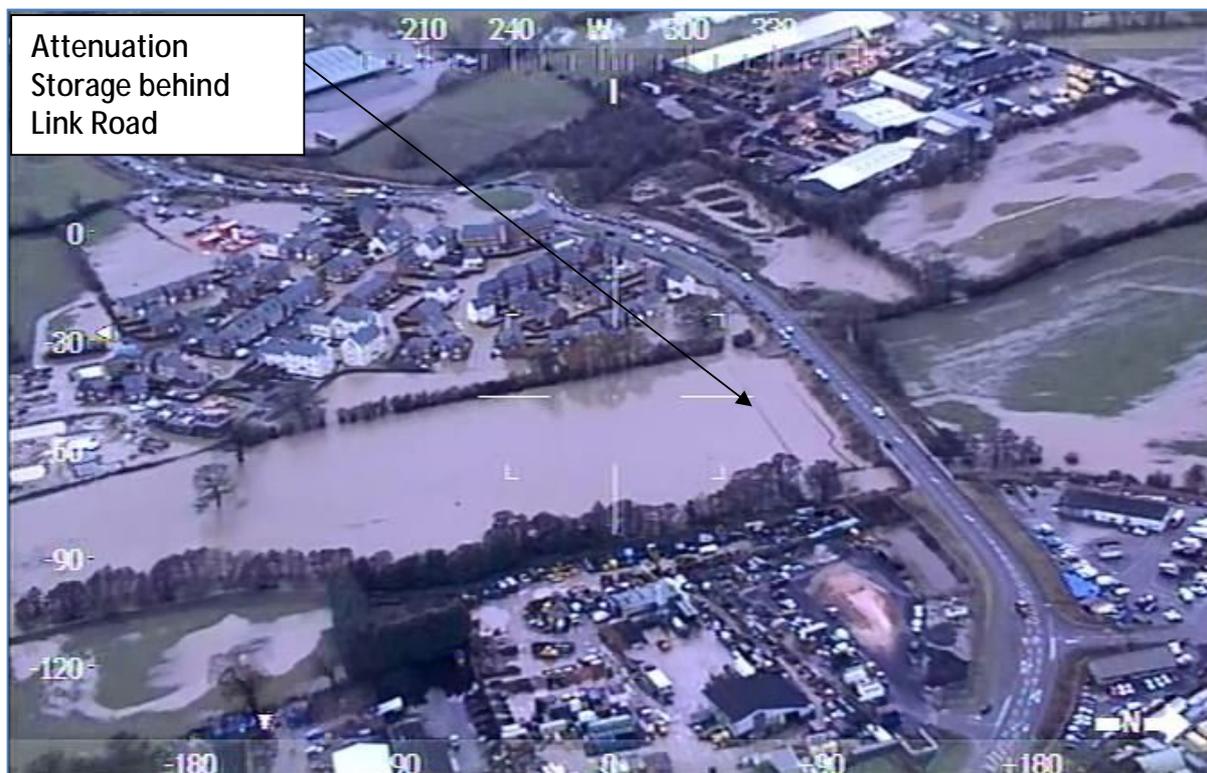
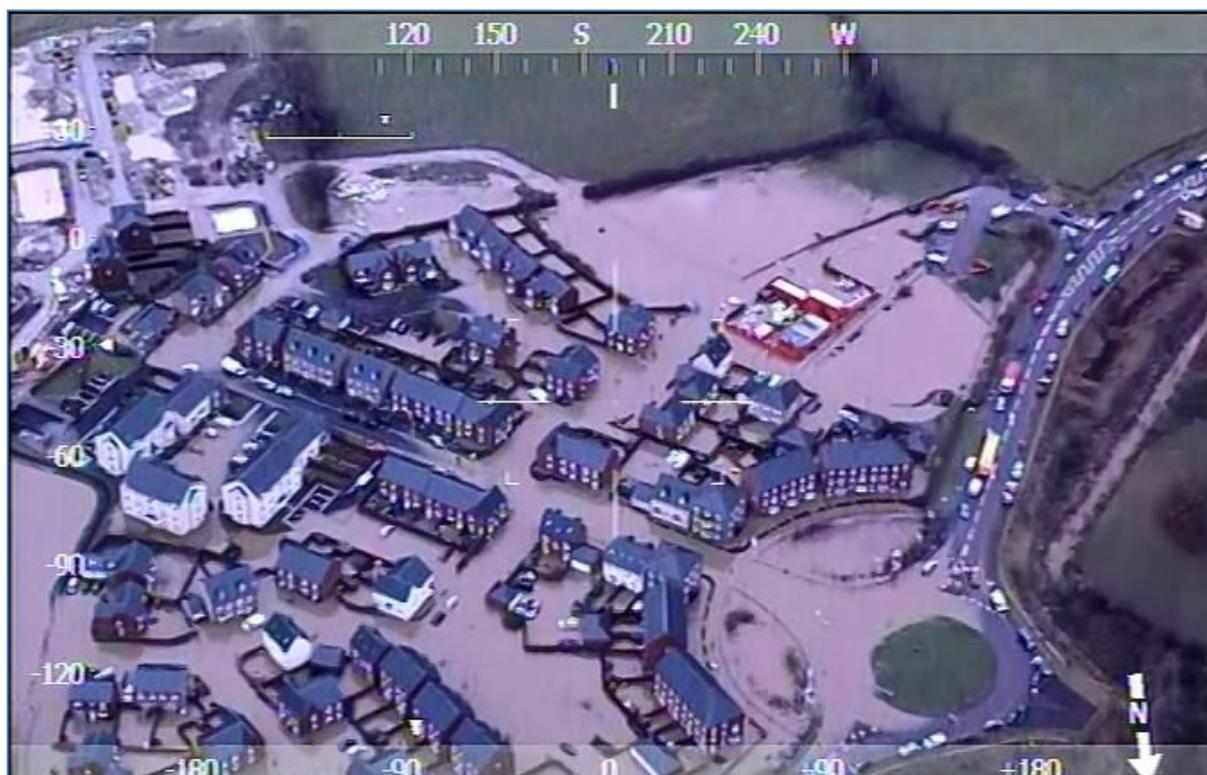
- Attenuation of flood water behind the causeway formed by the Ruthin Link Road.
- Reduced water levels downstream of the link road.
- Overtopping of the flood embankment bordering the estate.
- Flooding to the majority of the Glasdir Estate.
- No flooding adjacent to the Fire Station and the fields on the left bank directly downstream of Park Road.

Plate 8 - November 2012 flooding to Glasdir

Plate 9 - November 2012 flooding to Glasdir (view from west)

Plate 10 - November 2012 flooding to Glasdir (view from east)

Plate 11 - November 2012 flooding to Glasdir (view of Glasdir)

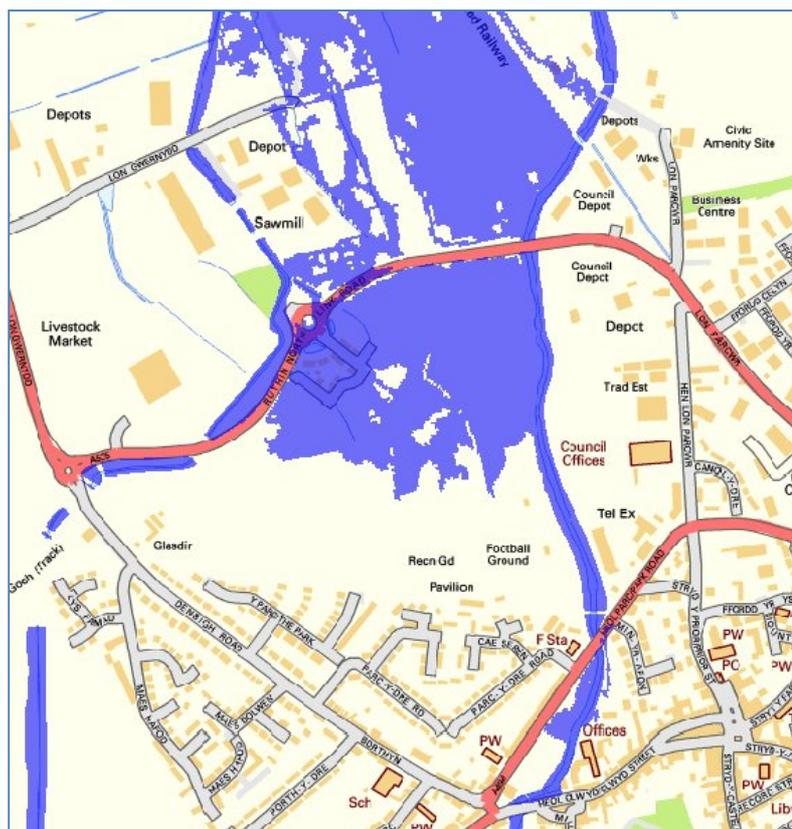
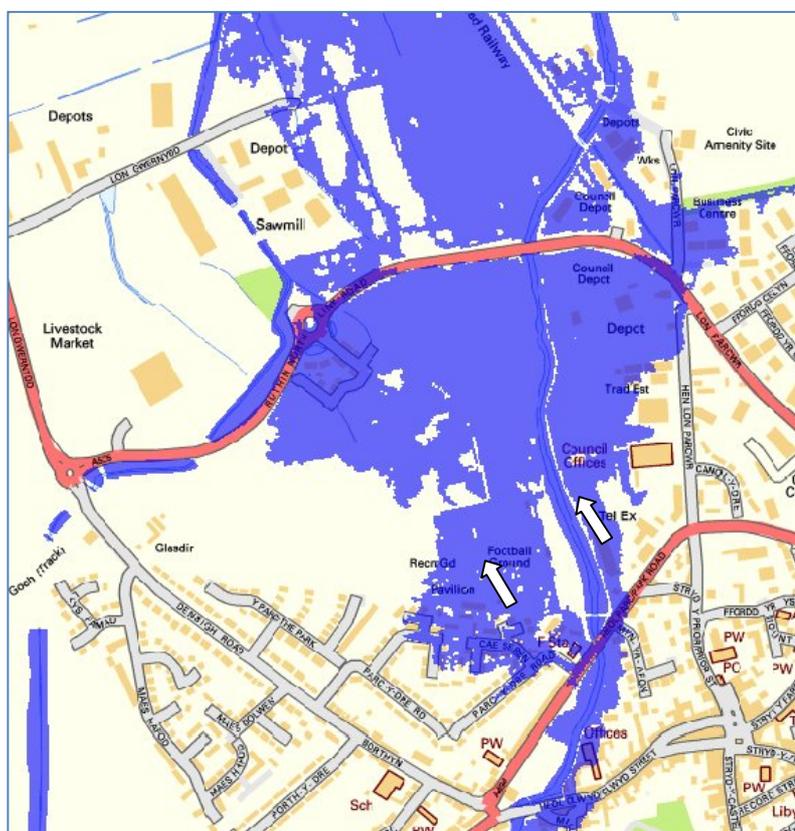
Figure 12 - Sensitivity to flow: November 2012 hydrology; blockage 95%; 70% scaling to JBA 31.4 m<sup>3</sup>/s

Figure 13 - Sensitivity to flow: November 2012 hydrology; blockage 95%; 80% scaling to JBA 35.9 m<sup>3</sup>/s

Figure 14 - Sensitivity to Flow: November 2012 hydrology; blockage 95%; 100% scaling to JBA 44.9 m<sup>3</sup>/s

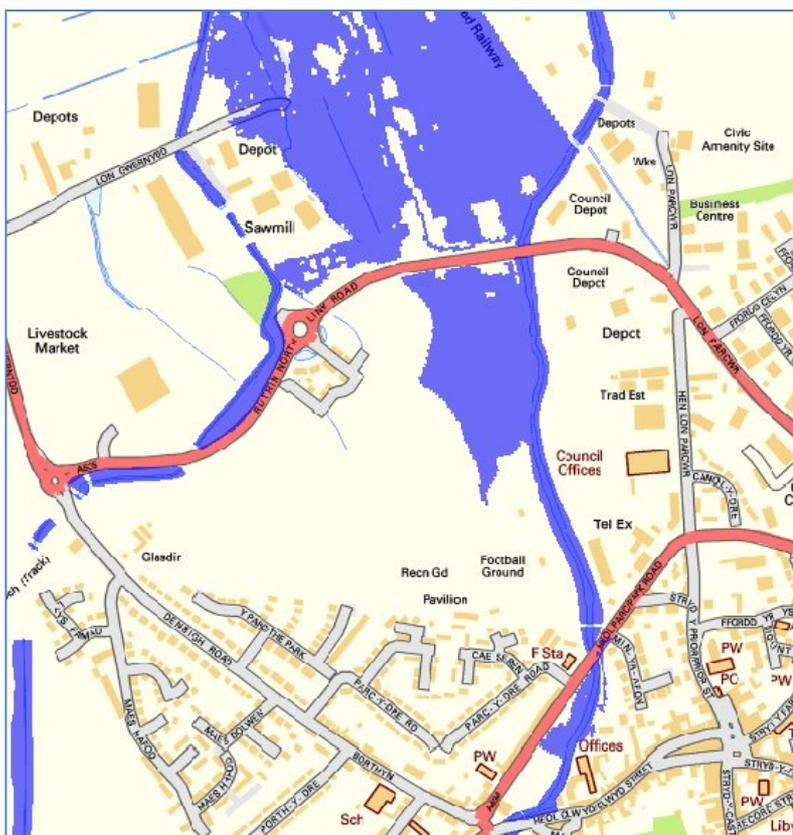
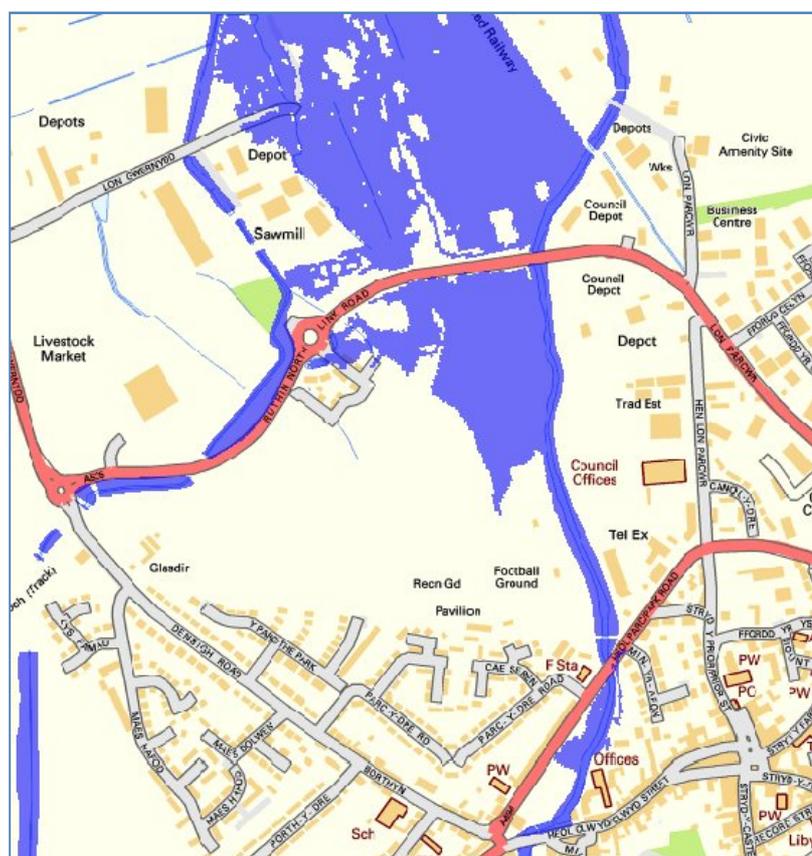
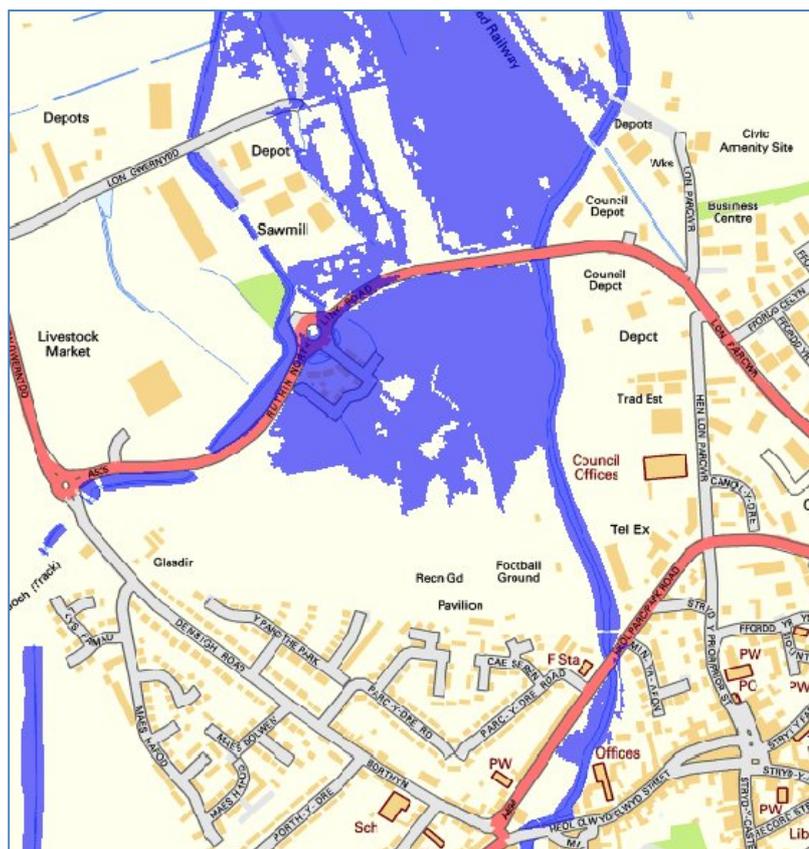
Between 66% and 95% blockage, significant flooding does occur and flood extents within Glasdir are largely similar to those observed during the event and as shown in Plate 8 to Plate 11. It is likely that blockage at the screens was in the order of 66% to 95%.

Figure 15 - Sensitivity to blockage: November 2012 hydrology;  $Q = 35.9 \text{ m}^3/\text{s} = 80\%$  scaling 33% blockage

Figure 16 - Sensitivity to blockage: November 2012 hydrology;  $Q = 35.9 \text{ m}^3/\text{s} = 80\%$  scaling 66% blockage

Figure 17 - Sensitivity to blockage: November 2012 hydrology; Q = 35.9 m<sup>3</sup>/s = 80% scaling 95% blockage

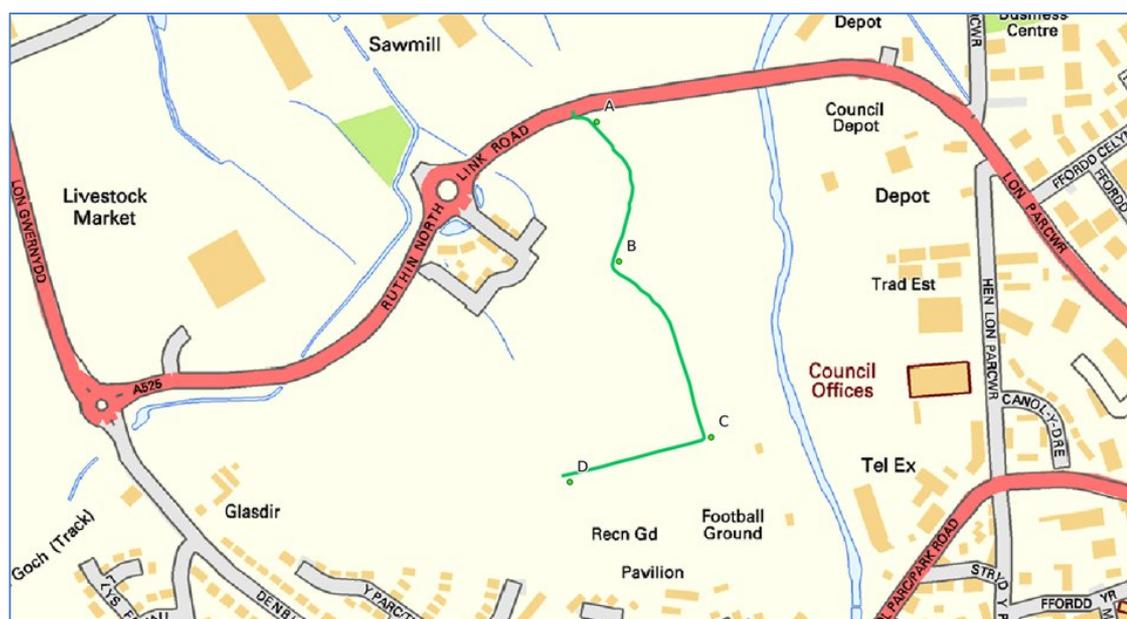
Figure 22 Location of level sample points provided in Table 7

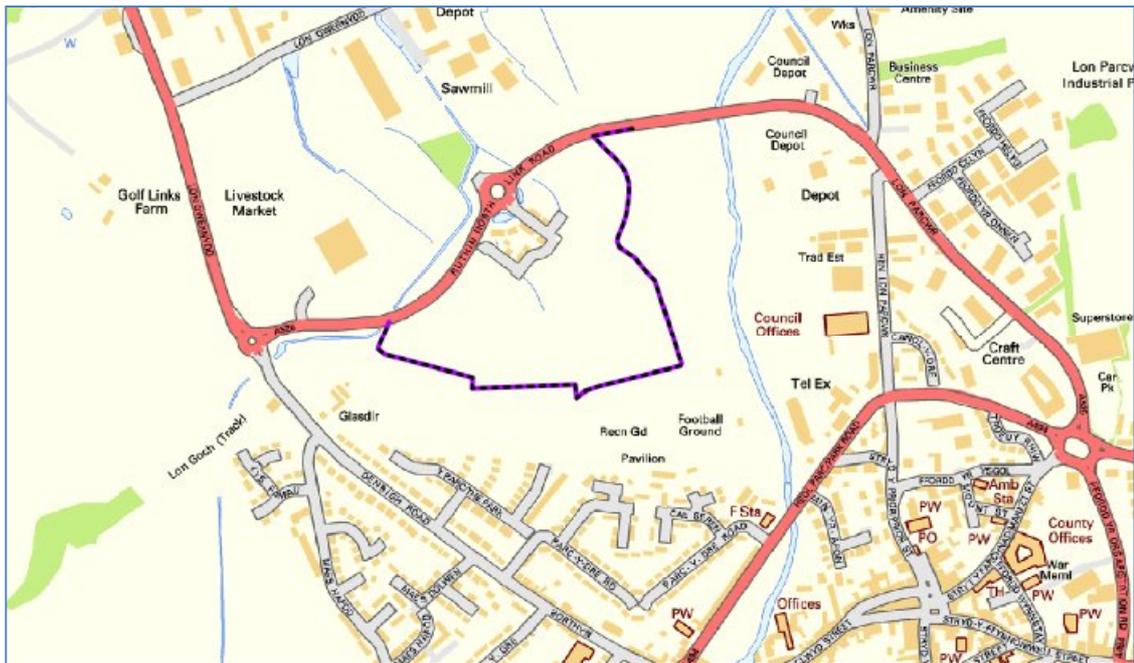
Figure 23 - Location of modelled Flood Defence around the Glasdir Estate. The line of the bund is for analytical purposes and does not indicate a suggested scheme.

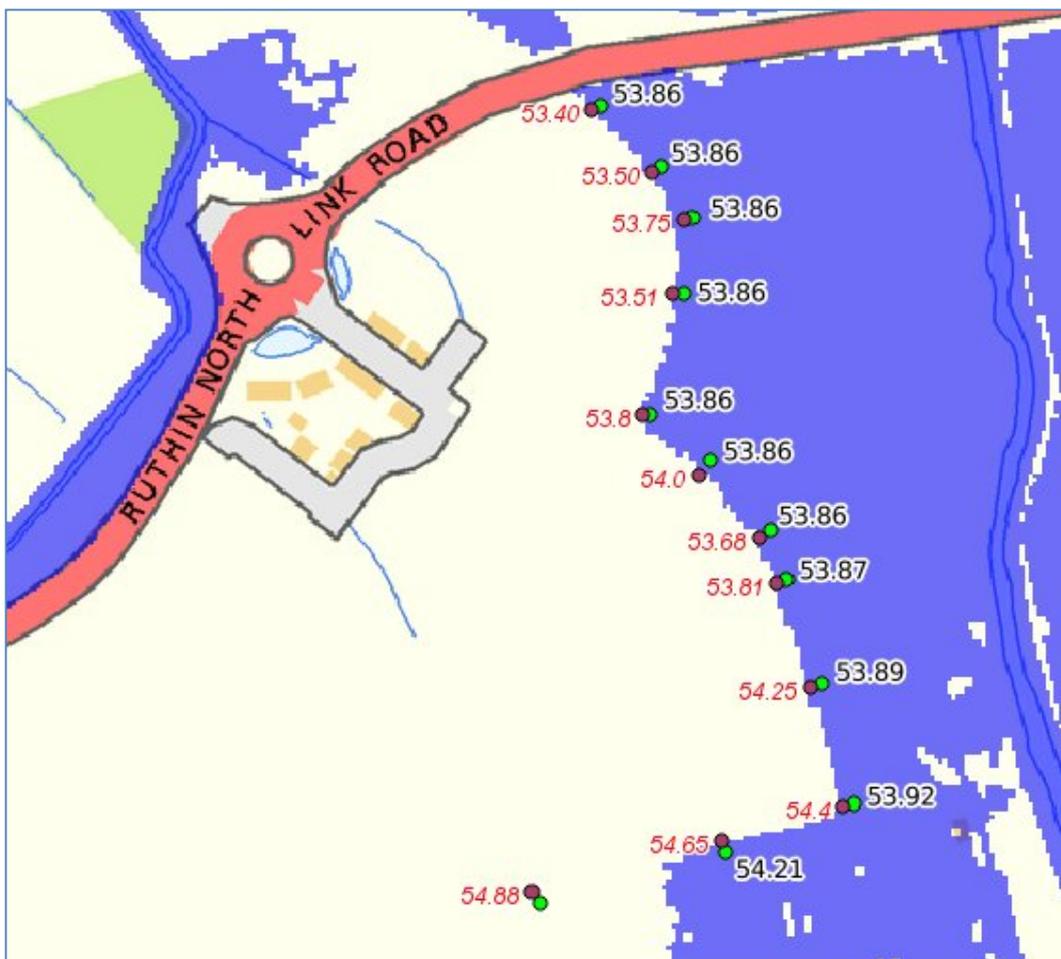
Figure 24 - Comparison of modelled peak water level for the 1 in 100 yr return period with Climate Change and 95% blockage, and existing embankment level. Existing embankment levels shown in red; modelled levels shown in black.

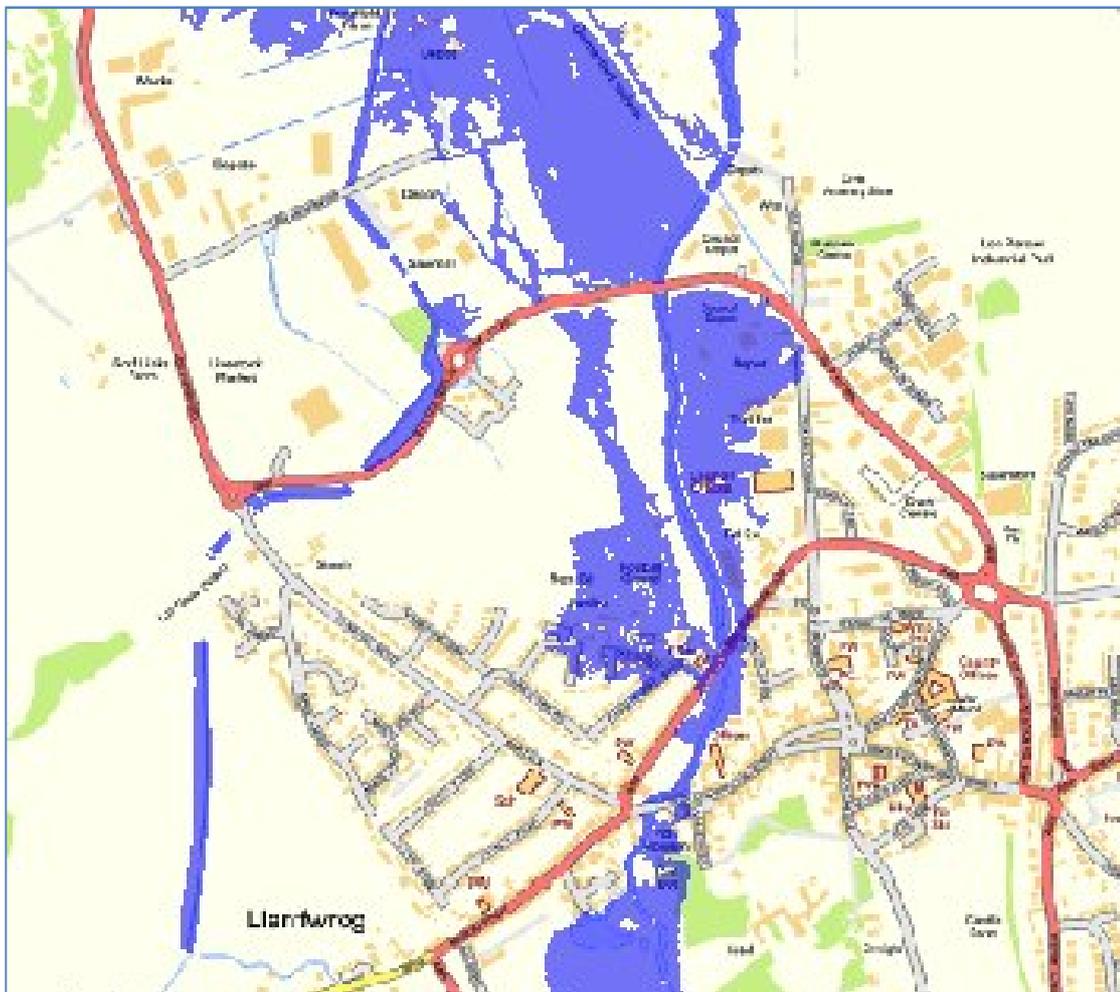
Figure 28 - Option 3 - ISIS TUFLOW Model Results for 1 in 100 year return period with Climate Change and 95% blockage

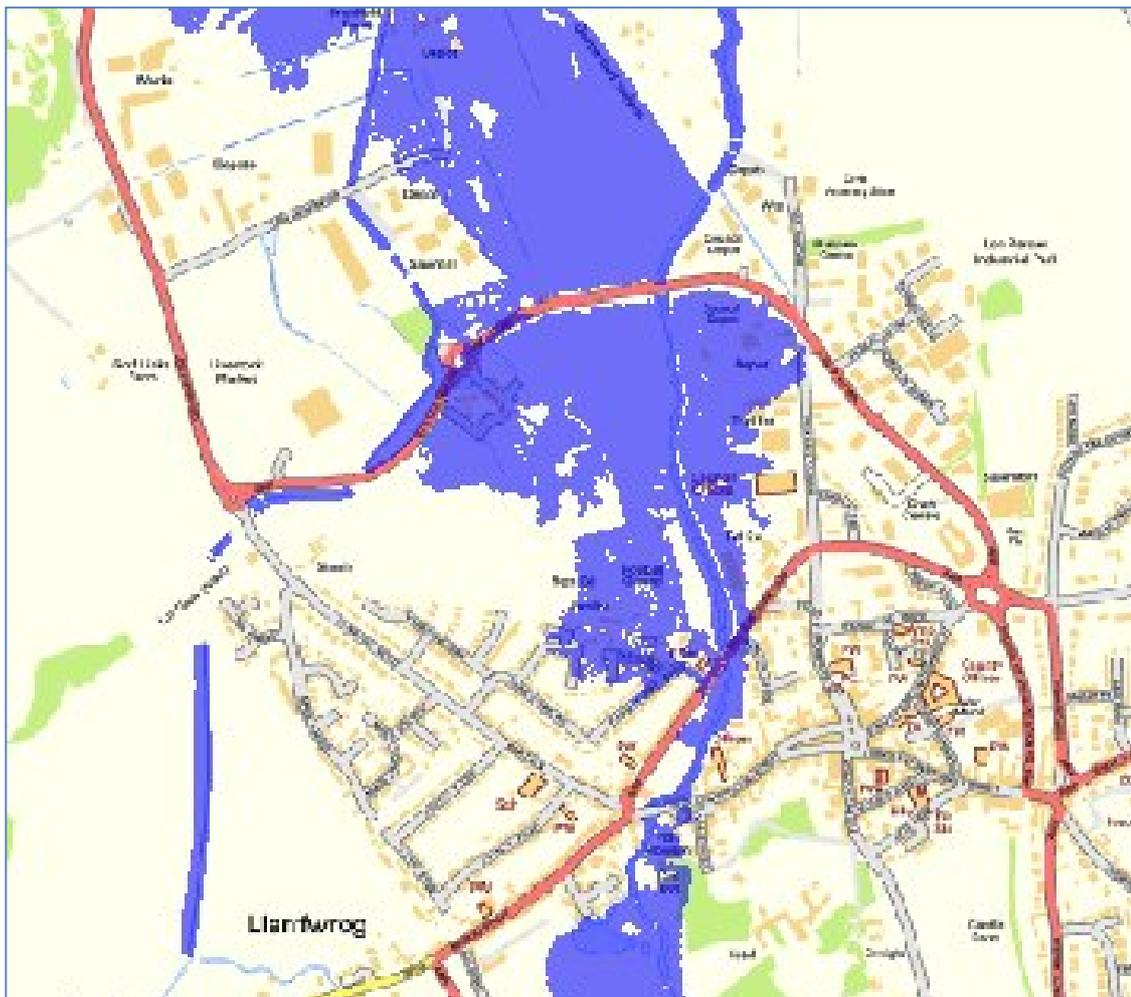
Figure 31 - Option 4 - ISIS TUFLOW Model Results for 1 in 100 year return period with Climate Change and 95% blockage

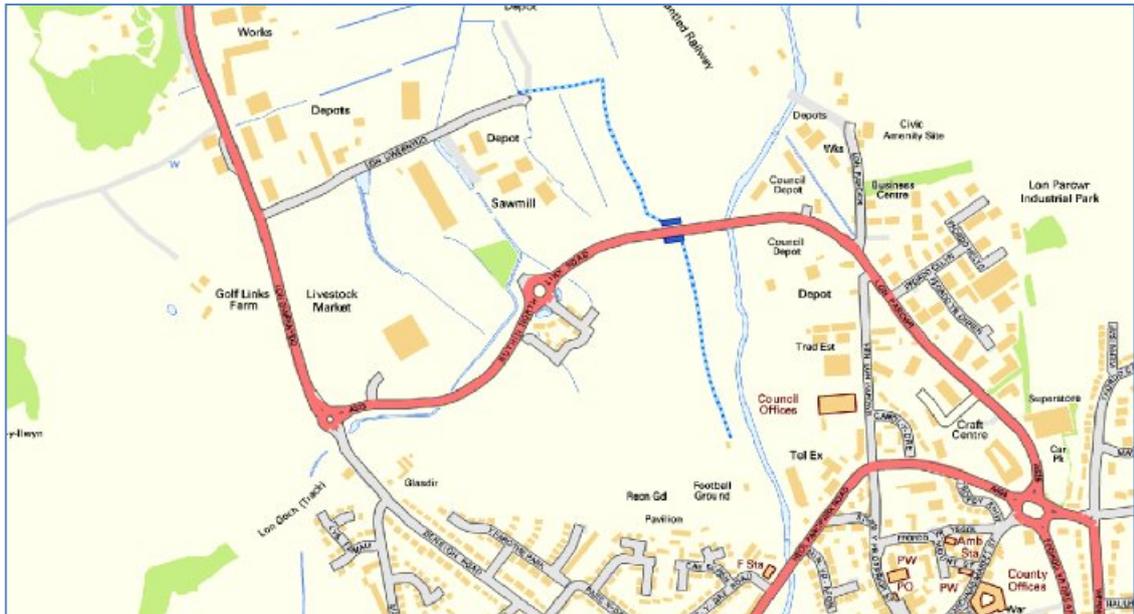
Figure 33 - Option 5 - Introduction of an Additional Flow Routes under the Ruthin Link Road (Scenario G)

Advantages	Disadvantages
<p>The scheme does deliver a higher standard of service to the Glasdir Estate.</p> <p>The environmental impact of this option is comparatively low.</p>	<p>Work will be required on land which is under the control / ownership of third parties and this will require negotiation to allow construction to proceed.</p> <p>The costs associated with implementing this option will be high.</p> <p>The likelihood of delivering this option will be low.</p> <p>Blockage to the structure by debris will be a risk.</p> <p>Disruption to the general public and residents associated with the construction of the scheme is high as a result of the work required to the Ruthin Link Road.</p> <p>There will be negative third party impacts downstream of the Ruthin Link Road which may require additional works to be undertaken to protect domestic / industrial / agricultural. Third party impacts will require further investigation to establish the scale of change in flood risk.</p>

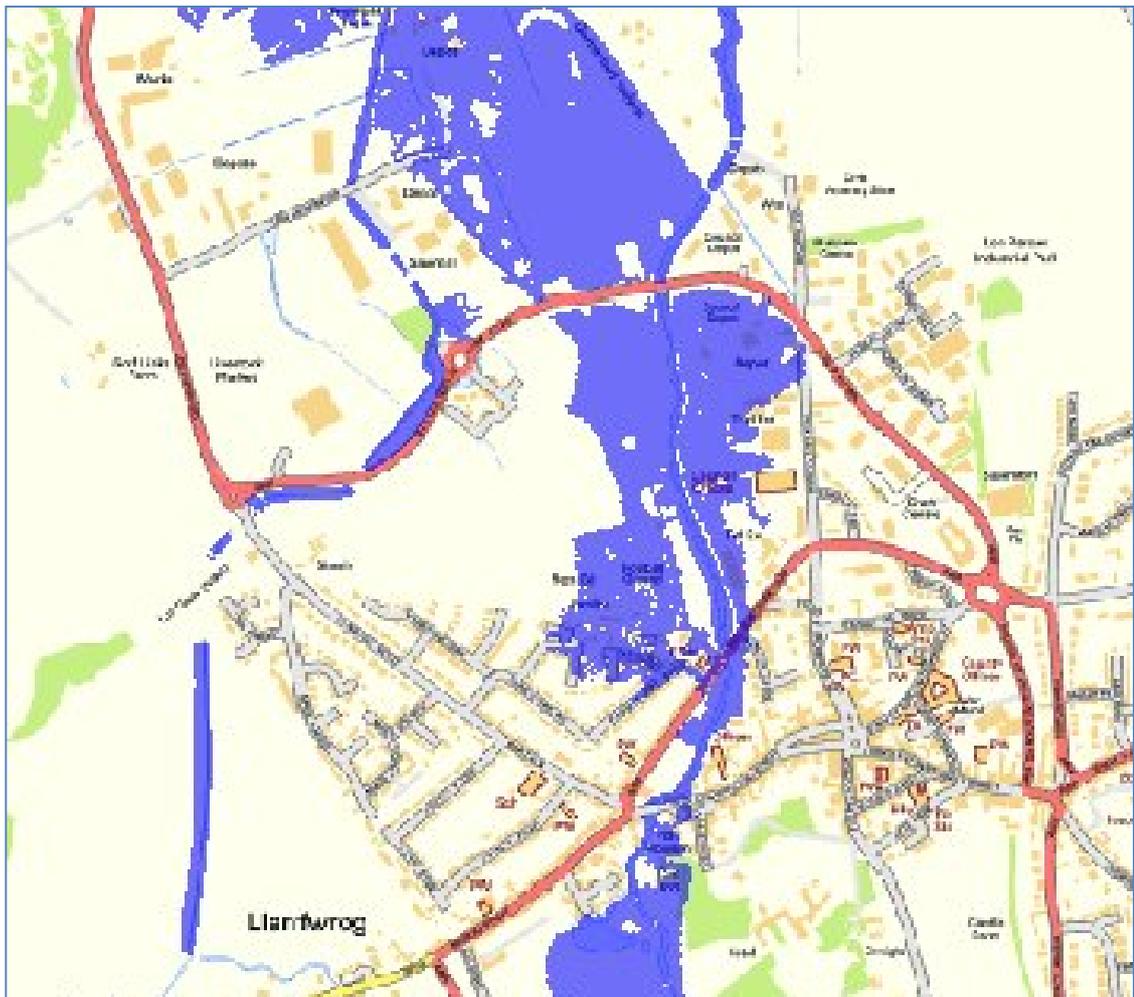
Figure 34 - Option 5- ISIS TUFLOW Model Results for 1 in 100 year return period with Climate Change and 95% blockage

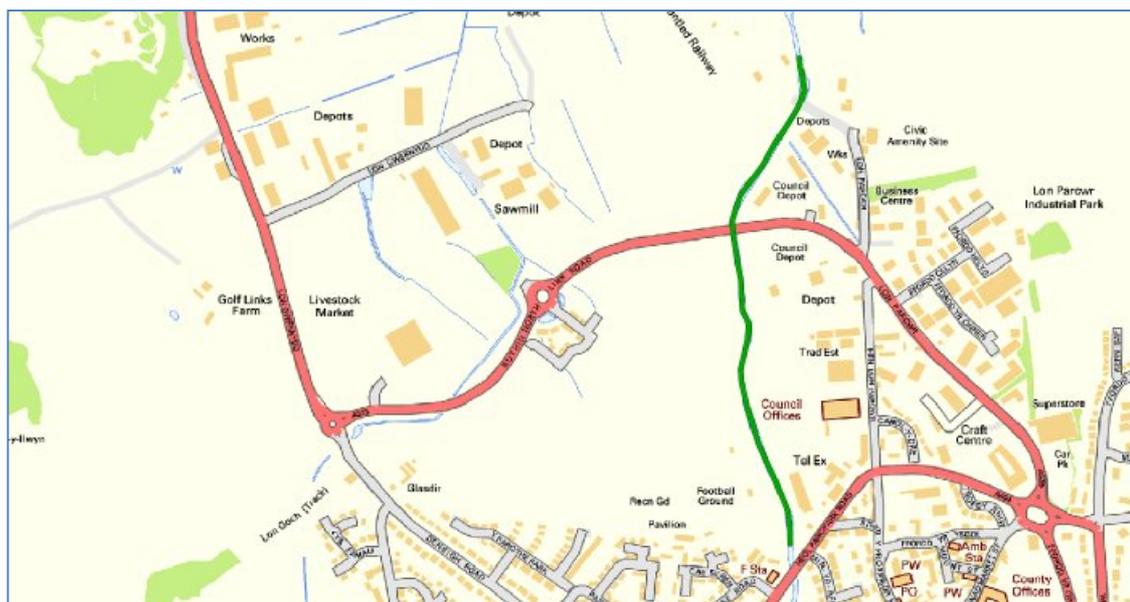
Figure 36 - 4.8 Option 6 - Removal of Ruthin Weir & Re-grading of the River Clwyd (Scenario H)

Advantages	Disadvantages
The scheme delivers a high standard of service to the Glasdir Estate.	The costs associated with implementing this option will be high.
The environmental impact of this option is potentially high during construction but reducing or improving in the long term.	The environmental impact of this option is potentially high during construction but reducing or improving in the long term.
	The foundations of bridge structures upstream of Ruthin Weir may be compromised.
	The likelihood of delivering this option will be low.
	There could be negative third party impacts downstream of the Ruthin Link Road which may require additional works to be undertaken to protect domestic / industrial / agricultural. Third party impacts will require further investigation to establish the scale of change in flood risk.

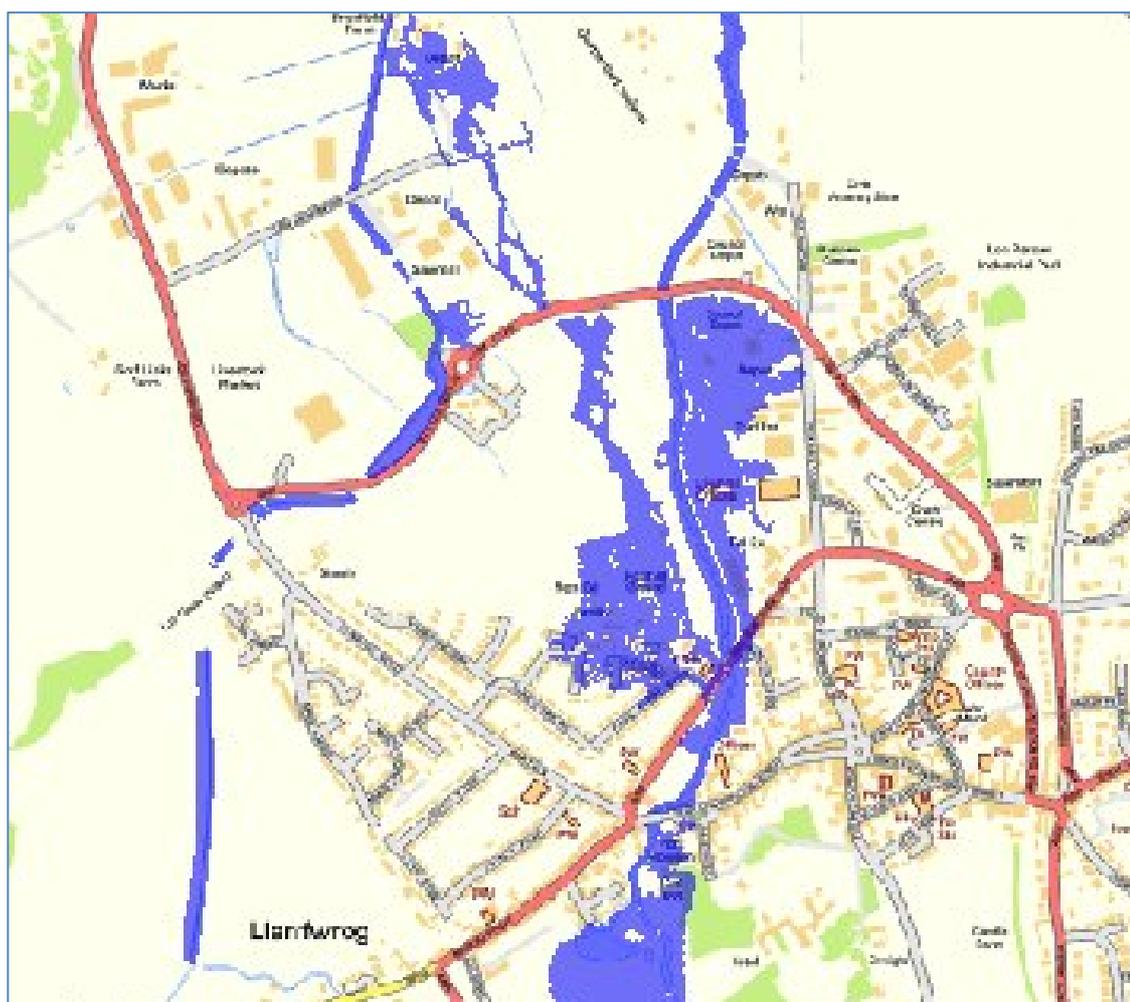
Figure 37 - Option 6 - ISIS TUFLOW Model Results for 1 in 100 year return period with Climate Change and 95% blockage
