APPENDIX A

Partnerships Scrutiny Committee – 3 April 2025

Pont Llannerch - Appendix A

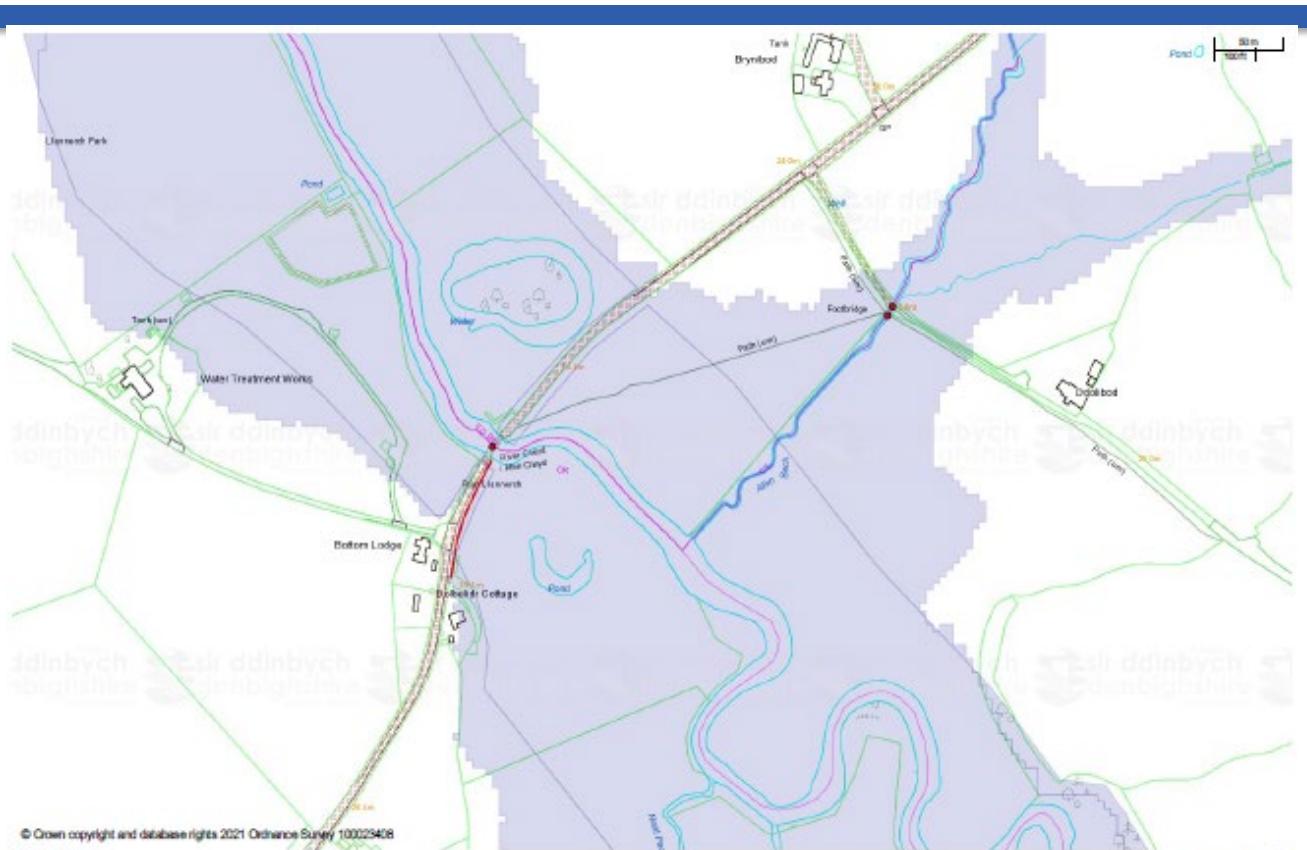
Flood Map

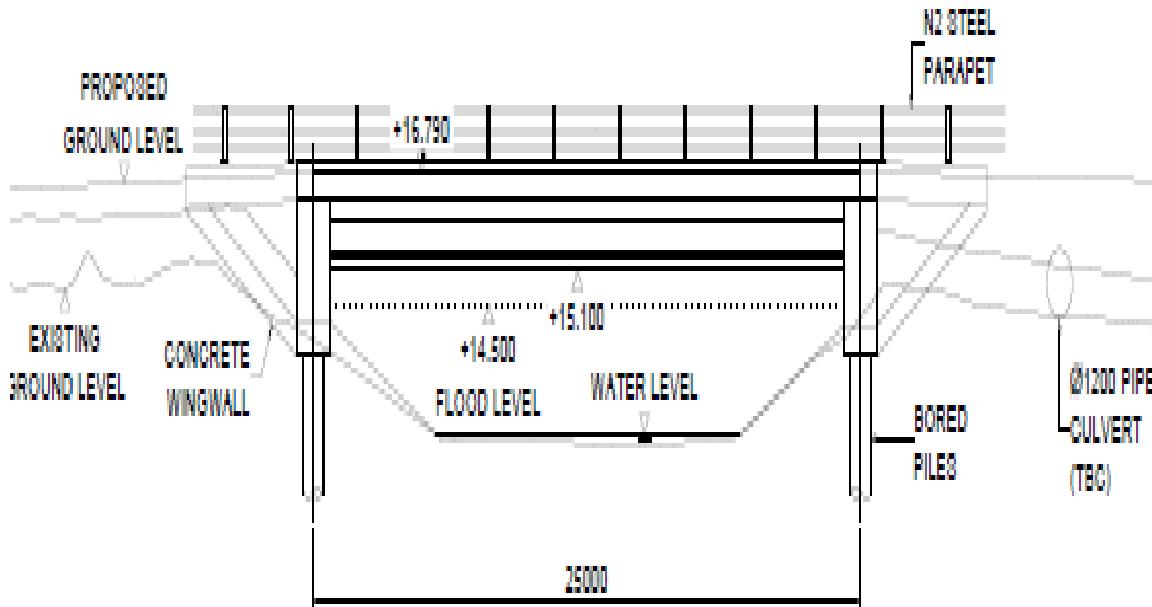
OPTION 1 - PRECAST CONCRETE INTEGRAL BRIDGE

Scale 1:200

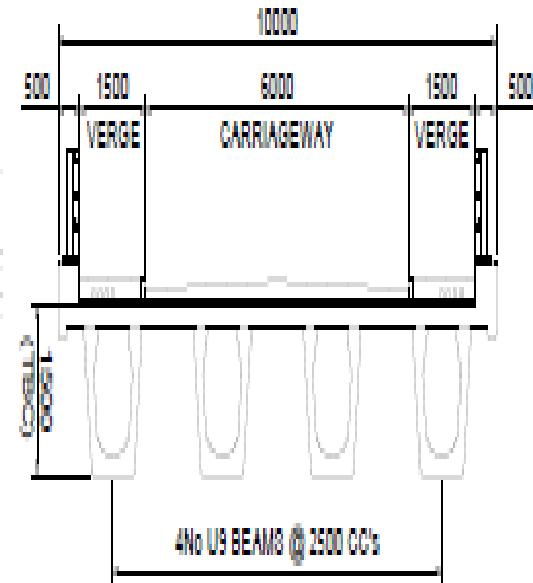
OPTION 1a - CROSS-SECTION

Scale 1:100

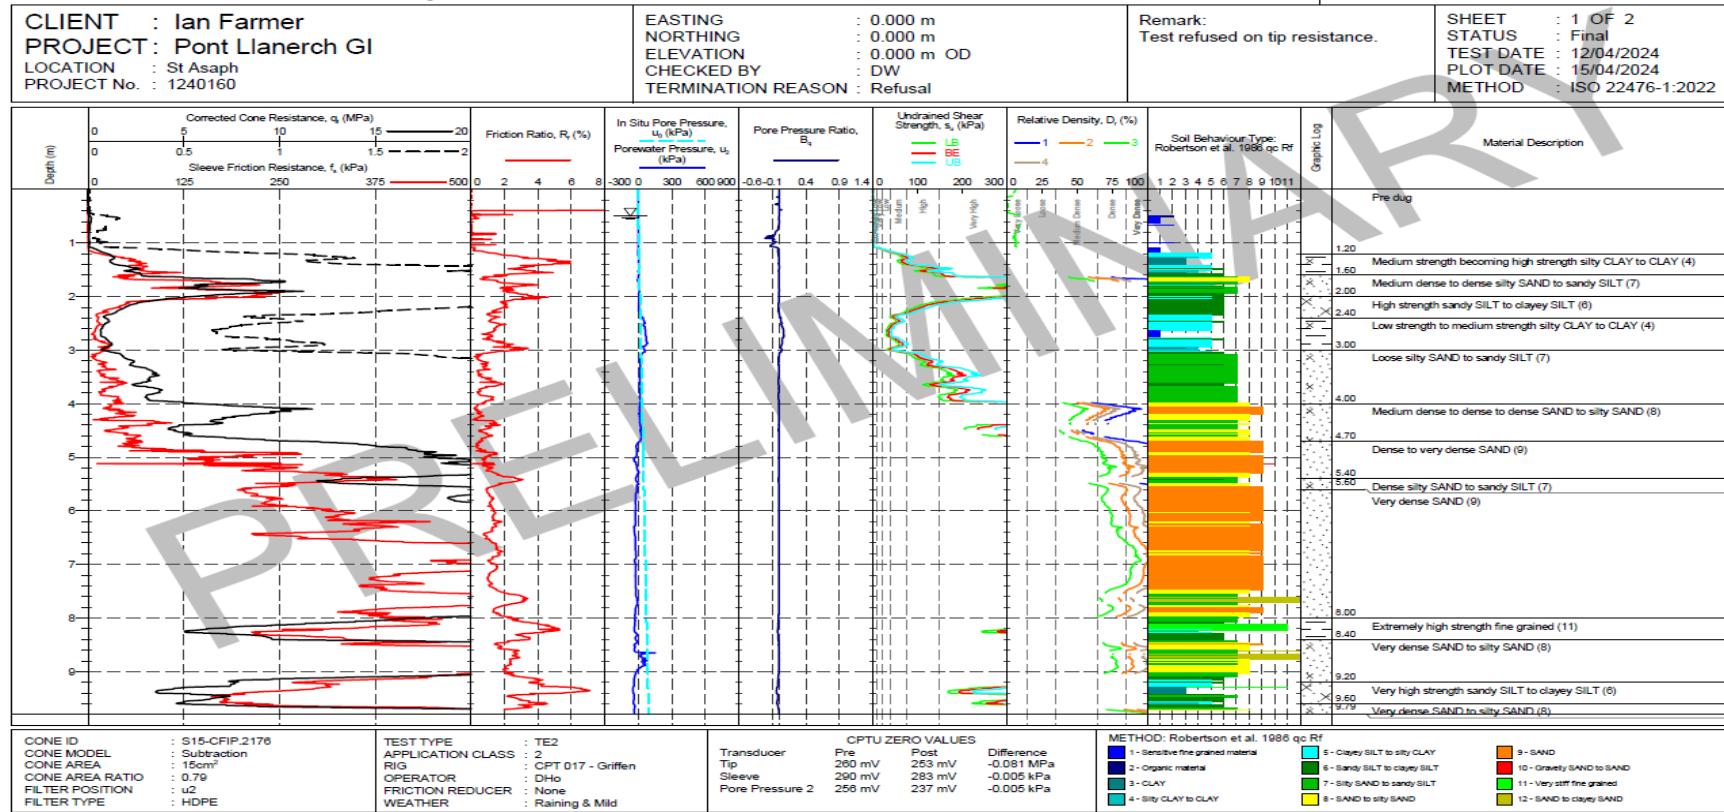
Ground Investigations

- By the end of the ground investigation process it was discovered that the depth of the river gravels is roughly 10m on one side of the river and 11m on the other.
- Beneath the river gravels we have been able to establish where the weathered section of sandstone is.

- However...we do not know, and it cannot be known how deep the weathered section is, where any fissures are, or how they are interconnected.
- This means we do not know where the aquifer water that forms the abstraction is under the bridge location.
