Section 19 Flood Investigation

July 19th 2017 Floods

Alex Bebbington & Paul Owen
7 March 2018

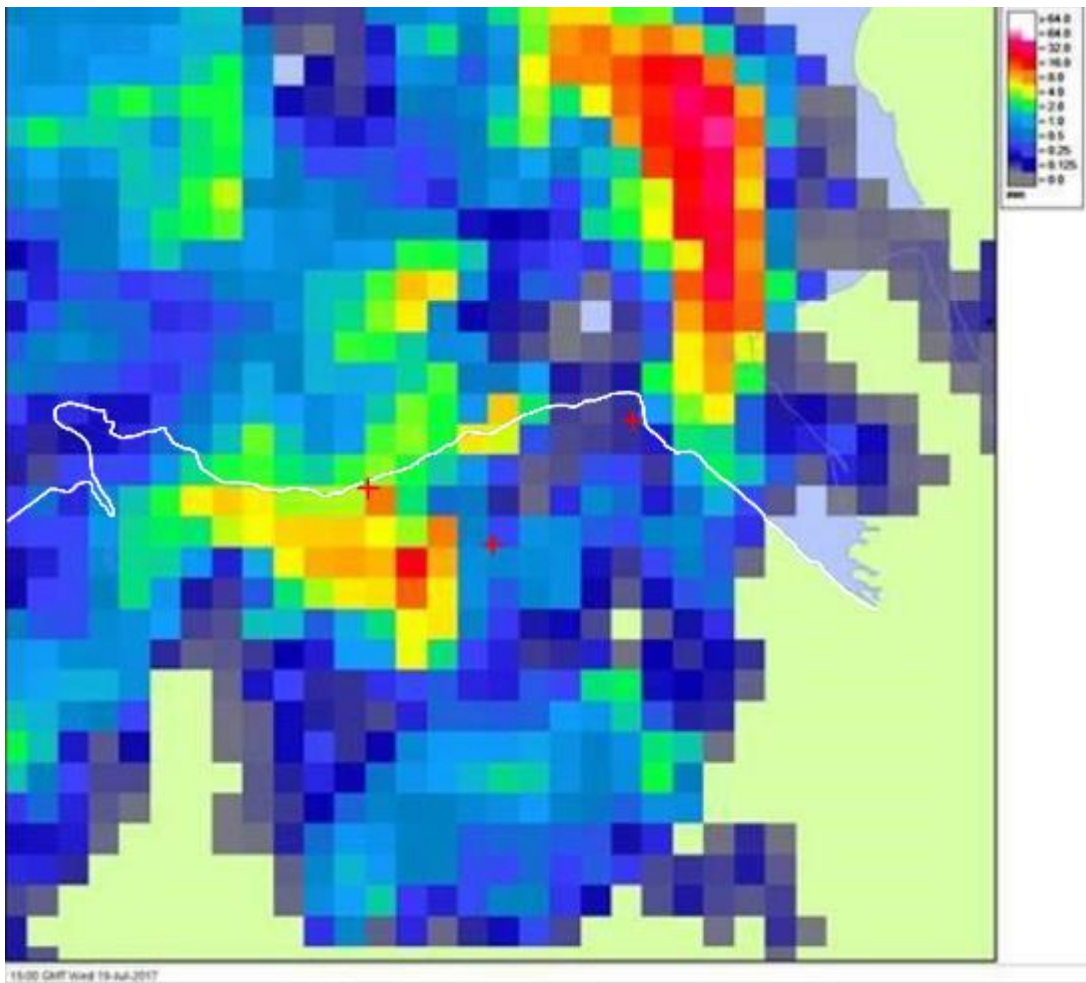
A second intense band of rainfall swept over the Pensarn area at 15:10 GMT, but appears to have missed the other rain gauges. HYRAD¹ (Figure 1) suggests this second band of rainfall would have affected Rhyl too, which could indicate a return period for the Prestatyn/Rhyl area broadly similar to that assessed for Pensarn rain gauge.

Figure 1: Rainfall intensity recorded at 3pm GMT 19TH JULY 2017 across North Wales

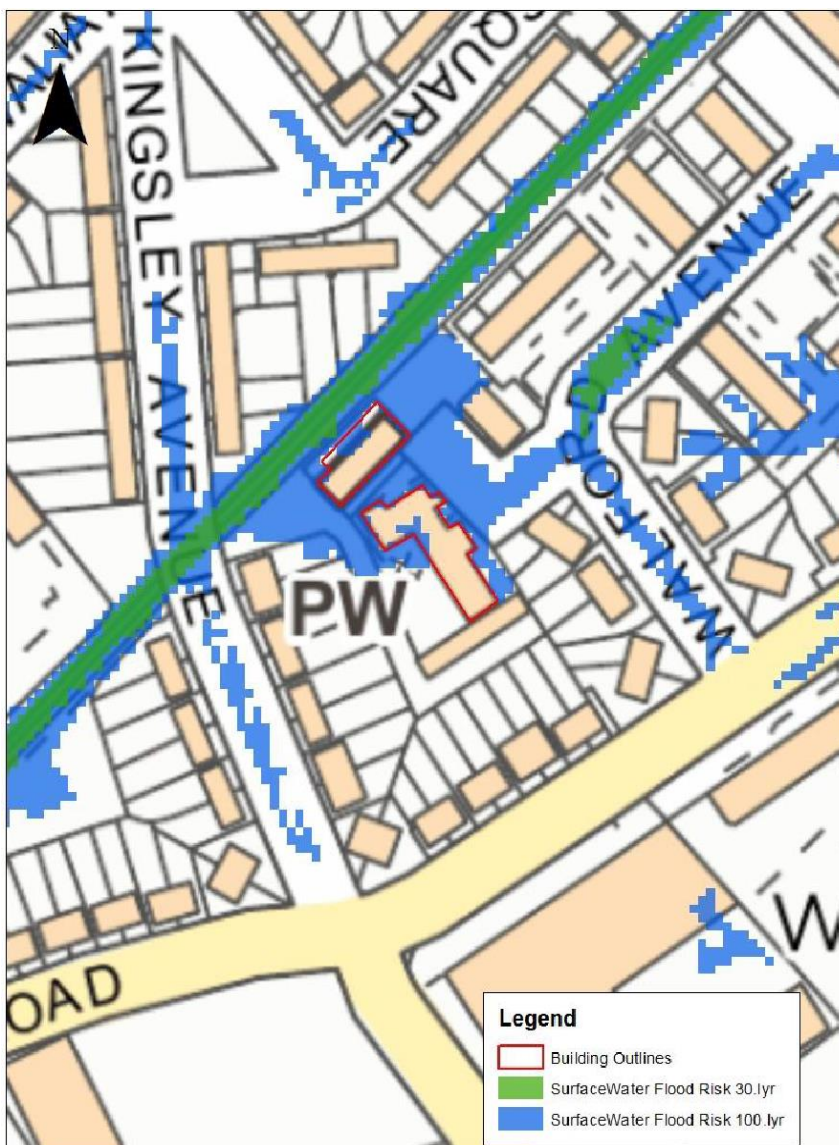
The two properties, which flooded in Rhyl on the 19th July 2017, both have a medium chance of flooding from surfacewater. Medium means that each year, this area has a chance of flooding between 1 in 100 (1%) and 1 in 30 (3.3%), as shown in Figure 2. The shading on the map shows the risk of flooding from surface water in this area.

Figure 2: Surfacewater Flood map

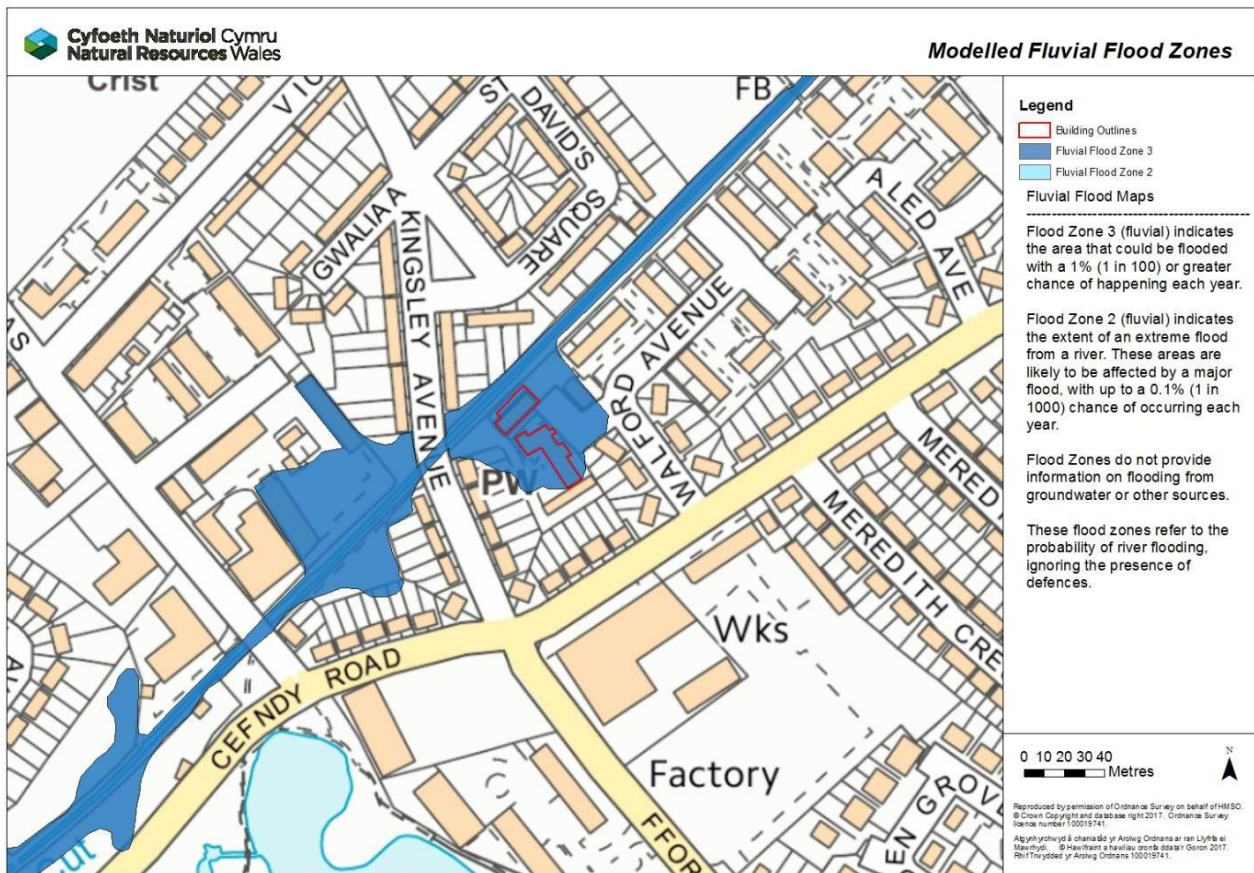
Flood zones are areas which would naturally be affected by flooding from rivers and the sea. Therefore, the presence of flood defences is not considered. Flood Zone 3 is defined as the extent of a flood from rivers with a 1% (1 in 100) chance or greater of happening in any given year. Both properties which were affected by flooding are in Flood Zone 3, as shown in Figure 3.

Water from Kinglsey Avenue and the un-adopted road in front of the dance studio inundated The Cut. Water could not drain away as the drainage outside the dance studio was completely silted up and therefore ineffective. This excess water caused The Cut to overflow onto the lowest point along the pathway. The pathway runs parallel between the side of the dance studio and The Cut. This floodwater came around the dance studio and flooded it internally through the side and front doors.

Figure 3: Modelled Fluvial Flood Zones

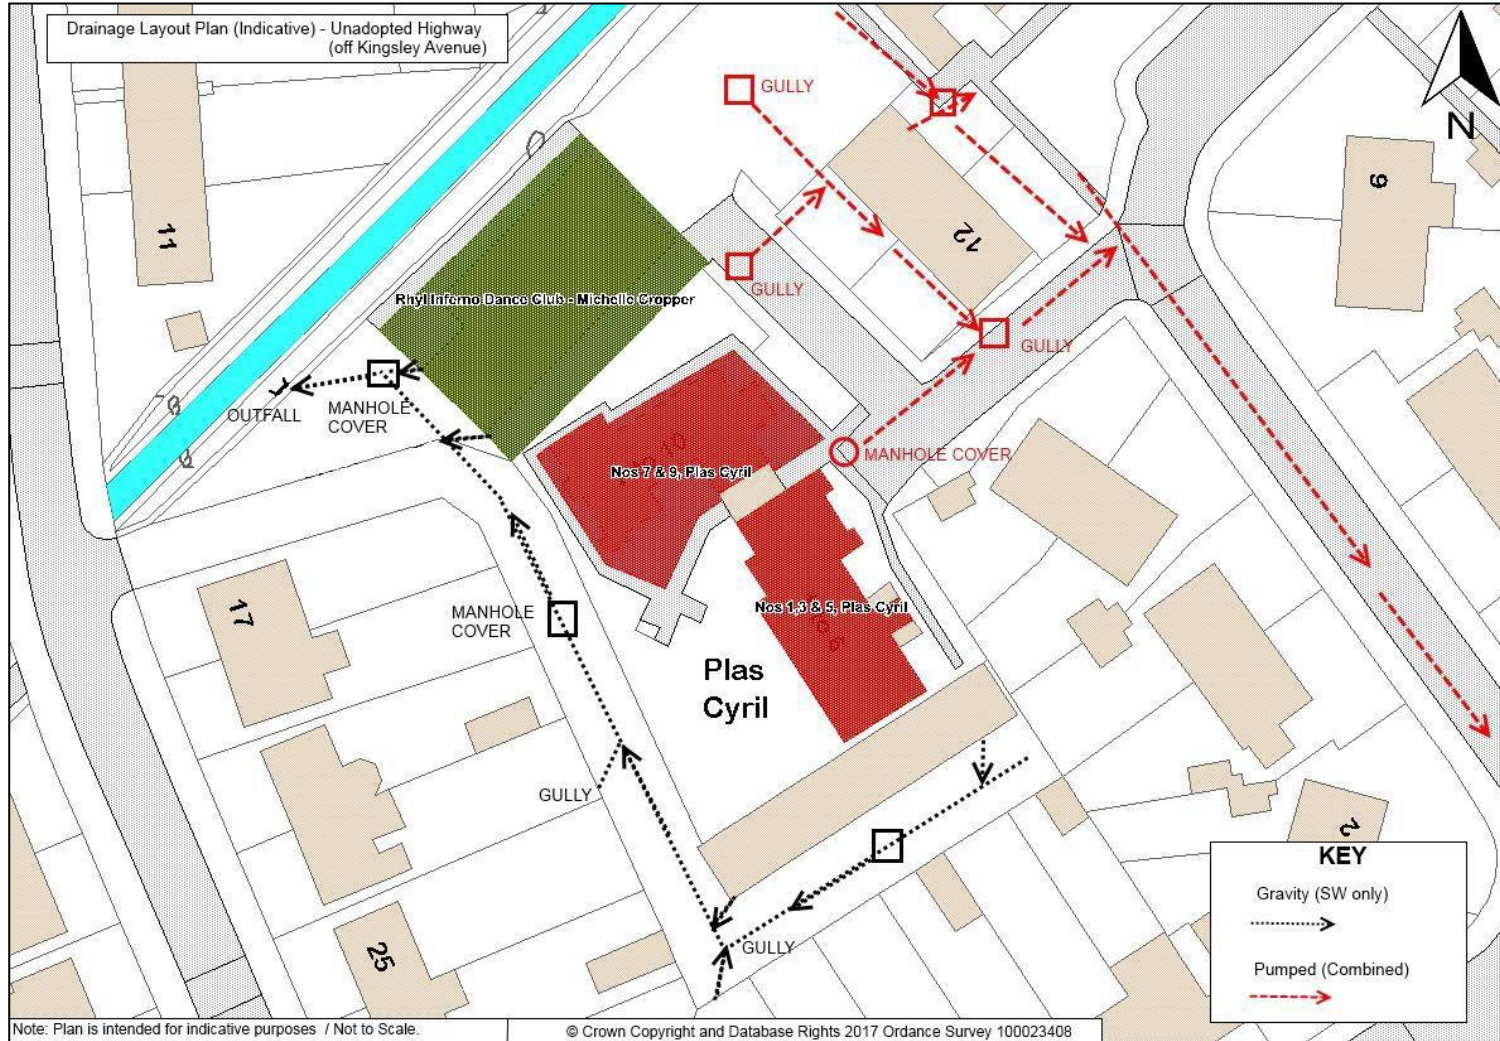
As mentioned earlier, there is an outfall next to the dance studio which drains surfacewater from the surrounding area of the un-adopted road in front of the dance studio and the garages behind the dance studio (Figure 5). Whilst surveying the Cut, after the flood event, it was found that this outfall was completely silted up (Figure 4), which would have prevented any surfacewater from being drained away from the dance studio, and the surrounding area. This would have exacerbated the surfacewater flooding to the dance studio

Figure 5: Drainage network around Inferno Dance Studio

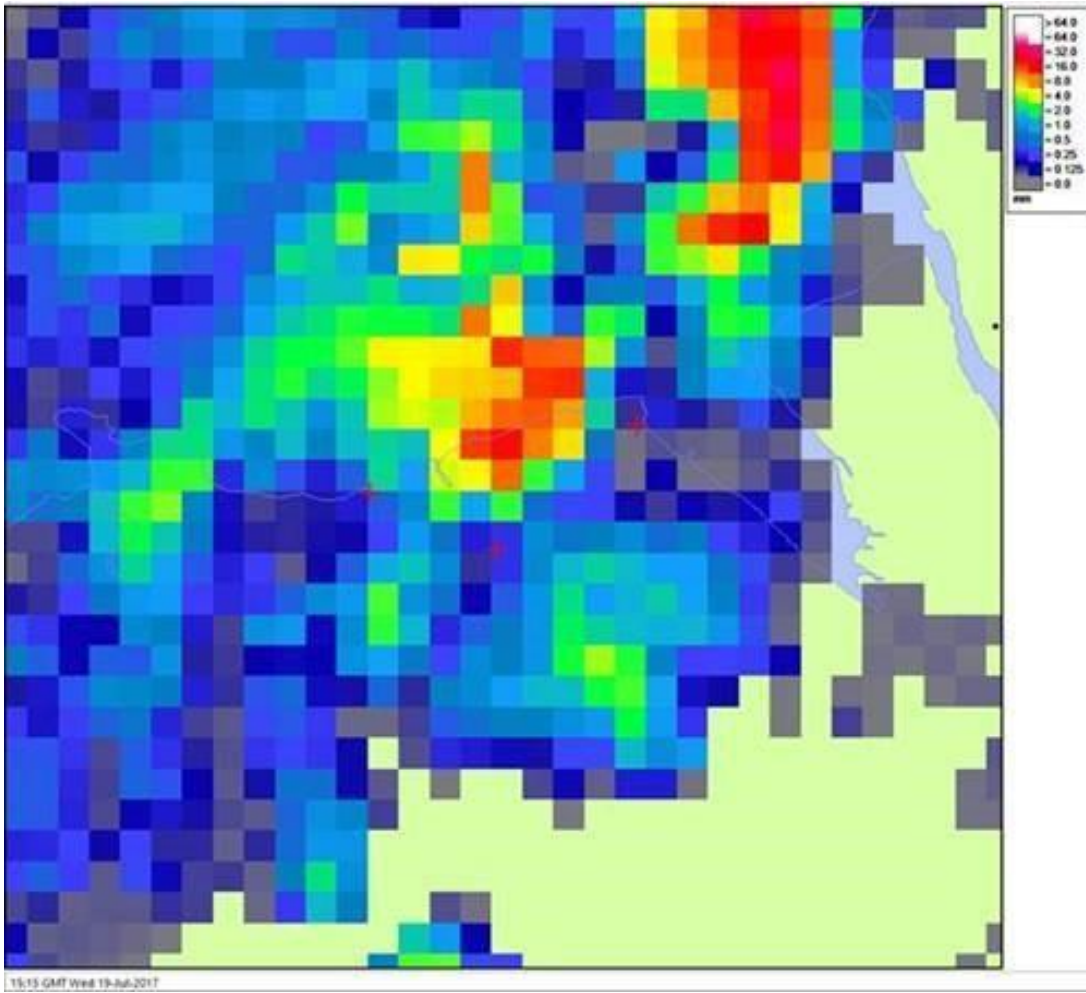
A second intense band of rainfall swept over the Pensarn at 15:10 GMT, that appears to have missed the other raingauges. HYRAD (Figure 9 & Figure 10) suggests this second band of rainfall would have affected Rhyl too, which could indicate a return period for the Prestatyn/Rhyl area broadly like that assessed for Pensarn raingauge.

Figure 10: Rainfall intensity 15:15 GMT 19th July 2017 (red crosses denote location of Pensarn, Llanasa and St Asaph rain gauges)

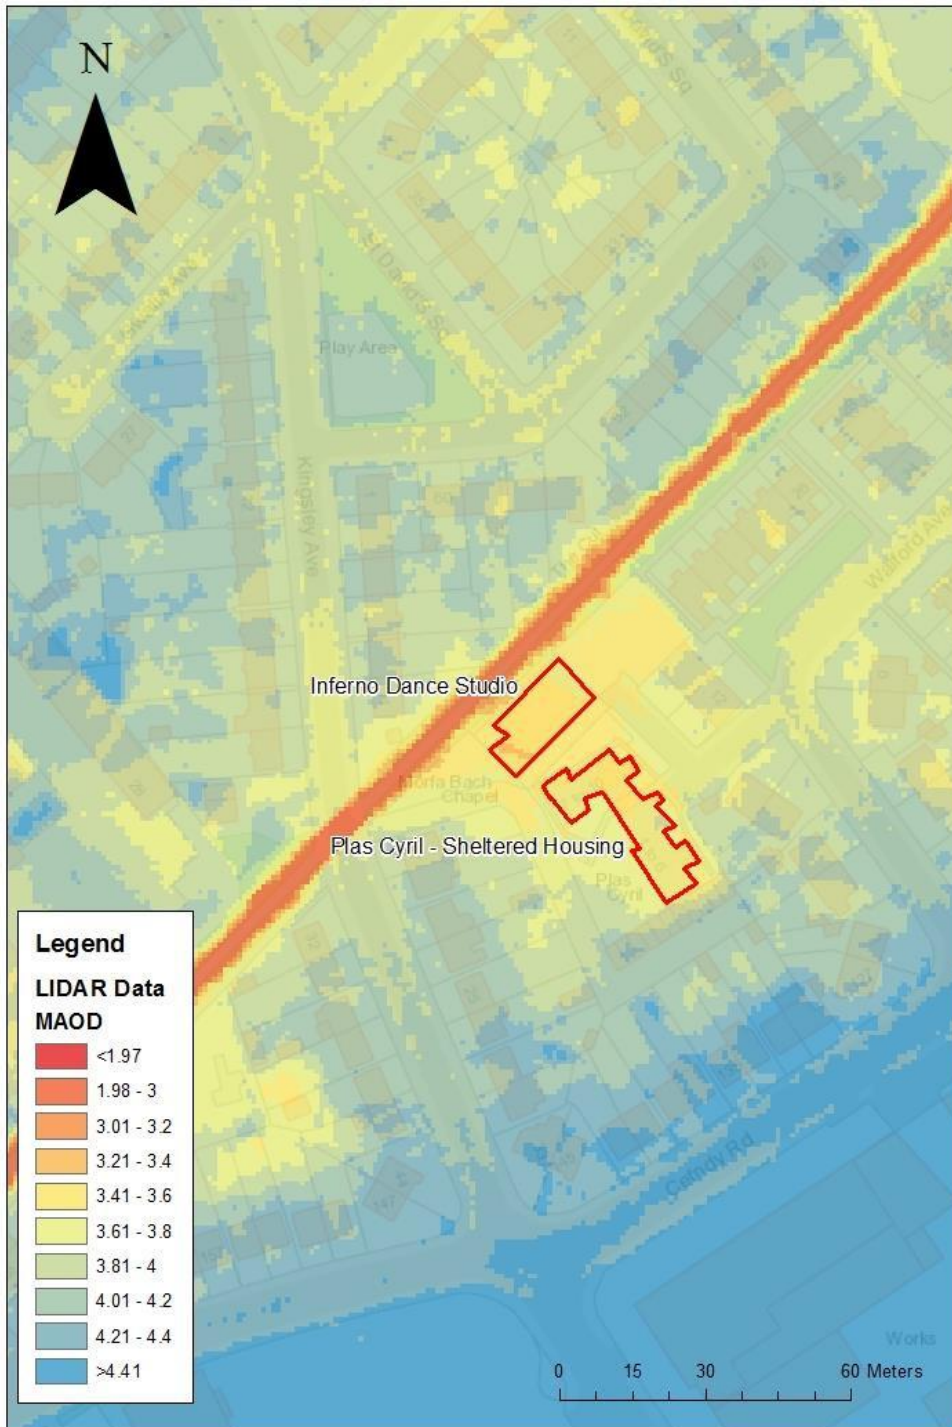
The LiDAR data used has a spatial resolution of 1m. From Figure 11, shown below, it is evident that Kingsley Avenue slopes downwards towards The Cut. Walford Avenue slopes downwards towards Plas Cyril. Within a 0.5km radius, and excluding The Cut, the dance studio is the lowest point in the neighbourhood at 3.37m AOD.

Figure 11: LiDAR data showing the topography of Inferno Dance Studio and Plas Cyril, in relation to The Cut.

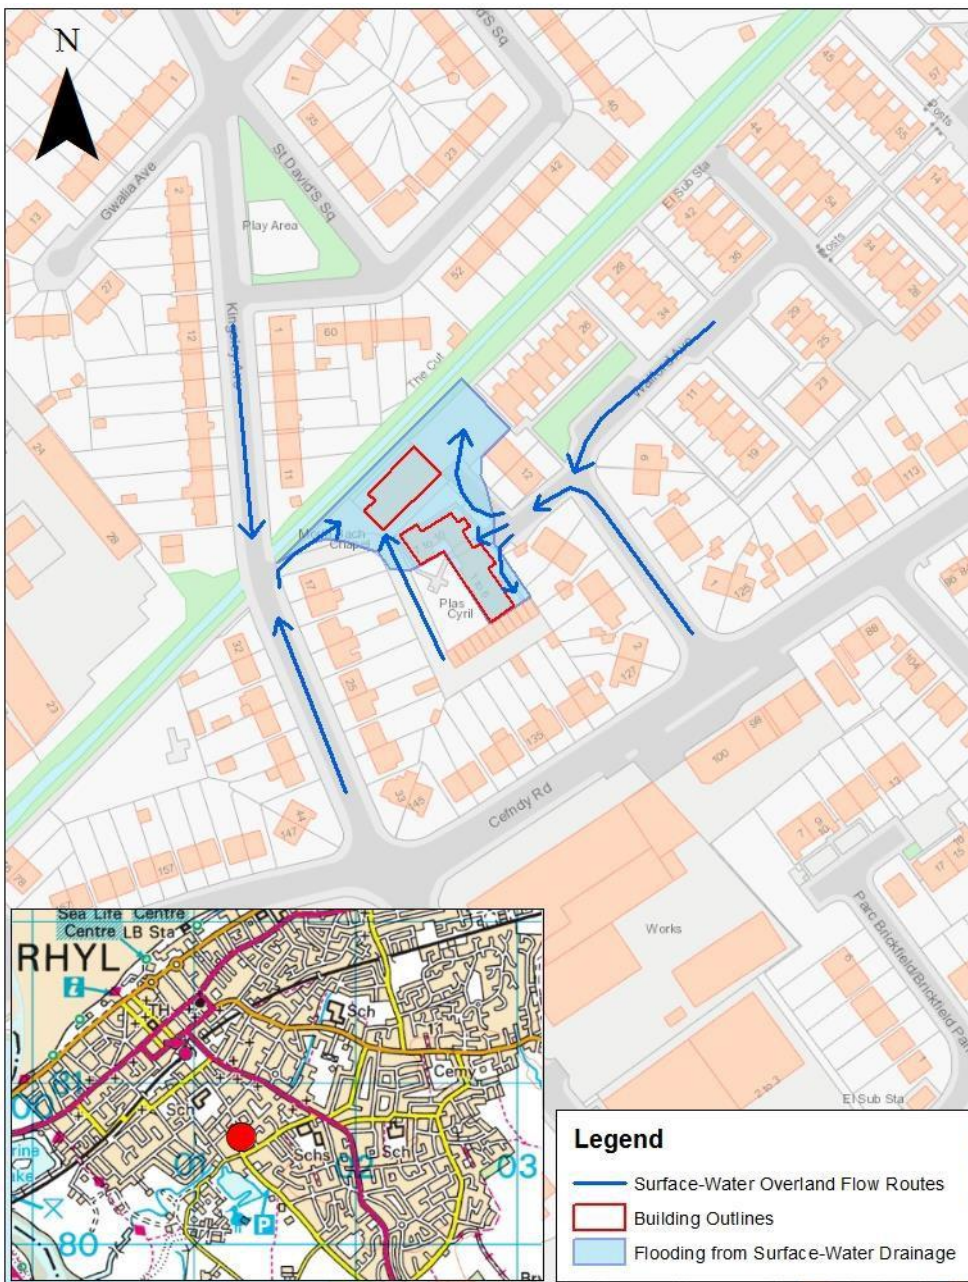
Surface water on Kingsley Avenue overwhelmed the drainage systems causing it to flow downhill towards The Cut (Figure 12). The floodwater flowed down the driveway in front of the dance studio and entered The Cut at this point (Figure 13). The water from The Cut pooled in front of the dance studio and raised to the same level as the dance studio causing floodwater to enter the property. Surface water on Walford Avenue also overwhelmed the silted-up drainage systems causing it to flow downhill towards Plas Cyril and towards the carpark behind the dance studio.

Figure 12: Surface water flow routes

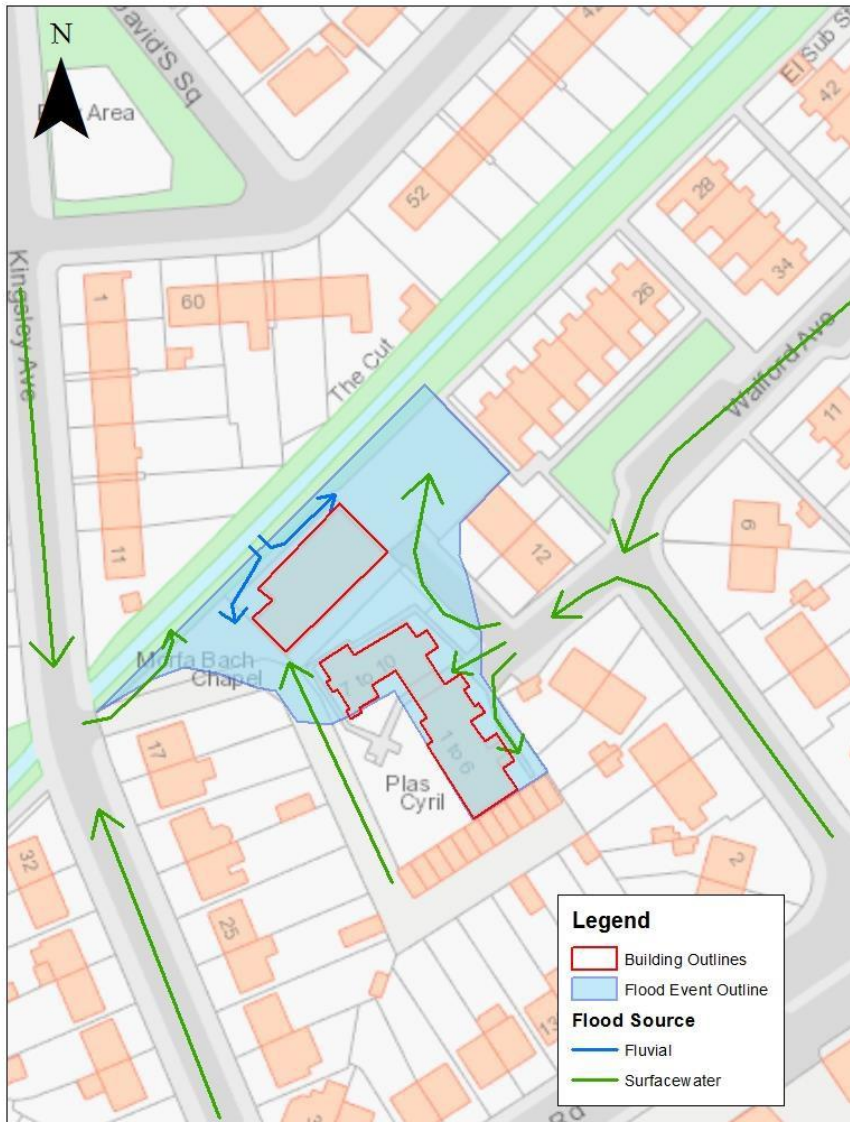
Figure 13: Flood Outline and Flow Routes

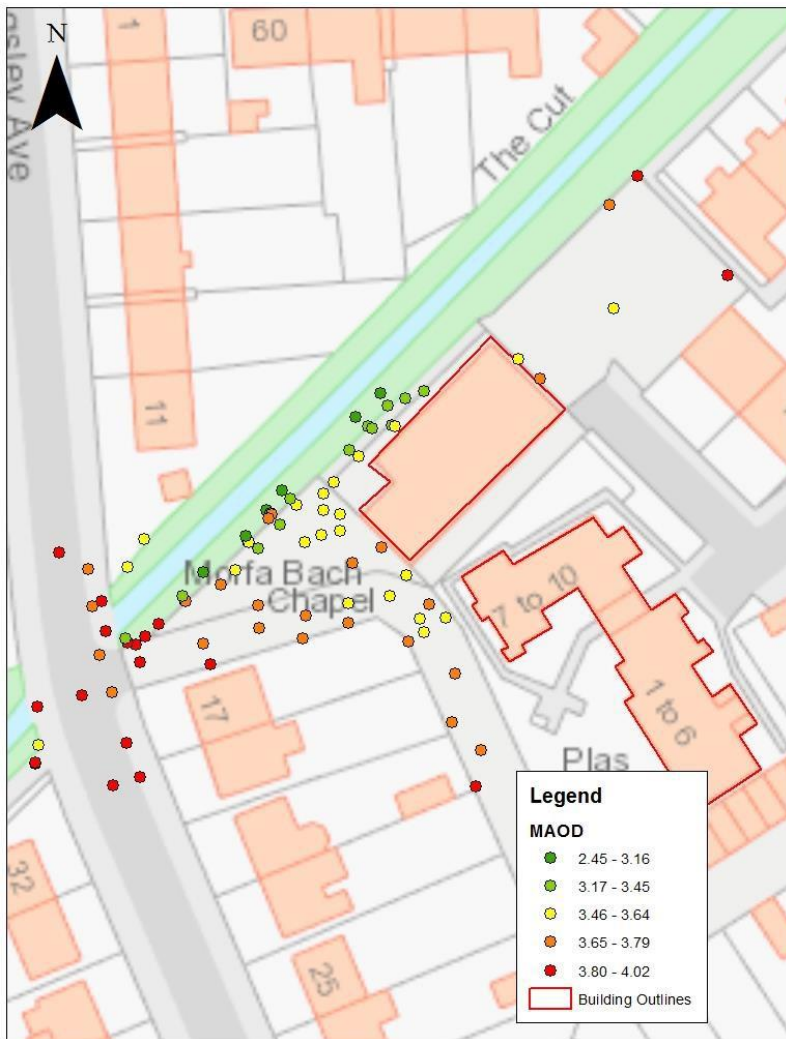
On the 4th August 2017, The Cut and its surrounding area was surveyed using a Leica GPS Surveying Kit; the results of which are shown in Figure 15 below. It is evident that Kingsley Avenue and the rear road, behind Plas Cyril, are both sloping downward towards The Cut and the Dance Studio. There is a low spot along the pathway which runs parallel between the side of the dance studio and the Cut. It is likely that this low point caused water to pool down the side of the dance studio causing internal flooding, the bank profile along the suspected low spot is shown in Figure 14.

Figure 15: Rhyll Survey Data: Inferno Dance Studio and The Cut

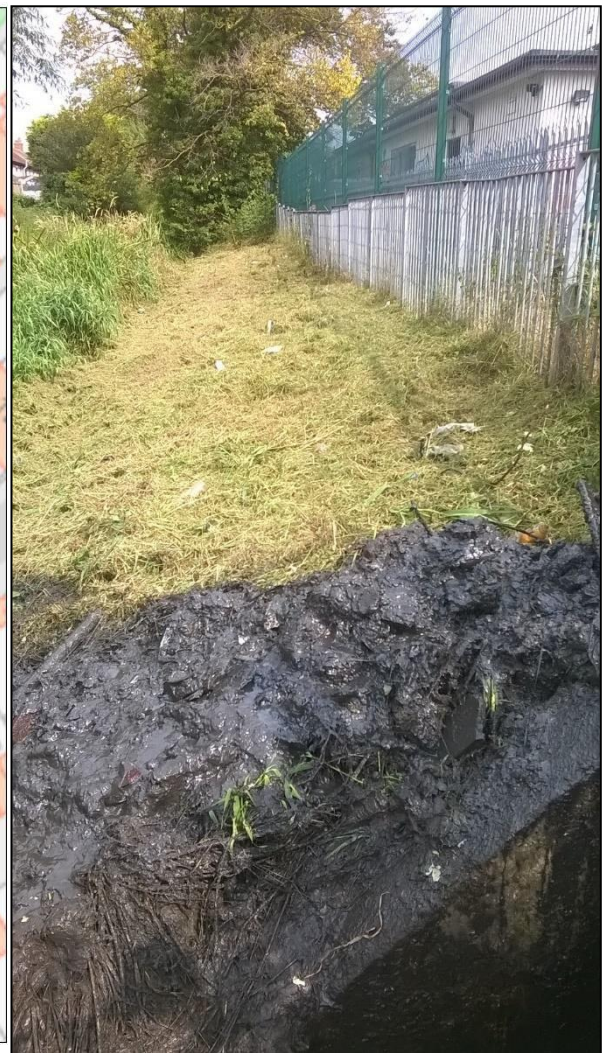
Figure 14: Visual profile along low spot on left bank of Rhyll Cut
