**Cyfoeth
Naturiol
Cymru**
**Natural
Resources
Wales**

Llantysilio Mountain Fire Preliminary Assessment and SSSI Management Recommendations

Katharine Longden
Penny Anderson Associates Ltd

Report No 372

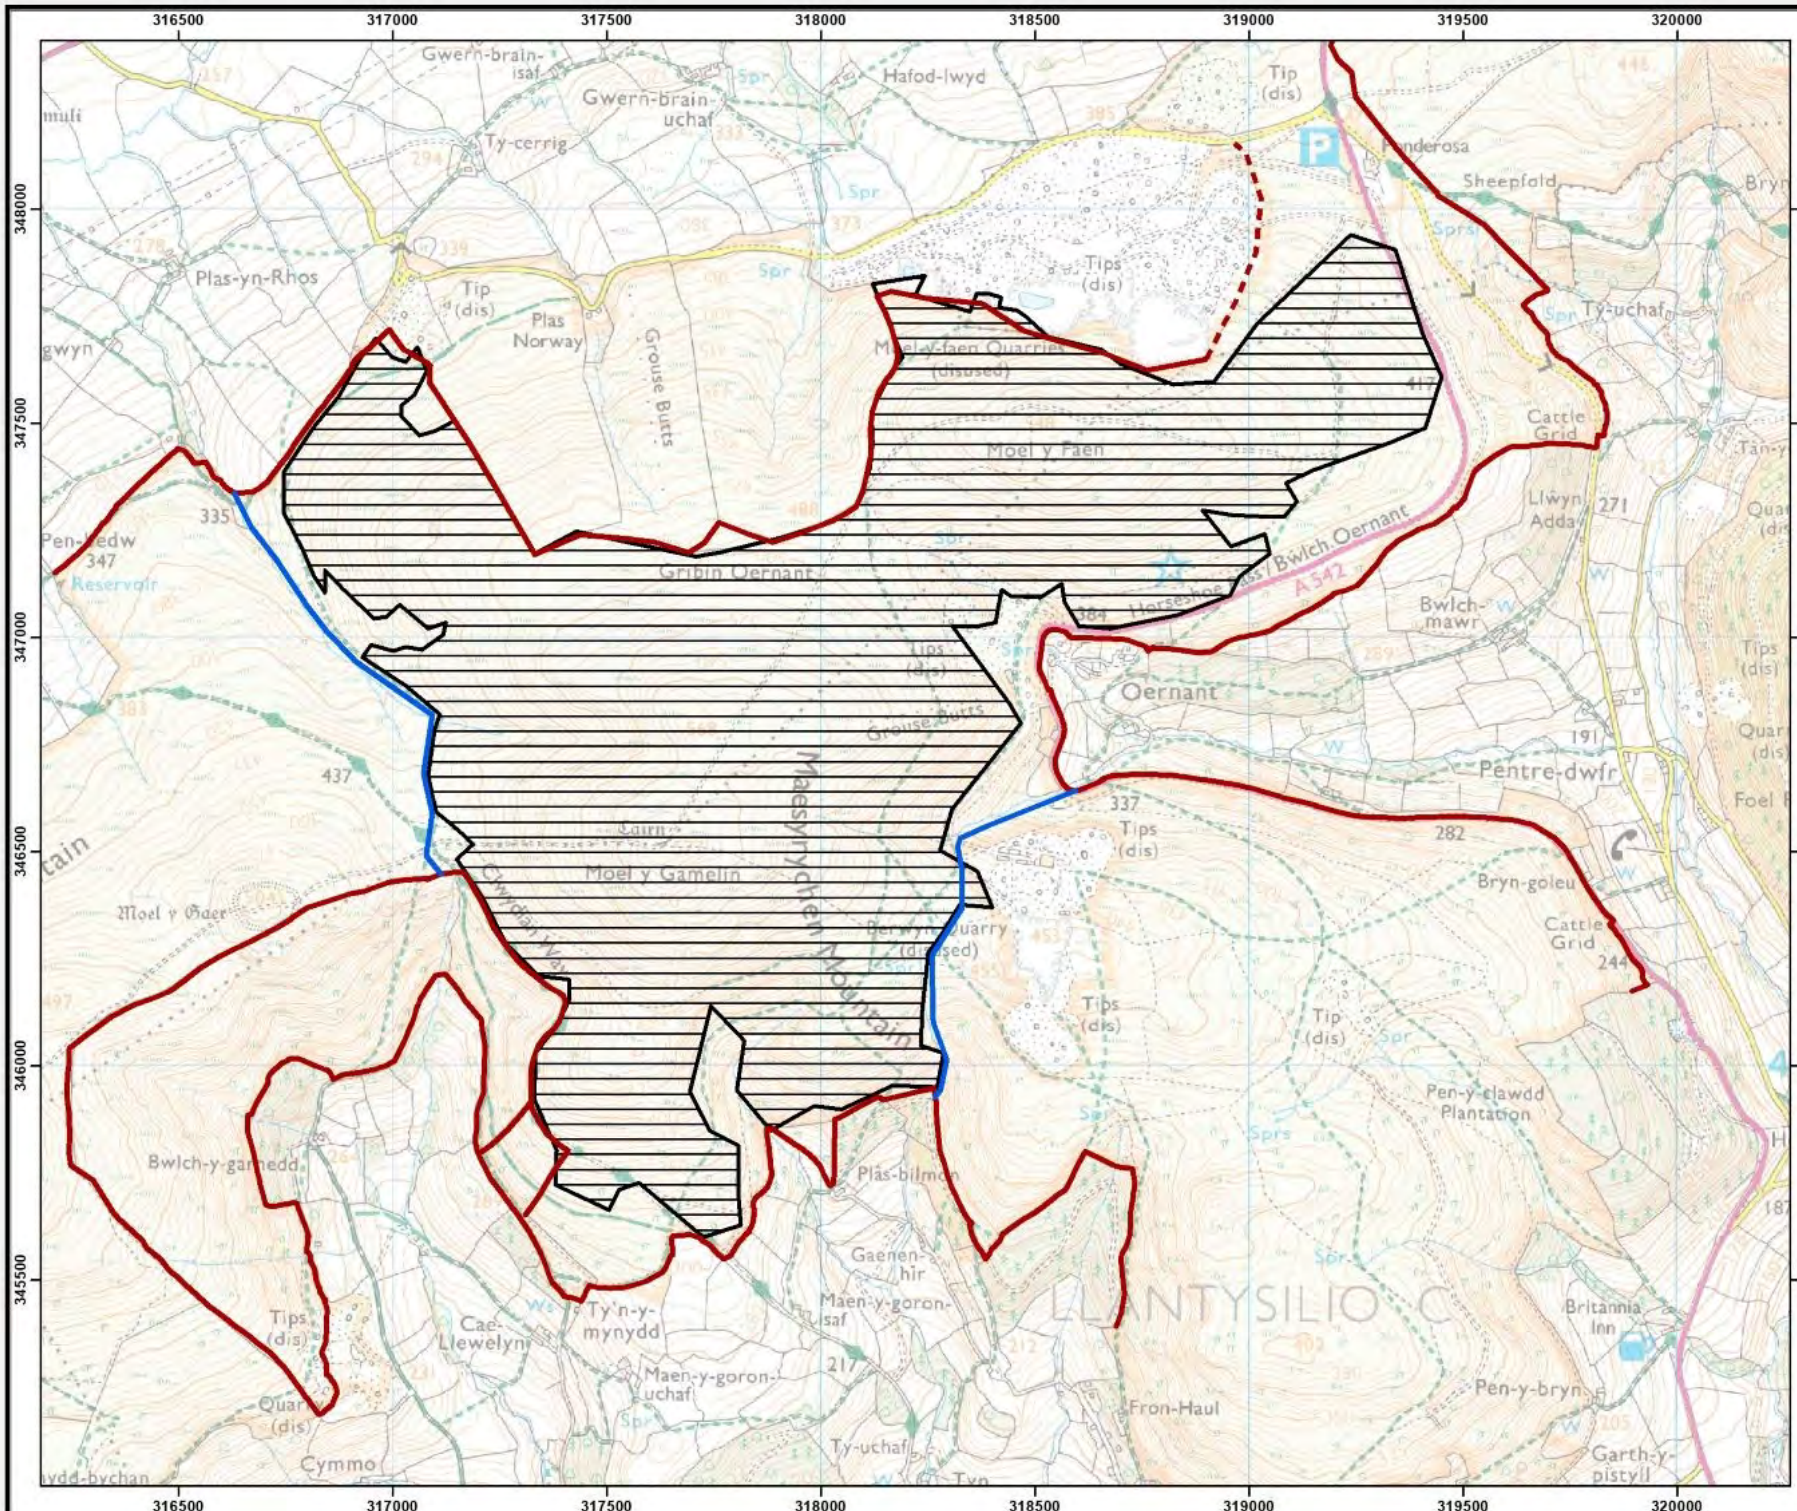
Scale: 1:12,500	Drawing No: Figure 6
Drawn By: CC	Signoff: KL
Check: CC	Date: 04/10/2019
Revised: 1.0	Revised: 1.0

achieve as Common Land consent is required from the Welsh Government and this can be time-consuming and contentious. If a fence was required and consent given, only two relatively small lengths of fencing would be required to exclude the majority of the burnt area from the common (Figure 6). The first section (c.1.09km) could be erected over the saddle between Moel Y Caer and Moel Y Gamelin and a second shorter length (0.93km), west of Berwyn Quarry. These two sections of fence would link with the existing fences and allow the rest of the common to the west and south-east to be grazed.

Erect temporary fencing on boundaries (Figure 6) and exclude sheep.

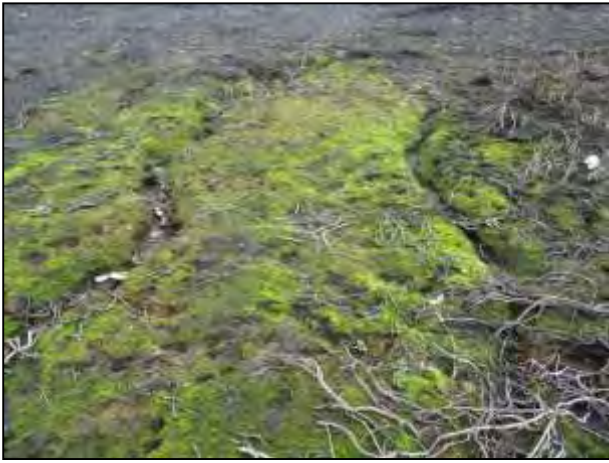
Target Note Number 1
Photograph 2055

Target Note No	Date	Grid Ref		TN Code	Description	Photograph	Bearing
		Easting	Northing				
1	25.06.19	17416	46539	Ch	7-8m section of rill/gully, very soft substrate - Category 2 damage	2055	70
2	25.06.19	17377	46561	F	Small flush - unburnt: bilberry, soft-rush, common bent, sweet vernal-grass, star sedge, mat-grass, Yorkshire fog, tormentil, wavy hair-grass	2057	220
3	25.06.19	17377	46561	Ch	Erosion channel from flush, 30cm wide, 5cm deep. Slow water run off with coir logs	2058	290
4	25.06.19	17298	46598	F	Small flush, 20m x 7m; bilberry (f), soft rush (o), sheep's fescue (o), wavy hair-grass (o), crowberry (r), <i>Sphagnum fallax</i> (lo), common sedge (lo), woodrush (r).		
5	25.06.19	17144	46547		Existing unburnt vegetation: bilberry (a), heather (f), wavy hair-grass (f)	2061	320
6	25.06.19	17171	46600		Substrate loss, moving as unstable - very small scale c .50cm	2062	
7	26.06.19	19303	47828		Area of older heather and gorse, c .30 x 100m parallel to the road. Average peat loss 5-7cm. No action recommended as heather and bilberry regeneration good, occasional gorse regen. Category 4 - plates of vegetation.	2075, 2076	180

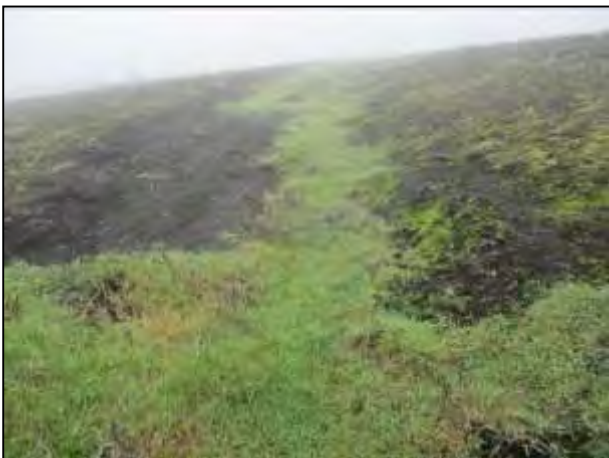
Target Note Number 8
Photograph 2078

8	26.06.19	19353	47743		Minor catch ditch 2-3m wide, 0.5m deep. Well vegetated with grasses and soft-rush.	2078	150
9	26.06.19	19385	47588		Good area of heather regeneration, Transect with 5m stops. 18/20 had heather seedlings		
10	26.06.19	19394	47448		Unburnt vegetation at the edge: bilberry (a), heather (f), western gorse (f-ld), wavy hair-grass (f), crowberry (o), heath bedstraw (o), rowan saplings (lo), <i>Polytrichum commune</i> (o), <i>Hypnum jutlandicum</i> (o). Most vegetation 40-45cm tall, gorse <1m, rowan 2-3m.	2079	60
11	26.06.19	19257	47545	SS	Division between two burn categories. Category 3 (left, SS2) and 4/5mosaic (right, SS1). The Category 3 area needs restoration as 5-6cm peat lost and seed bank.	2080	180
12	26.06.19	18743	47222		Steep slope with gorse and bracken and very little else. Bilberry rare, bracken rhizomes are exposed and burnt in places, minimal erosion but increased moss cover.	2085	340

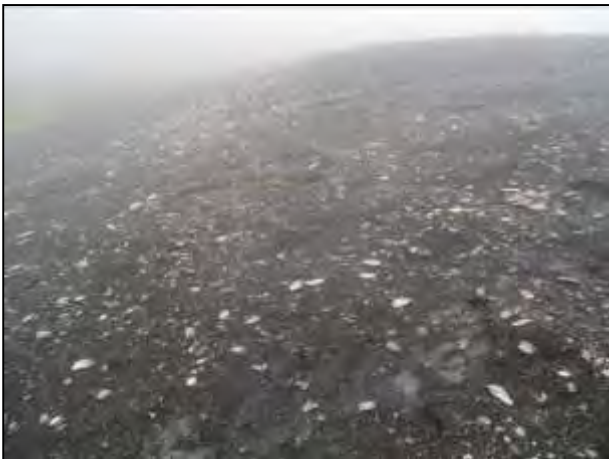
Target Note Number 14
Photograph 2086

13	26.06.19	18755	47294		Increasing bilberry and bell heather in patches, 6 sheep seen here		
14	26.06.19	18848	47407		Very bare, Category 1, shale area visible c .50m ² on small ridge	2086	2800
15	26.06.19	18700	47496		Hotspot on the crest burnt down to shale and areas of charred peat	2087	
16	26.06.19	18477	47485	P	Deeper peat, eroding and dried out, peat eroded a minimum of 10cm	2089	270
17	26.06.19	18464	47492	P	Peat erosion 15-17cm, area of deepest peat but very damaged non functioning, very dry.	2090	
18	26.06.19	18427	47505	P	Area of deeper peat now remaining as plates, cracked and damaged. Heather regeneration good where surface remains. Peat will dry and crack on edges so not stable in the long term. Limited scope for erosion control.	2091	160
19	26.06.19	18591	47398	Ch	Localised water erosion into clay material, 10-15cm below the new surface, 5 channels approx 10m long. Coir logs required to slow the flow, very soft ground.	2092	310

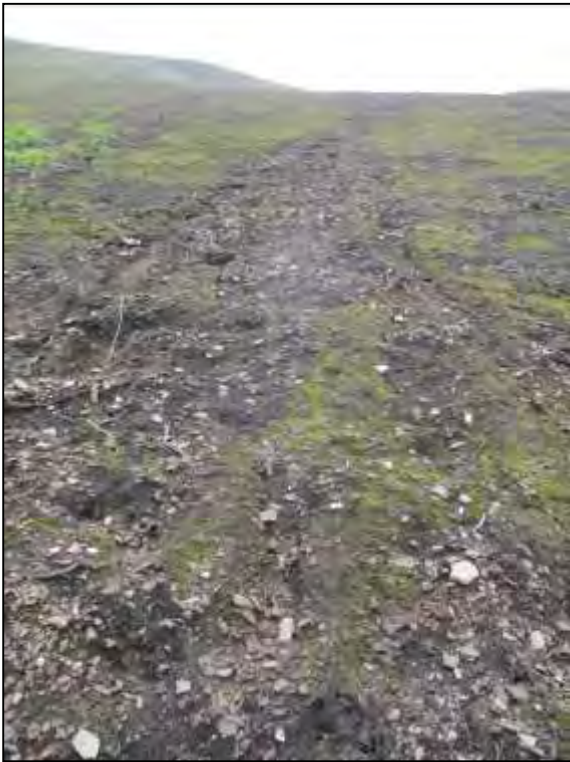
Target Note Number 20
Photograph 2096

20	26.06.19	18616	47229	Ch	Riling down the slope, may be more upslope - check. Surface soft and vulnerable actively eroding 50cm wide x 10cm deep.	2096	10
21	26.06.19	18392	47263		Soil/peat erosion around gorse stumps, c. 10cm lost	2098	-
22	26.06.19	18392	47263		Photograph of bracken in valley leading to Oernant, clear potential for bracken to spread	2099	250
23	26.06.19	18392	47263		View of lower eastern slopes of Moel y and quarry tips	2100	220
24	26.06.19	18099	47343		NE slopes of Moel y Gamelin, Category 5 with occasional bare areas, the pre-burn management pattern is obvious in the response of the vegetation to the burn	2101	240
25	26.06.19	18079	47305		Soils by fence edge scrapped up leaving c .1m bare ground and c2m disturbed soils. Peat here after the burn very shallow c .4cm.		
26	26.06.19	18234	46951		Burn Category 2 with orange colouration	2105	-
27	26.06.19	18032	46607		Bracken area, some unburnt with acid grassland and bilberry underneath

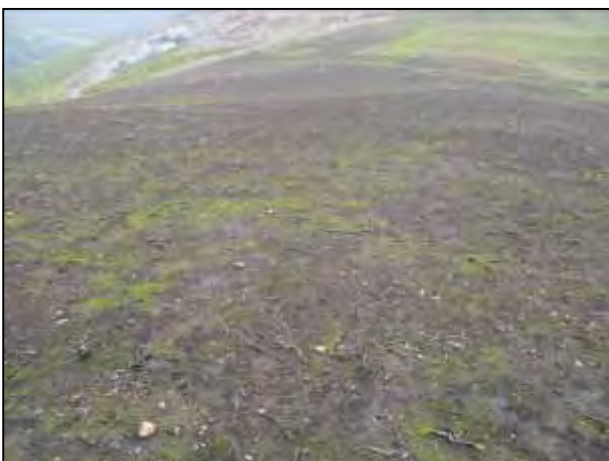
Target Note Number 29
Photograph 2108

Target Note No	Date	Grid Ref		TN Code	Description	Photograph	Bearing
		Easting	Northing				
29	26.06.19	18165	46439		80% of area Category 1, 20% Category 2. No heather and very little bilberry, occasional burnt/dead standing heather stick. Sheep in this area	2108	80
30	26.06.19	18057	46251		Burnt gorse stick, c .5cm proud of previous surface, with little regeneration.	2109	-
31	26.06.19	17942	46268		Whole side of the hill burnt (Categories 1 and 2), bracken in foreground, other green colour is moss	2110	170
32	26.06.19	17691	46161		South-western face of hill visible, Category 1 burn, no revegetation on steep slopes (bracken in valley not burnt)	2111	150
33	26.06.19	17548	45983	SS	Soil sample 3, Category 1		
34	26.06.19	17592	45912		Gorse regeneration	2114	-
35	26.06.19	17592	45912		Wider view, moderate natural revegetation	2115, 2116	150, 210
36	26.06.19	17478	46230		Plates of bilberry and gorse, Category 4 interspersed with bare areas, still requires revegetation assistance.	2117	200

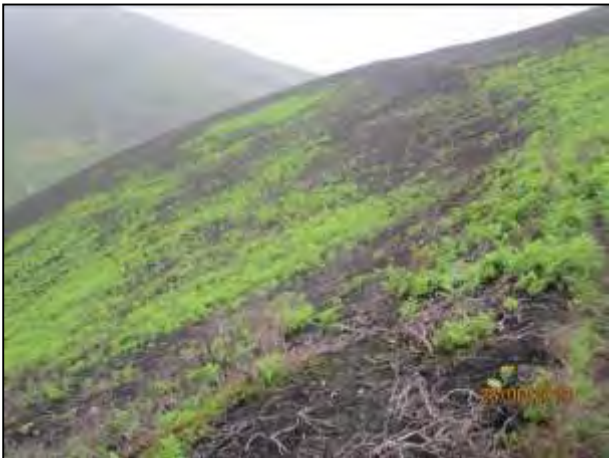
Target Note Number 37
Photograph 2118

37	26.06.19	17478	46230		Bare except for bracken, mosaic of Categories 1 and 3	2118	300
38	26.06.19	17658	46343		Locally frequent bell heather seedlings in this area		
39	26.06.19	18137	47382	SS	Soil sample 4, Category 2 burn	2119	-
40	27.06.19	18837	47601		Area of bare ground c.50m ² Category 1/2 amongst a mosaic of Categories 4/5. Surface puffy with mosses colonising, some blown brash on surface. Several of these patches in area.	2121	240
41	27.06.19	18658	47520		Top of ridge, bare areas, very exposed. Use jute mess to help restoration here		
42	27.06.19	18586	47486		Close to the top of Moel y Faen, looking to the summit, soils/peat and brash in foreground, outcropping shale/rocks in distance	2122	300
43	27.06.19	18556	47484	P	Very small area of peat pedestals c.3x3m. Remaining peat up to 20cm tall, thin crust on surface and very fractured	2123	-
44	27.06.19	18706	47442	Ch	Erosion channels, 20cm deep, 40cm wide in soft substrate Category 2 burn

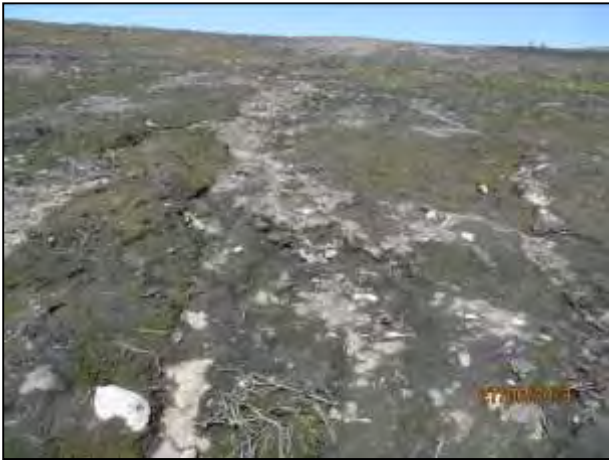
Target Note Number 45
Photograph 2125

45	27.06.19	18987	47398		Complex pattern of plates and bare areas, could map in detail or preferably revegetate whole area. Heather seedlings and bilberry shoots frequent on plates.	2125	40
46	27.06.19	18717	47427	Ch	Erosion channels in soft, Category 2 substrate. Approx 20 coir rolls needed 20cm x 1m	2126	290
47	27.06.19	18596	47370	P	Small coll/dip with area of deeper peat and soils. c. 20cm peat eroded/removed at the edges of the peat block. Several small erosion channels here too but very short with water dissipating over wide area. Appears a very hot burn with Category 2 damage close		
48	27.06.19	18509	47423	P	Deeper peat with some remaining pedestals, burnt and eroded, very oxidised and non functioning.	2127	300
49	27.06.19	18514	47490	P	Peat pedestals, 20 x10m area, burnt and eroded, very uneven and exposed.	2128	290
50	27.06.19	18496	47529		Existing vegetation bilberry and heather co-dominant with wavy hair-grass, sheep's fescue and heath bedstraw all frequent, Occasional <i>Rhynchospora squarrosa</i> . Peat/soil 13cm deep, vegetation height 35cm max. Heather c.15 years plus and grazed hard last winter	2129	350

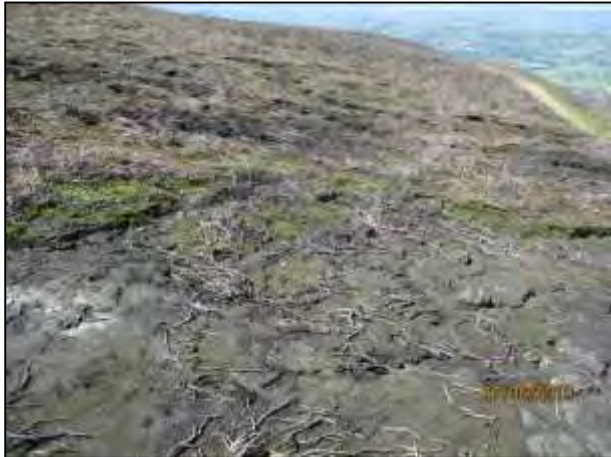
Target Note Number 51
Photograph 2132

51	27.06.19	18557	47564	P	Deeper peat c .20cm on slope but with hard crust, eroding and fragile. Lots of dead heather stems in area and moss colonising but significant peat lost and no current heather regeneration.	2132	260
52	27.06.19	18448	47498	P	Area of damaged deeper peat c .20cm with areas of pedestals, no regeneration vegetation.	2134	260
53	27.06.19	18144	47501		A small area of intact surface, with abundant heather seedlings in a large area of Category 1/3 burn	2135	-
54	27.06.19	18208	47405	P	Area of deeper peats, very disturbed and eroded. c. 20m x 50m	2136	100
55	27.06.19	18276	47330		Edge of deep peat area. Original surface with bracken	2137	-
56	27.06.19	17695	47198		Large Category 5 area with occasional small areas of more serious burns. Regeneration of bilberry and heather good as after management burn	2138	260
57	27.06.19	17551	47122	F	Grassland /flush vegetation dominated by acid grassland species, <i>Sphagnum</i> and marsh thistle.

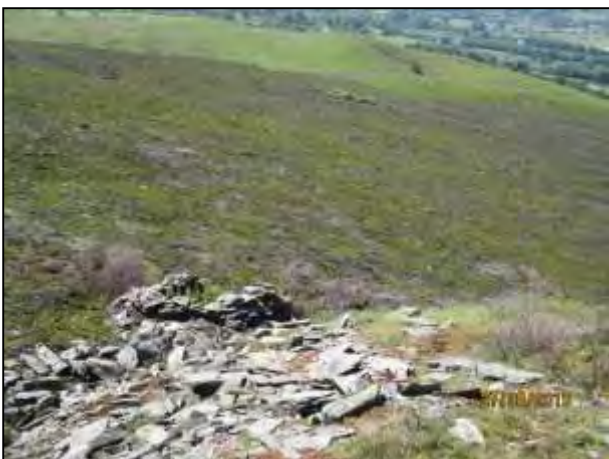
Target Note Number 58
Photograph 2139

58	27.06.19	17250	47139		Small patches of vegetation, smaller than typical Category 4 'plate' descriptions but moderate bilberry regeneration.	2139	-
59	27.06.19	17146	47218	Ch	Erosion channel less than 40cm wide and c .20cm deep in soft Category 2 burn substrate.

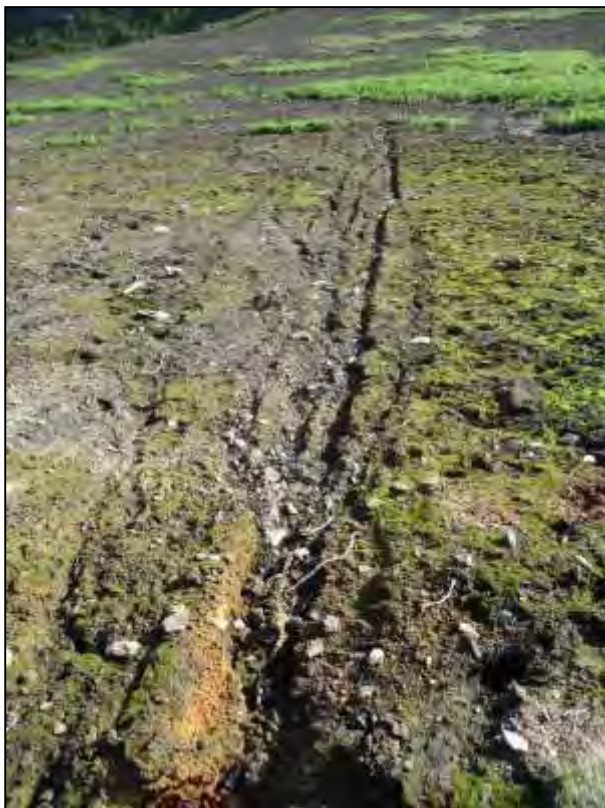
Target Note Number 65
Photograph 2150

65	27.06.19	17122	46738		Edge of fire damage, eroded peat/soil and bracken turf	2150	-
66	27.06.19	17700	46450		Some significant bare areas (up to 40 x 40m) in this patch of vegetation. Bare areas not mapped.		
67	27.06.19	17993	46704		Series of rocky outcrops, more heavily burnt, bare, but as surrounded by regenerating vegetation not priorities for restoration		
68	27.06.19	18428	47389	Ch	Rills and/or bike damage, consider coir logs	2157	210
