Flood Investigation Report

Brookhouse, Denbigh

9th February 2020

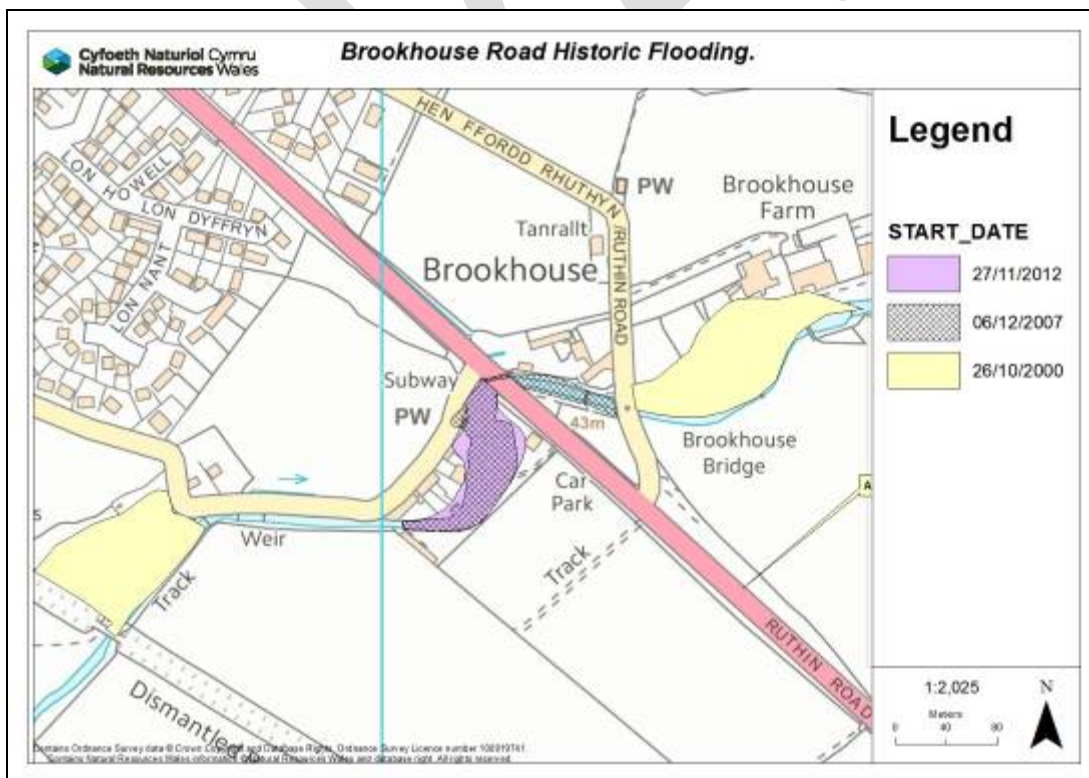
Figure 3: Historic Flood Outlines

Properties on Brookhouse Road have previously flooded in October/November 2000, December 2007 and November 2012. This was due to overtopping of the left bank of the Afon Ystrad. In November 2012 this resulted in the flooding of 8 properties.

Nos. 3 – 8 all had Individual Property Protection (IPP) Flood guards in place therefore it is believed that water entered via the flooring or via non-sealed pipes at ground level. This assumption is supported by the lower levels of internal flooding being observed.

The Pottery backs directly onto the river. No flood defence door was in place during the 2012 event, so the backdoor is the assumed point of entry for flood water. The Resident stated that the premises did not flood during the event of 2000.

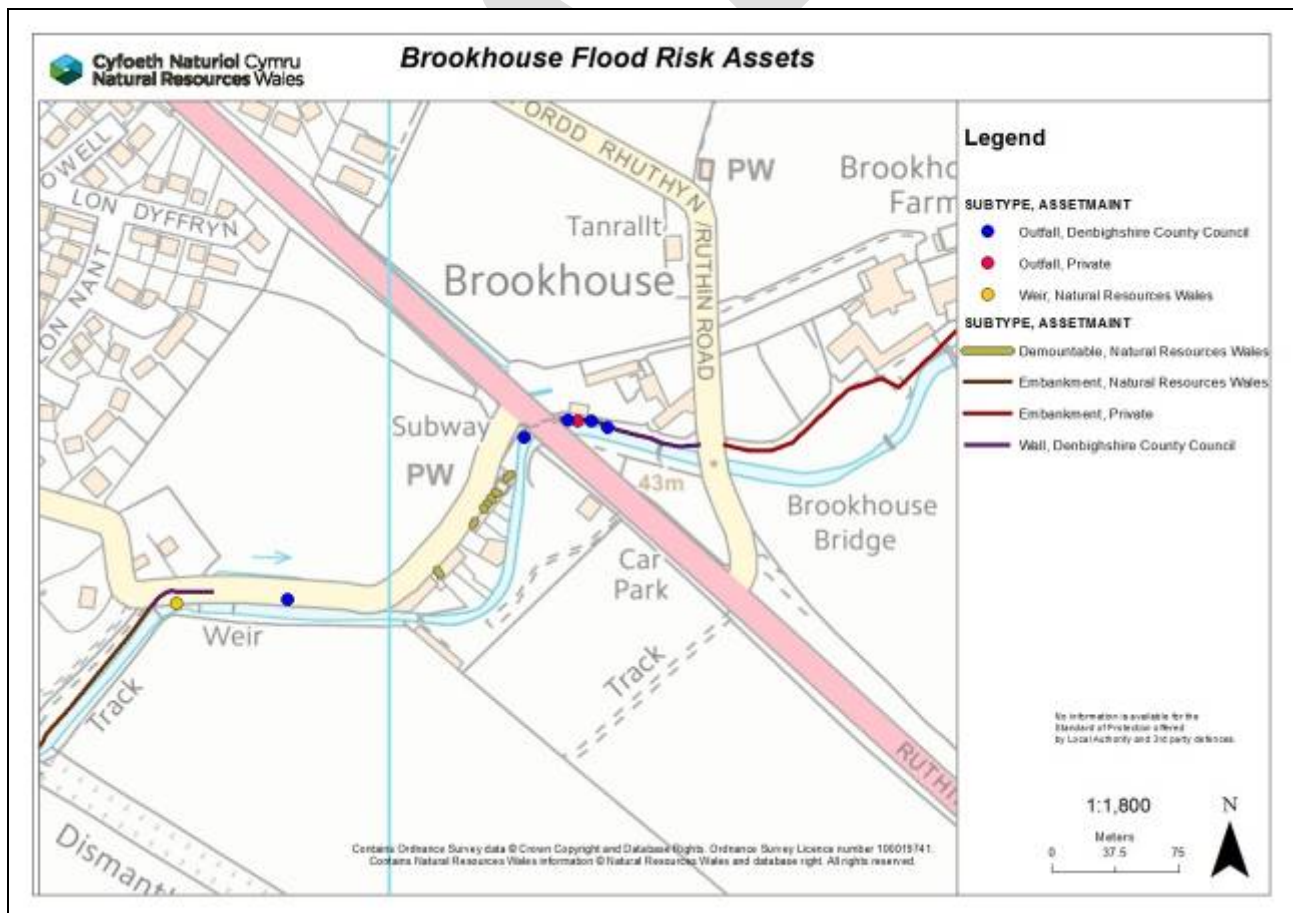
Figure 4: Asset map extracted from AMX database

NRW maintain a weir 100m upstream of the Brookhouse Cottages which includes a staircase type fish pass. The Weir is a Public Safety Risk Assessment (PSRA) site. NRW also maintain an embankment directly upstream of the Weir. Most outfalls on the left bank along this stretch are owned and maintained by Denbighshire County Council.

Six of the properties along Brookhouse Road have IPP. The properties identified as 'Glan Llyn, Nos. 6, 7, 8 and 9 all confirmed to have IPP installed during the event.

The Old Chapel (Hen Capel) and properties Nos.4 and 5 placed sandbags at the front of the properties to help protect against any flood waters coming from this direction, which has often been the case in past events.

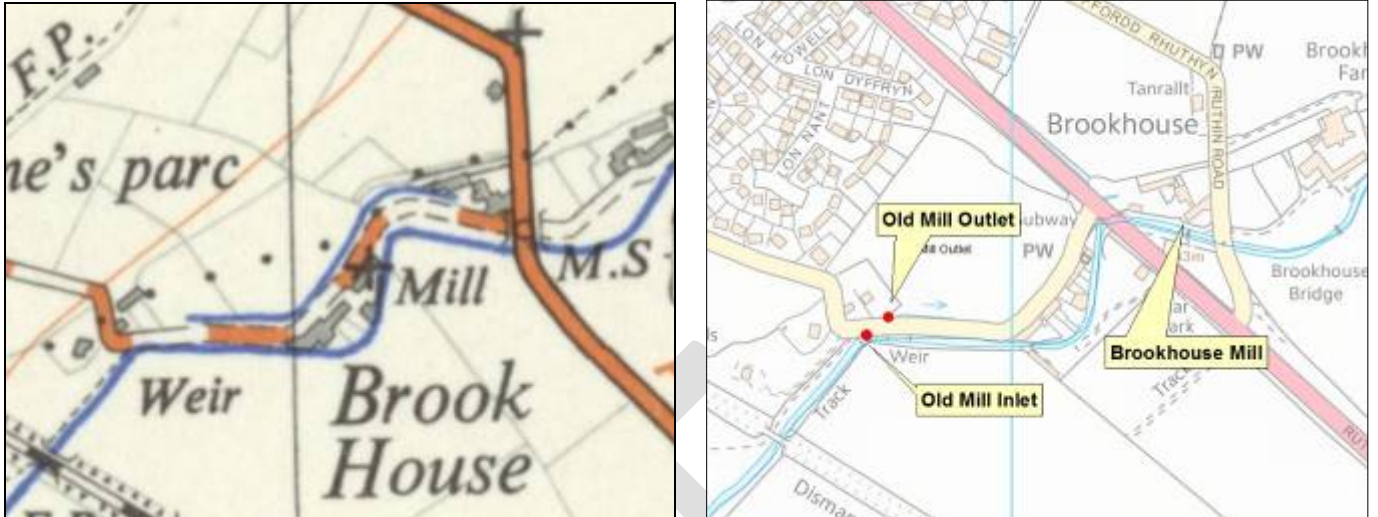
Figure 11: 1937 Map showing route of man-made channel on Brookhouse Road to Brookhouse Mill adjacent to present day map Source: <https://maps.nls.uk/> Contains OS data © Crown copyright [2020]

Historically, Brookhouse Mill, situated on the left bank upstream of the A525, was supplied by a man-made channel across the field, that was fed by the Ystrad through an old Mill inlet. It connected to the other side of the road via a culvert (306892, 365673).

Several decades ago when the new road was built, the Mill leat appears to have been blocked off, however the archway still exists (See Photo below Figure 12) and a small flow into but not through is present.

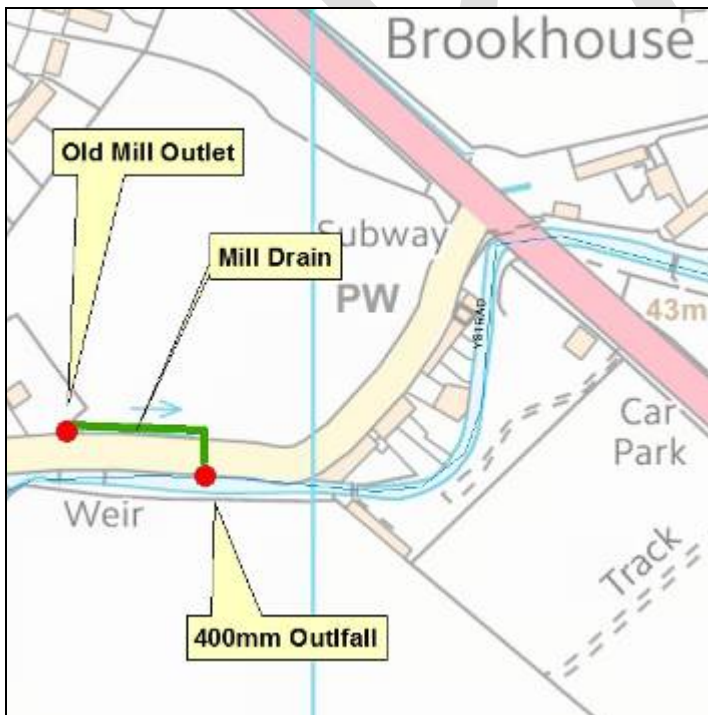
Figure 14: Map showing outlet and 400m Outfall associated with Mill Race Drain. Source: NRW

The Mill race/drain running along the wall in the field was clear, there is a 400mm diameter Outfall to allow surface water drainage from the field back into the river (Figure 15). This was clear and no debris was seen within the river itself.

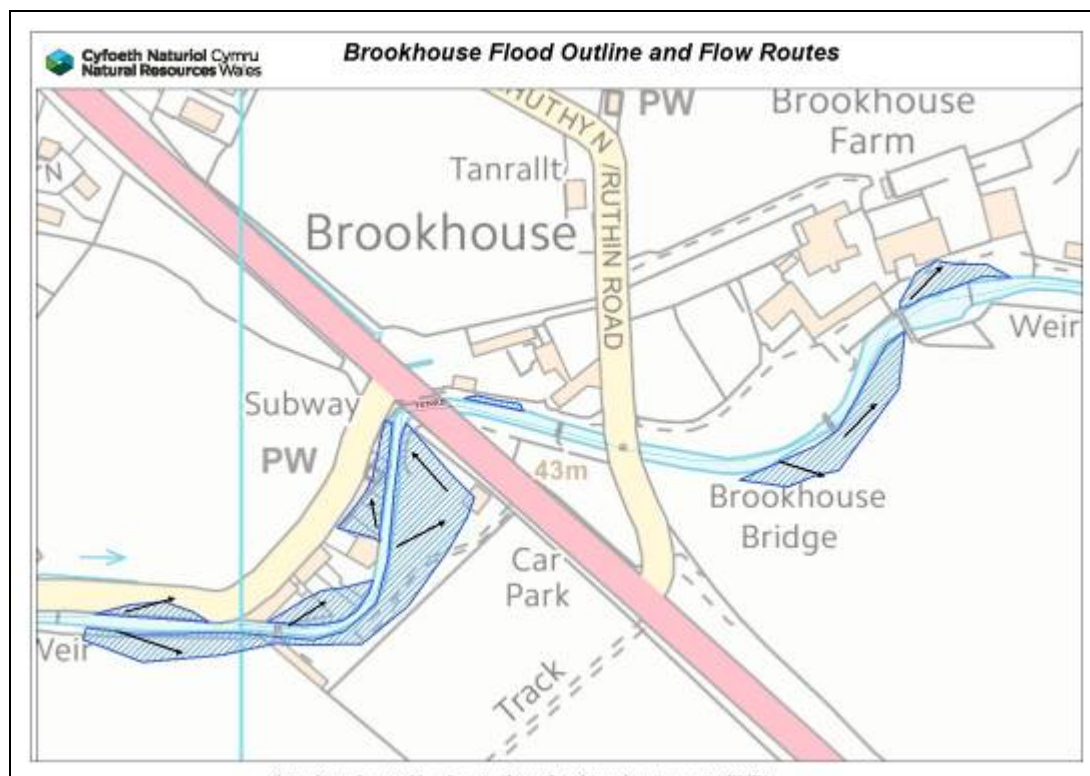
Figure 21: Outline and Route

On this occasion, flooding was caused by the overtopping of the Afon Ystrad at the back of the properties. Recent tree clearance above the weir may have decreased the risk of blockage of the Ystrad and subsequent overtopping upstream of the weir, thus impeding this flow route along Brookhouse Road towards the properties. The tree work may have resulted in a greater river conveyance made the Afon Ystrad react more quickly to heavy rainfall.

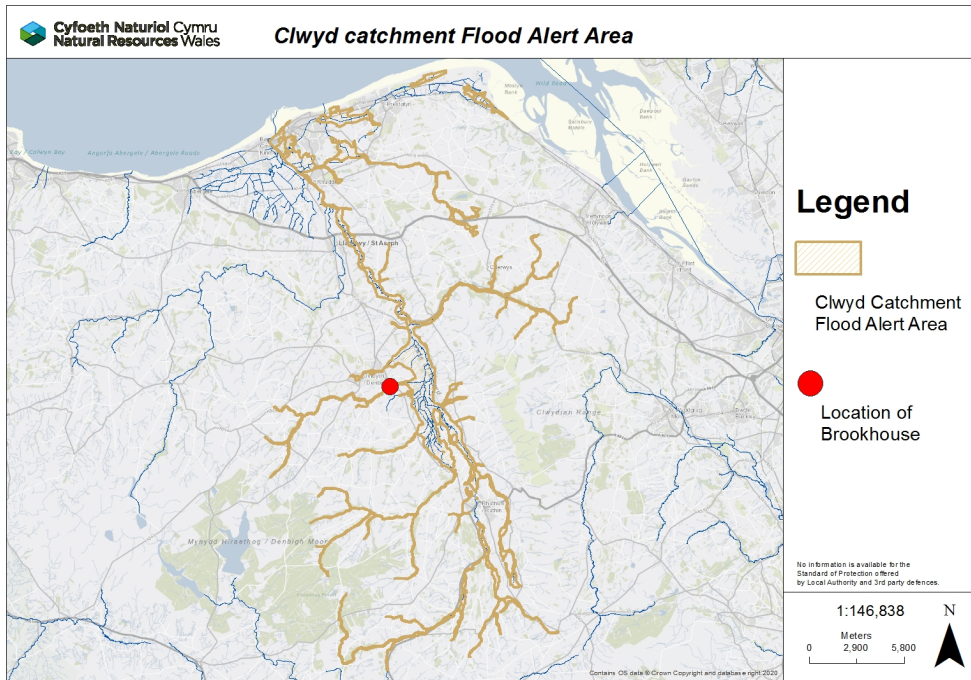
Figure 22: Flood Alert Area – Clwyd Catchment Total Extent.

Residents of Brookhouse can register for the Clwyd Catchment Flood Alert but this covers a much broader area (Fig.22) and the main rivers covered by this alert are much slower to react than the Afon Ystrad. This is a free service that provides flood warnings by telephone, mobile, email and SMS text message. This would provide residents prior warning of a fluvial flood event. However, it should be noted that this would only give warning of fluvial flooding in this area and would not cover pluvial or groundwater flooding. A Flood Alert was issued by NRW at 09.48hrs for the Clwyd catchment on the 9th February.

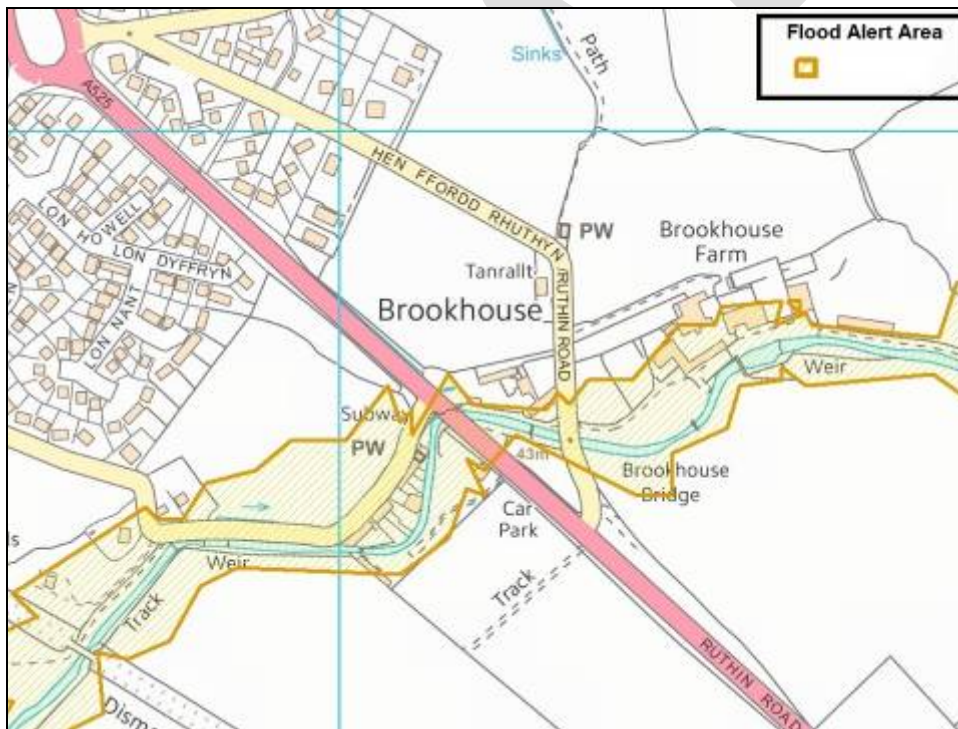
Figure 23: Flood Alert Area – Clwyd Catchment in locality of Brookhouse.

The following addresses are registered to receive warnings for the Clwyd catchment: Old Chapel, Nos. 7, 9, and 16.
