Flood Investigation Report Ruthin 20 January 2021

This investigation report is a best estimate representation of the flood incident at Ruthin, written as a formal way for Natural Resources Wales to record the incident. It is based on evidence gathered by Natural Resources Wales' officers through several sources and is deemed as fit for purpose at the approved date.

It was considered appropriate to carry out an investigation as 23 residential/business properties suffered from internal flooding following heavy rainfall on the 20 January 2021. The Afon Clwyd overtopped the raised flood embankment between Cae Ddol and the Crispin Yard Car Park on the Clwyd's right bank and flooded 22 properties. One property was also flooded internally by the Clwyd in the Maes Ffynnon estate.

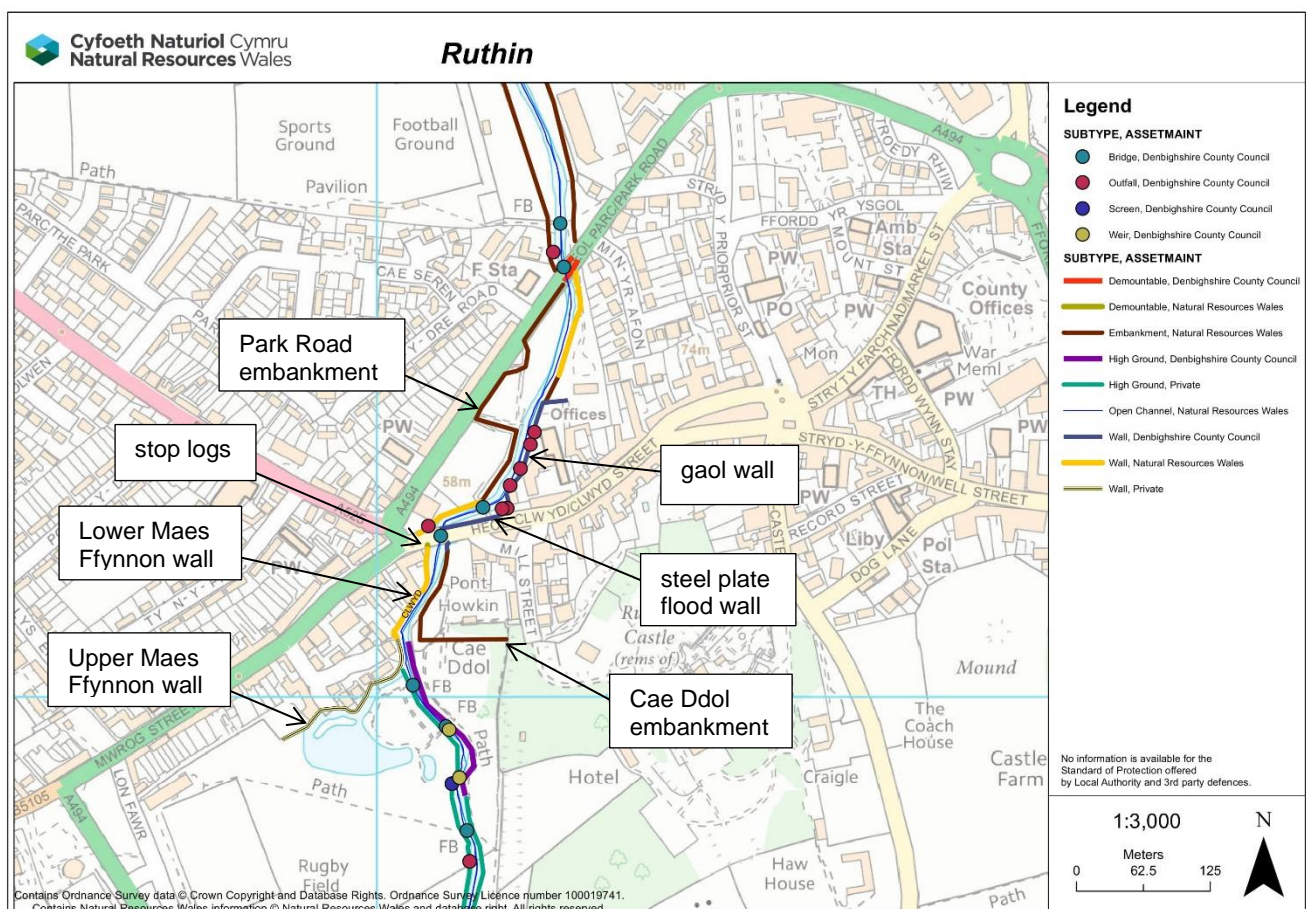
Figure 3: Ruthin flood risk management assets

All raised defences in the Ruthin area are visually inspected on a 6-month schedule. All assets have a condition score allocated in reference to the 2012 Condition Assessment Manual². At the time of the January 2021 storm event, majority of NRW maintained flood risk management assets in Ruthin were performing at or above their target condition with only the lower Maes Ffynnon wall slightly below its target condition.

The most recent asset inspection of the Cae Ddol embankment did identify a localised defect with the condition of the embankment adjacent to the castle wall. Whilst not sufficient to decrease the overall condition assessment of the embankment the defect was raised with the Operations team and a repair was due to be undertaken this summer when conditions allowed.

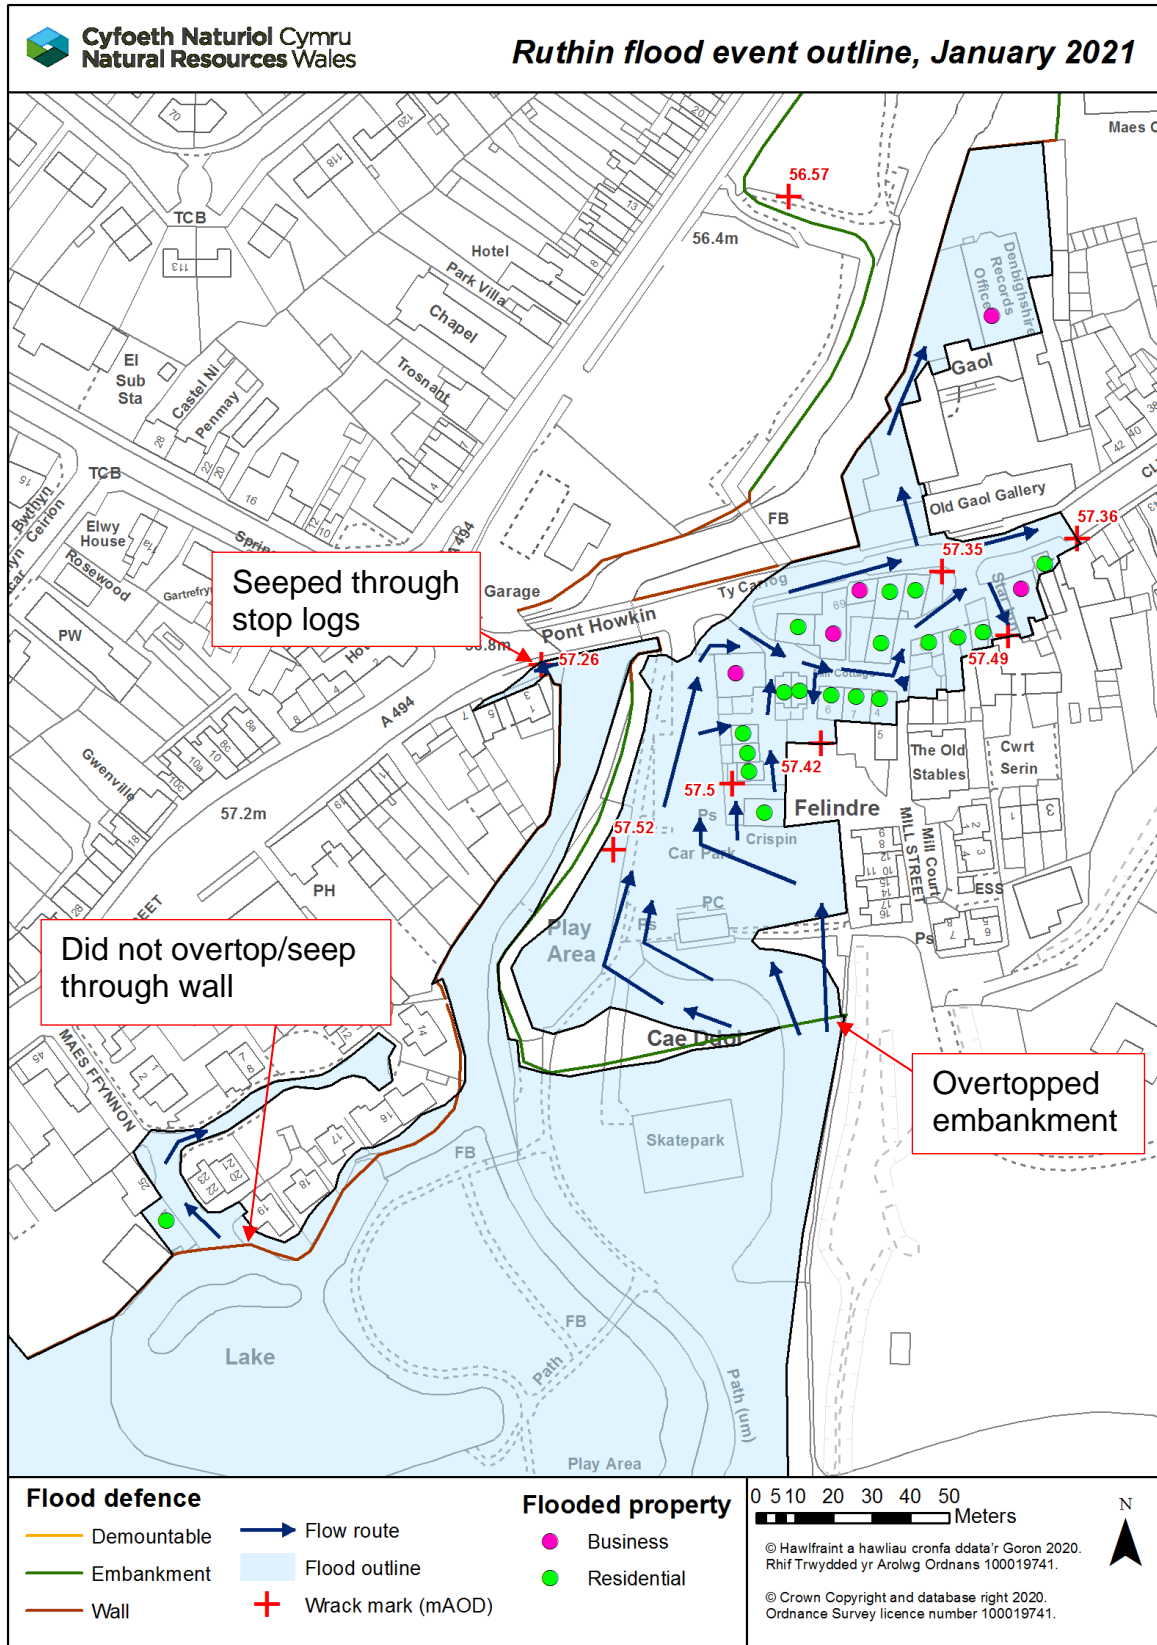
Figure 13: Outline and Route

As a result of the rising river level, the Afon Clwyd overtopped the Cae Ddol flood defence embankment and flooded areas of Mill Street and Clwyd Street in Ruthin. Areas around Maes Ffynnon estate and outside of 1 Mwrog Street were also affected by Clwyd floodwater.

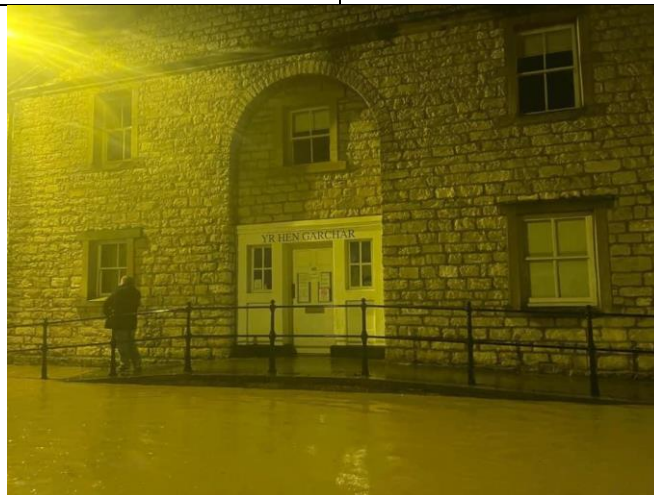
We attended the area twice and no flooding was observed. Flood water stayed within the former Gaol bunded area.

View towards Gaol

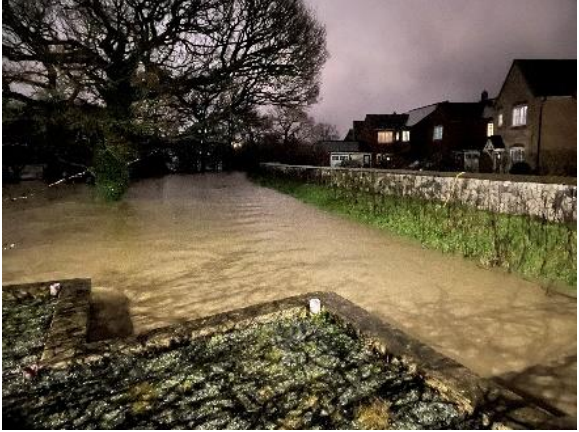
<p>View south from highway culverts toward floodplain</p>	<p>View from highway towards Glasdir</p>

<p>View from Glasdir towards highway culverts</p>	<p>View from Glasdir towards highway culverts</p>

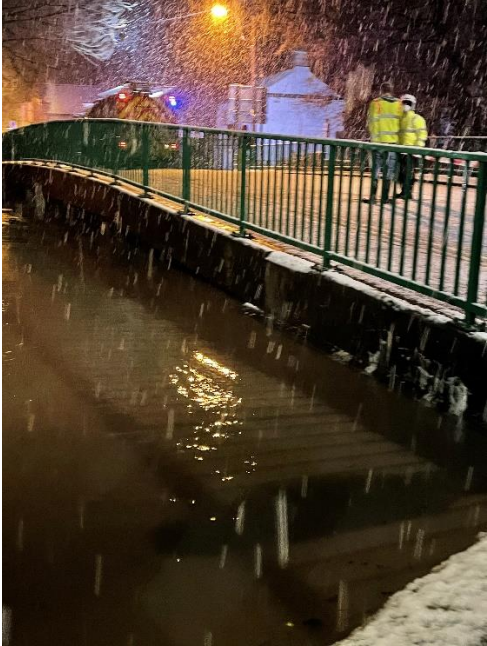
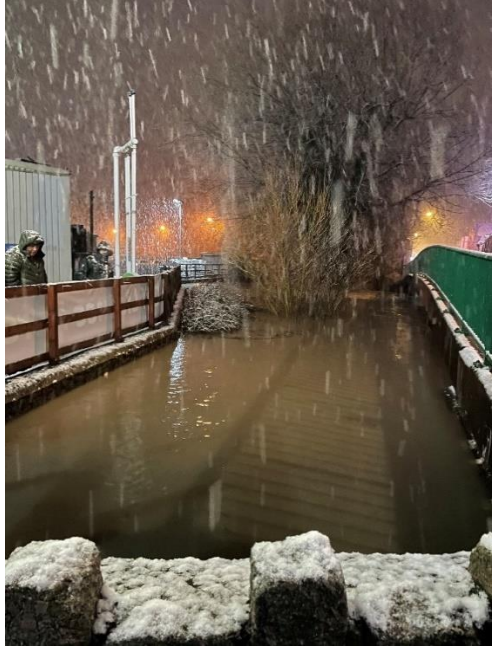
The outfall at the BP Garage appeared to be discharging at full bore. The first upstream manhole in the highway (next to the Park Place public house) had been fenced off by residents. It was assumed that this action had been taken in advance of the manhole cover potentially blowing. We visited the manhole twice and observed minimal surcharging onto the road.

<p>View above outfall towards road bridge</p>	<p>Outfall view – BT garage to left, road bridge to right</p>

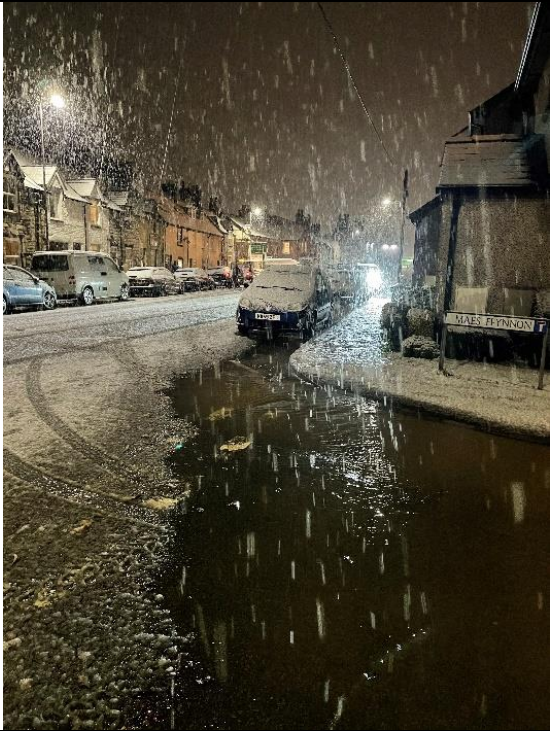
Approximately 200m upstream of the outfall, highway gullies were observed to be surcharging and flooding towards Maes Ffynnon. It is assumed that the gullies discharge into the culvert. The cul-de-sac appeared flooded, but no properties appeared to be affected internally.

<p>Surcharging manhole adjacent to Park Place pub</p>	<p>Entrance to Maes Ffynnon cul-de-sac</p>

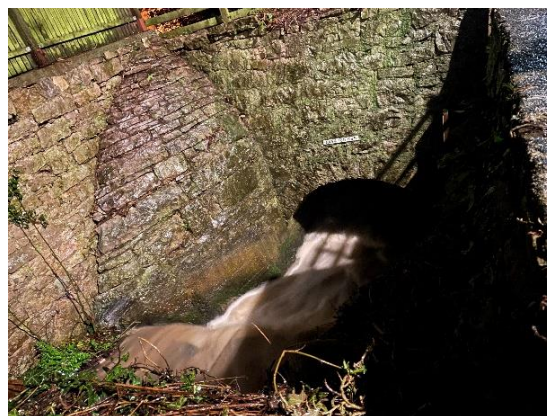
Llanfwrog culvert inlet

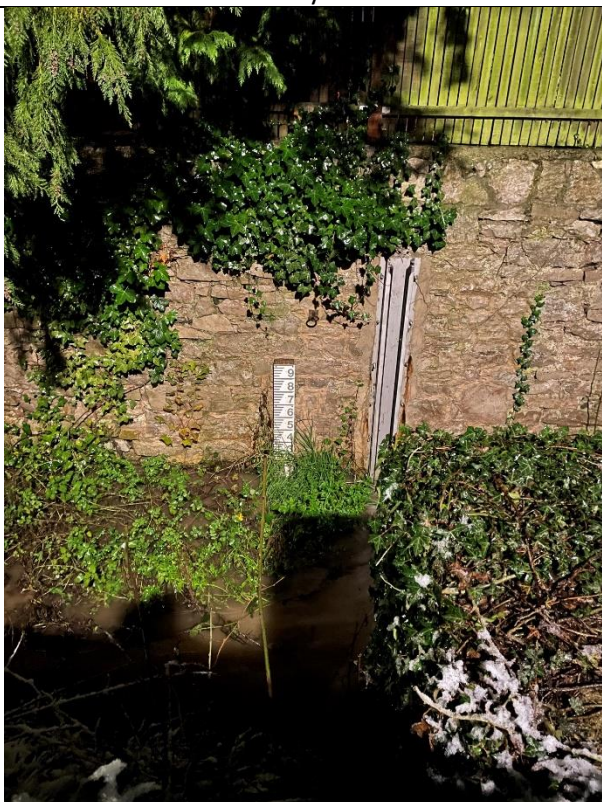
Llanfwrog open channel water level

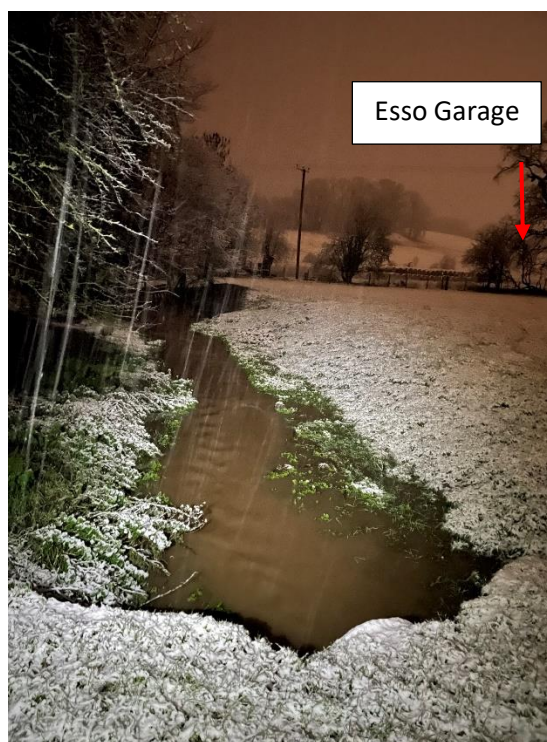
Open channel watercourse adjacent to Llanfwrog Church
