SECTION 19 FLOOD INVESTIGATION REPORT

**20th OCTOBER 2023
FLOOD EVENT**

LOCATION: DENBIGHSHIRE

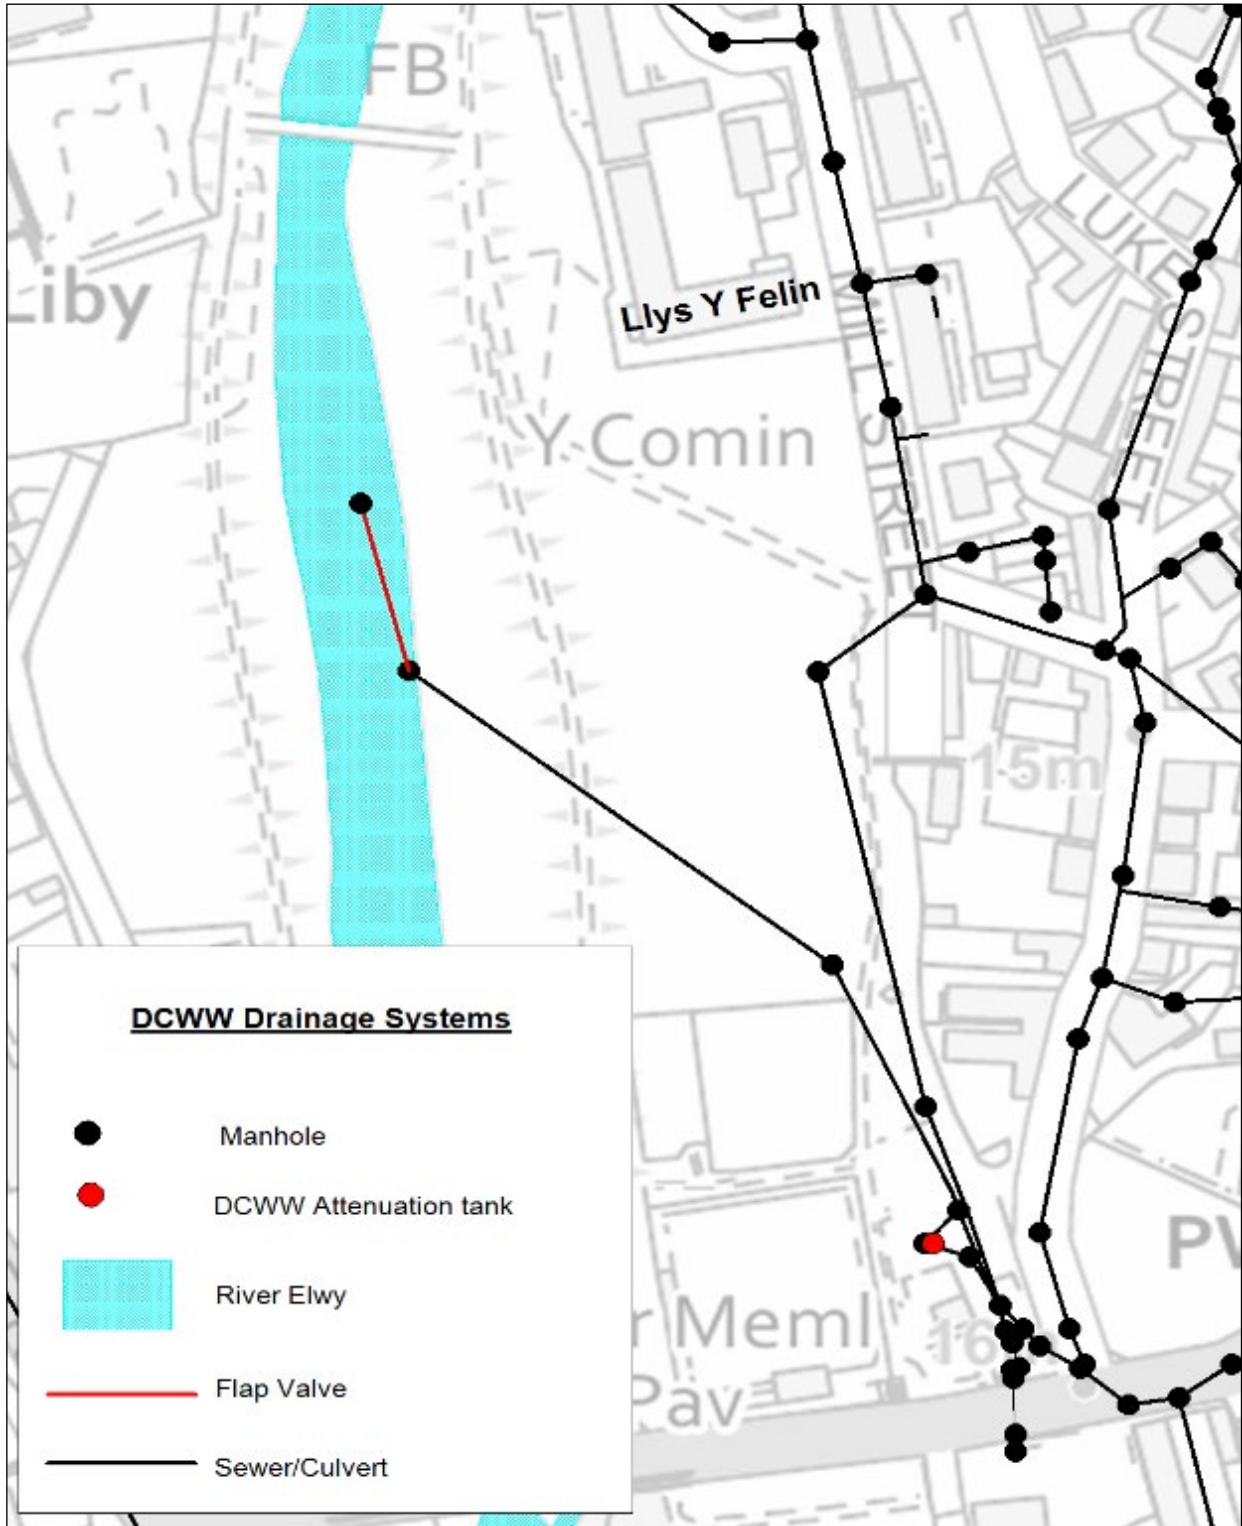
Figure 9: DCWW drainage systems for the area around Llys Y Felin

River Elwy passes through lower St.Asaph. The catchment for this River can be seen in figure 8 below and the usual depth range of the Elwy at St Asaph is between 0.95m and 2.05m. It has been between these levels for 90% of the time since monitoring began ⁴. Llys y Felin (marked with a blue pin on figure 8) is indirectly effected by the fluctuating depths, which play a role in how storm water is drained into the Elwy via DCWW drainage systems, which will be looked in section 4.3.2 below.

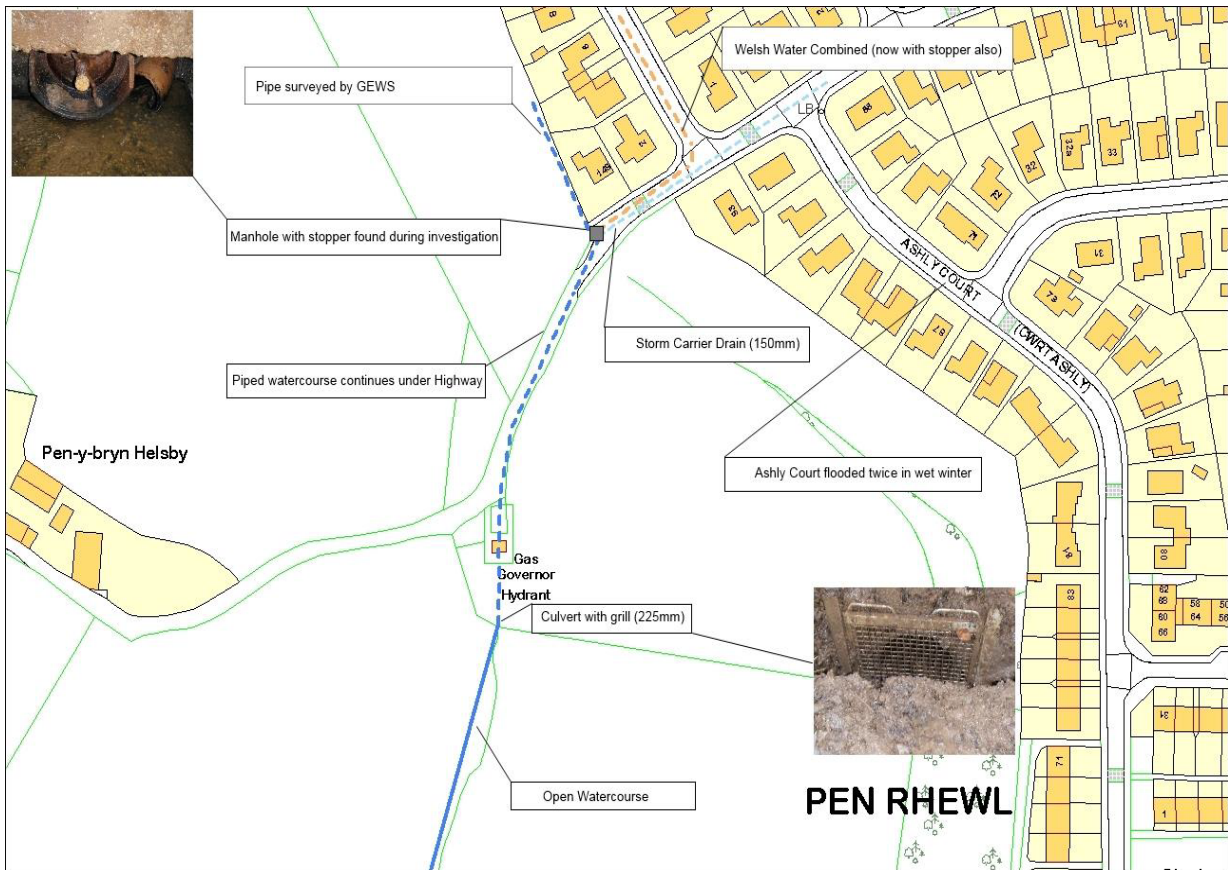
Figure 10: Drainage systems for Hoel Esgob

With regard to the catchment characteristics at Heol Esgob, a small stream from the land above Ashly Court (near to Heol Esgob), enters a piped system at the rear of a Wales and West gas installation as shown in Figure 10 below. The stream is piped for approximately 120m via a 225mm dia. pipe, into a manhole (termed hereafter 'connection

chamber’) at the head of Heol Esgob, at the edge of the residential area. Within this chamber there are three other connections’ - the first is a pipe to DCWW combined sewer system, a higher-level connection to a surface water sewer operated by DCC and a final outlet which flows to a series of drainage ditches and culverts in the rear gardens of the properties on the western side of Tan-y-Bryn road.

It is possible that the chamber originally served simply to turn the stream water through 90 degrees into the ditch line and the highway drain flowed into this chamber. The ditch now ceases to function, but at some time a cross connection to the combined sewer was installed to take the flow. However, it is understood that, when DCWW were alerted to the presence of this watercourse connection they installed a stopper to prevent stream water entering the combined sewer, on the basis that this increased the risk of foul water flooding. There is no record of where the DCC highway drain ultimately discharges, but it is believed to outfall into the River Elwy by the Roe.

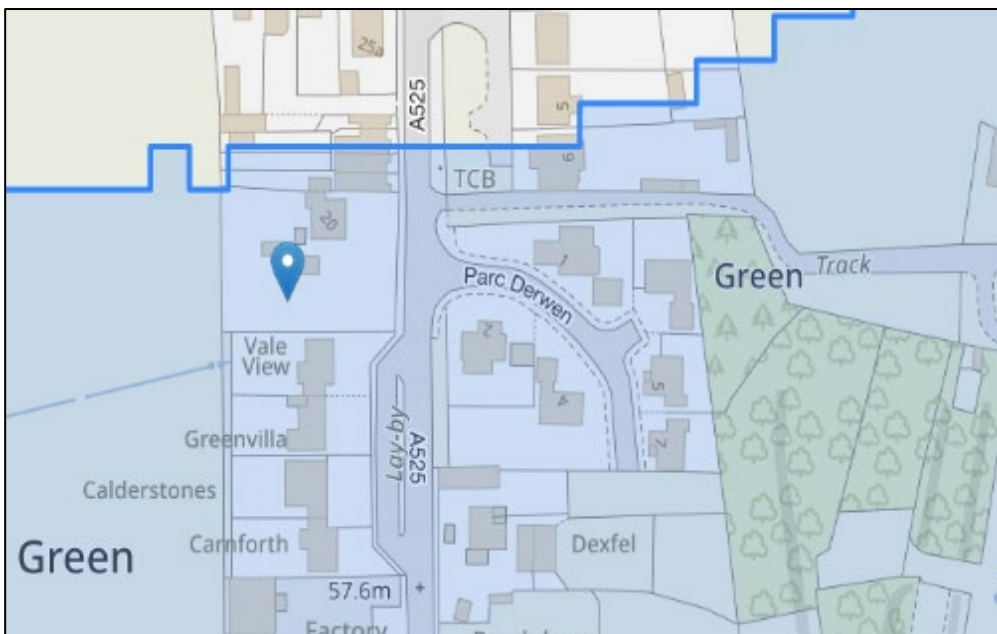
Figure 14: Location of the culverted watercourse.

Within the investigation area for Denbigh Green, there are a number of watercourses which run from the fields behind the affected properties. One of the watercourses is culverted at the point where it leaves agricultural land, whereby it runs underneath the A525 to an open channel, parallel to a farm track.

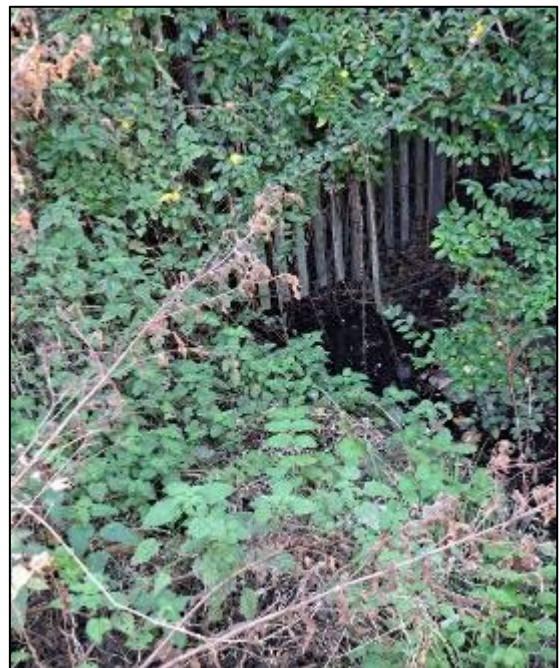
Photo 4: Railway Culvert

No other blockages were observed in the watercourse itself, although it might be that the footbridge culvert further down-stream of Llys y Gwennol (see red circle in figure 27 for location) may have restricted flows further, but there was no evidence of over-topping here. According to a resident of Maes Y Gog, there is also a possibility that the upstream culvert at the railway crossing and Lyons Holiday Park caused water to back-up to the Maes Gwilym Drain as both were allegedly blocked with debris on the day of the flooding, Photo 3 and 4 show both culverts respectively, but were not taken on the day of the flooding.

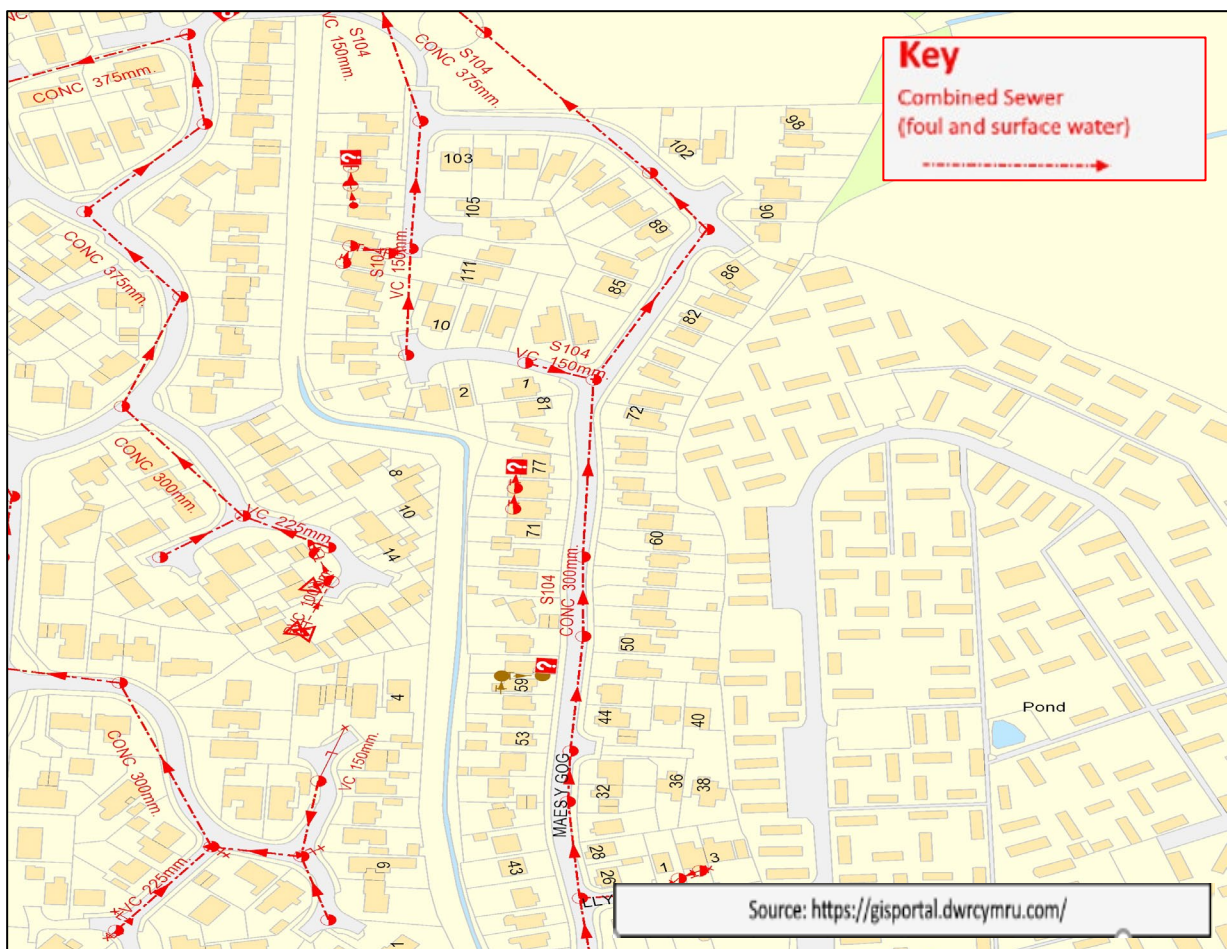
Figure 28 : DCWW apparatus at Maes y Gog/Llys Gwennol & Lon Eglyn

DCWW is responsible for the sewerage infrastructure serving Maes Y Gog/Llys Gwennol/Lon Eglyn, with figure 28 showing the sewerage network for this area as being combined, which drains to the main Rhyl Coast Road Pumping Station (see figure 4 for

The drains in the vicinity of the flooding at these locations may have surcharged during the event while the pumping station caught up, primarily due to the volume of flooding from other sources. DCWW deem this type of flooding to be coincidental where, flooding has occurred but the public sewer system is not at fault and has been inundated by an external source of water, in this case from the local watercourse system.

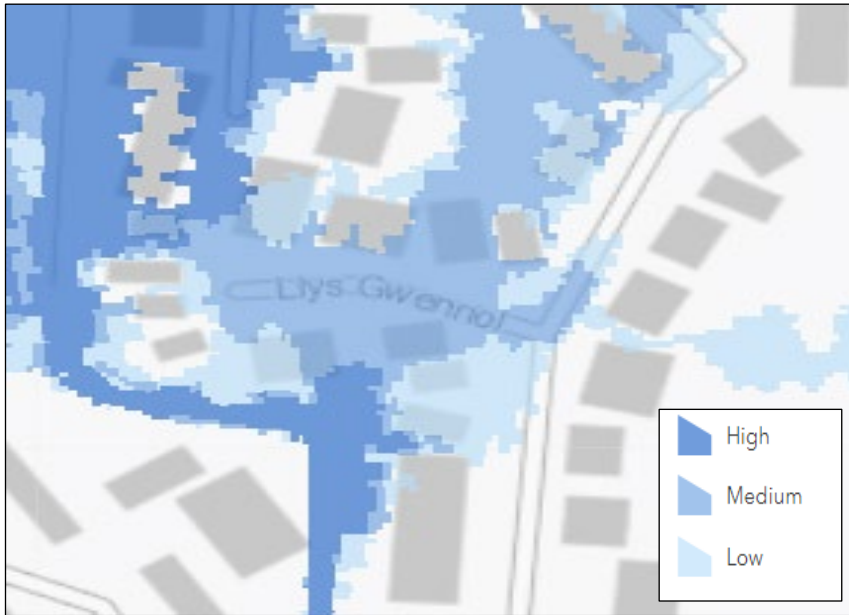
Figure 29: The NRW Flood and Coastal Erosion Risk Maps for Rivers showing Llys y Gwennol

In terms of the likelihood of this type of flooding happening again, the NRW Flood and Coastal Erosion Risk Maps for Rivers shows in figure 29 parts of Llys Y Gwennol having a medium to high risk of being flooded by the Maes Gwilym Drain.

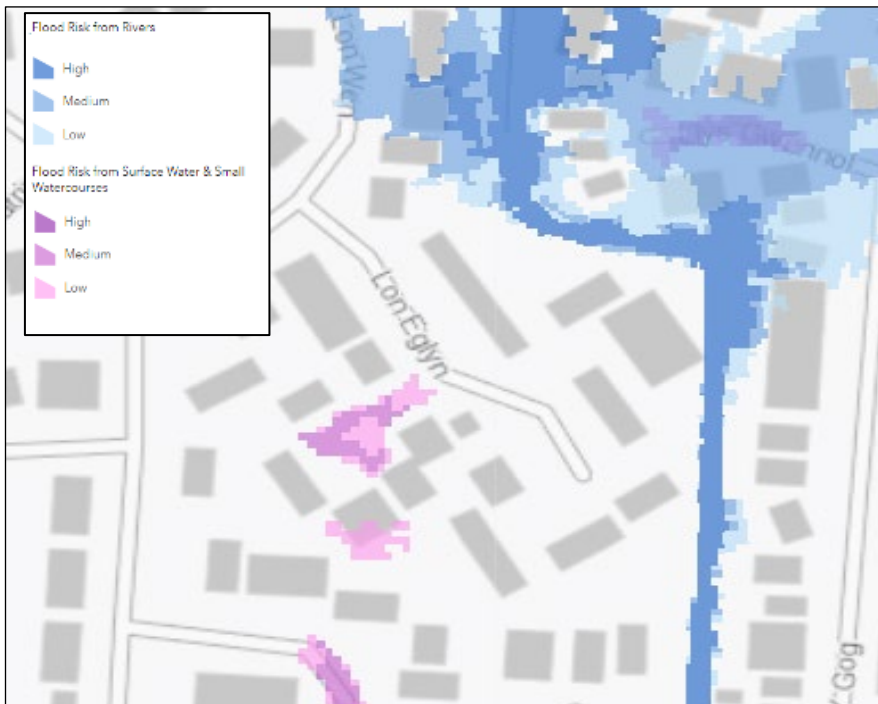
Figure 30: The NRW Flood and Coastal Erosion Risk Maps for Rivers and surface water showing Lon Eglyn

For Lon Eglyn, figure 30 shows that the Risk Maps for rivers and surface water flooding does not currently have the effected houses as being at risk of flooding from these two flood sources. Hence, it is difficult to say how likely the scale of flooding from Storm Babet will happen again, but there is a potential contributing factor to flood risk through surface water, most notably the on-going housing development upstream of Maes Y Gog, which was granted planning permission prior to the statutory implementation of sustainable drainage (SuDS) for all new developments over 100 square metres.

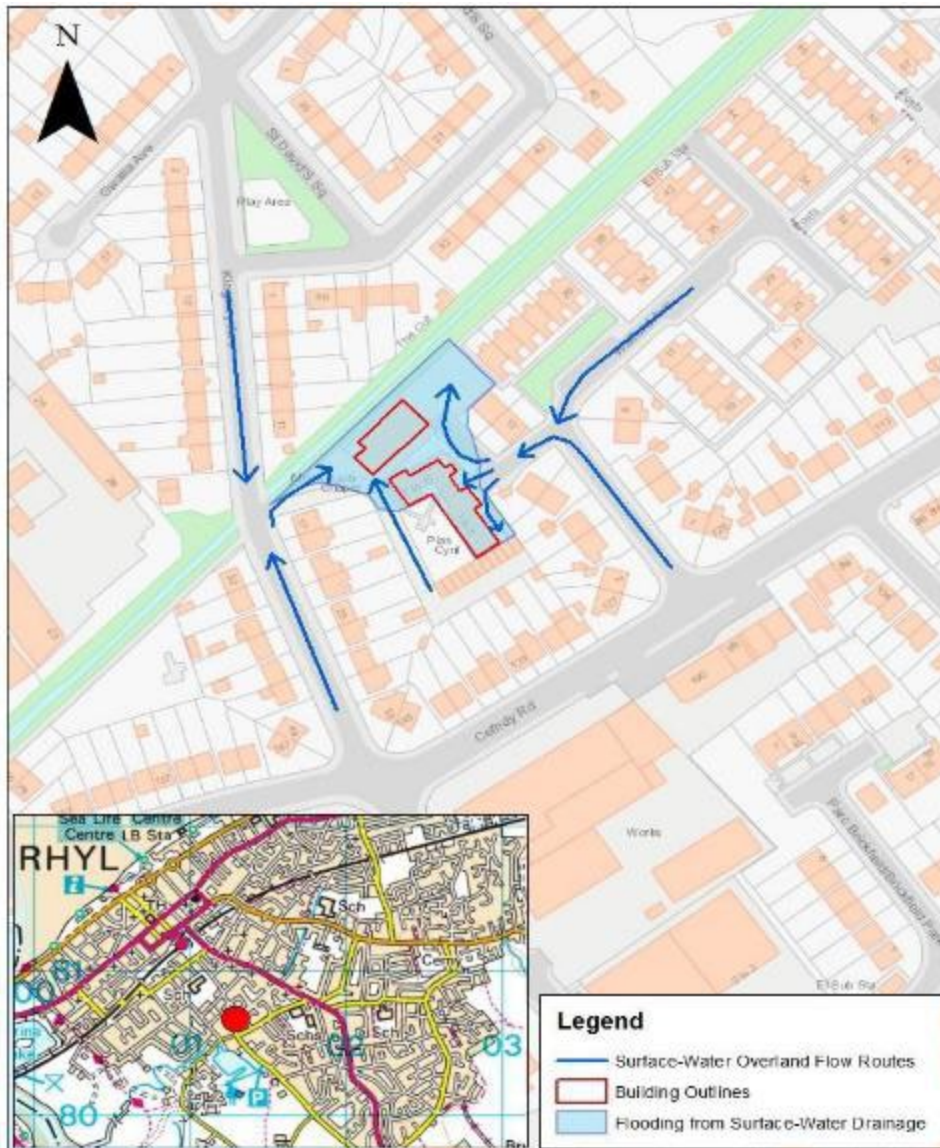
Figure 31: Flood outline and direction for Plas Cyril and the Dance Studio

The sewage and drainage pipes had also reached capacity and raw sewage was present in a yard to the side of the Studio. Apparently DCWW had been in to jet and empty pipes and chambers within the vicinity and were due back at some point to continue cleaning the yard area located alongside the Dance Studio.

Figure 31 shows the flow route and flooding extent for the Plas Cyril and the Dance studio.

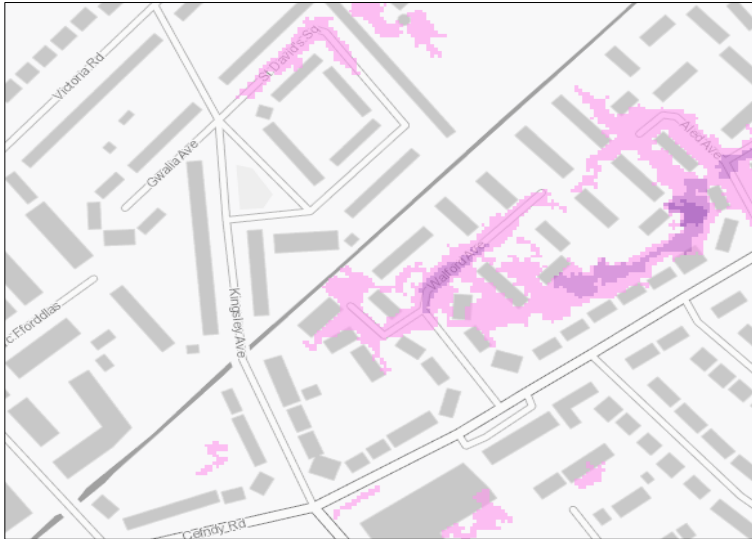
Figure 32: Surface Water Flood Map at Plas Cyril and the Dance Studio

For Plas Cyril and the Dance Studio, the chances of surface water flooding occurring again is at low to medium risk as shown in figure 32 below, which was taken from NRW's Flood and Coastal Risk Maps.

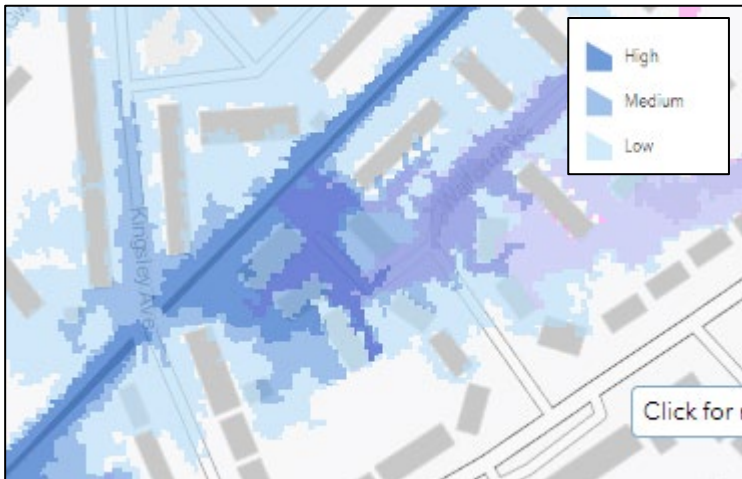
Figure 33: NRW Flood and Coastal Risk Maps for Rivers at Plas Cyril and the Dance Studio

Both properties were flooded in 2017, with the Dance Studio in particular suffering further flooding in the past from the Rhyll Cut. Indeed, figure 33, from the Flood and Coastal Risk Maps for Rivers puts both properties at medium to high risk of flooding from rivers, that is, the Rhyll Cut.

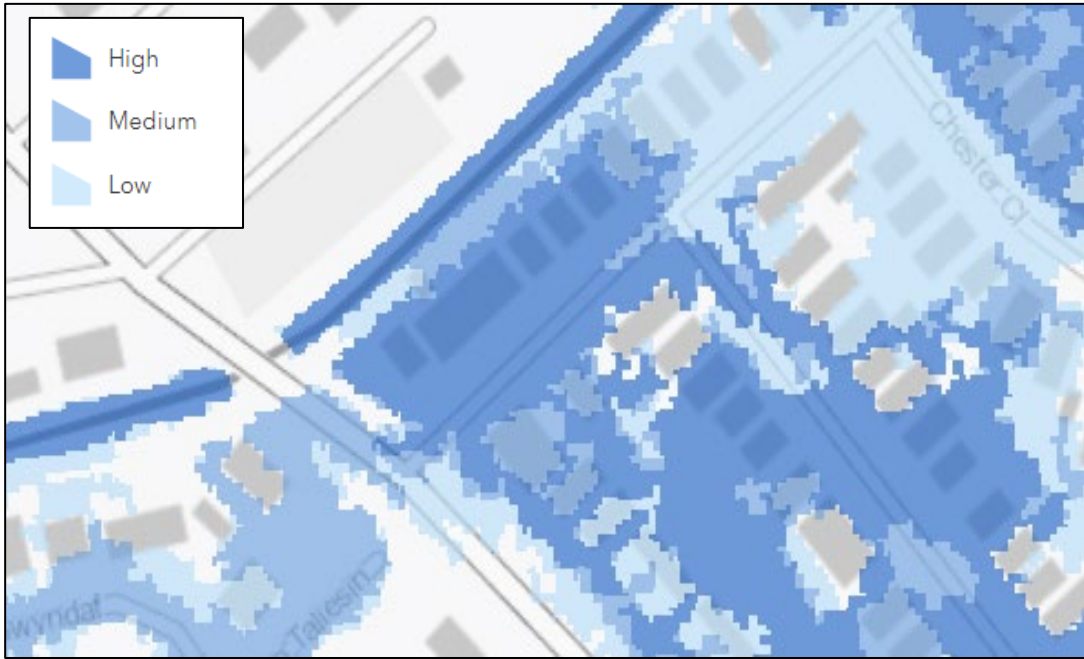
Figure 35: NRW Flood and Coastal Erosion Risk Maps for Rivers at Winchester Drive

Historically sewer flooding has occurred at this location on Winchester Drive on a number of occasions, notably 2007 & 2008, with near misses as recently as 2017.

Figure 35 below taken from the NRW Flood and Coastal Erosion Risk Maps, shows Winchester Drive from numbers 1 to 17 having a high risk of being flooded from the Main River, that is the Prestatyn Gutter.

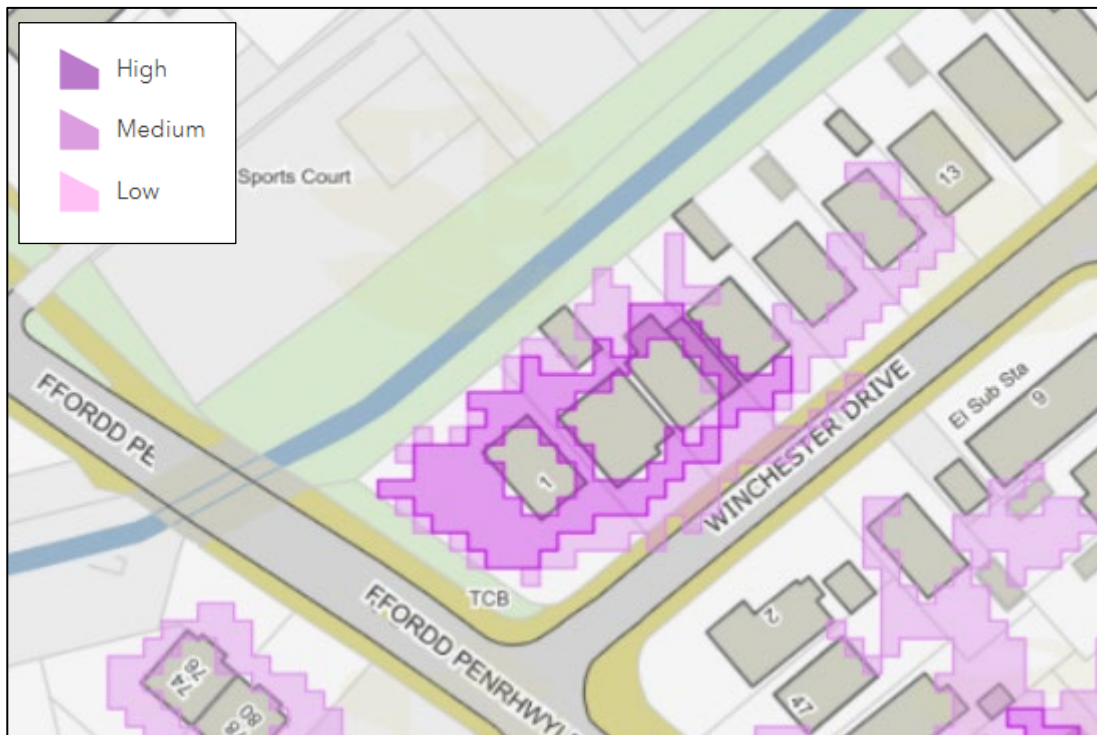
Figure 36: : NRW Flood and Coastal erosion Risk Maps for Surface Water at Winchester Drive

On the other hand, for surface water, the NRW Risk Maps in figure 36 show a low to medium risk of surface water flooding occurring for properties 1 to 7 on Winchester Drive.

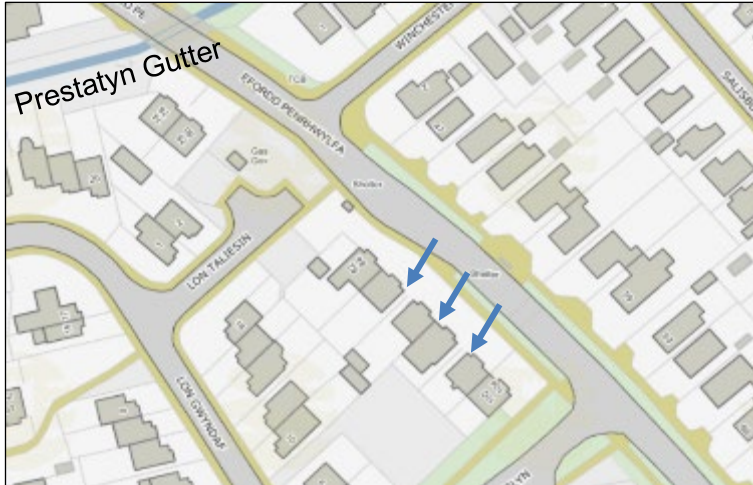
Figure 37: Flow direction of flood waters at Ffordd Penwhylfa

All the ground floor flats from No 88 to No 102 experienced internal flooding on the 20th October as a result of Storm Babet.

Highway gullies feed into the DCWW surface water system which discharges into the Prestatyn Gutter. It's Likely that due to high levels in the Gutter, water was unable to discharge effectively, hence water backed up and flooded the highway, which then made its way to the ground floor flats as shown by the blue arrows in figure 37 below.

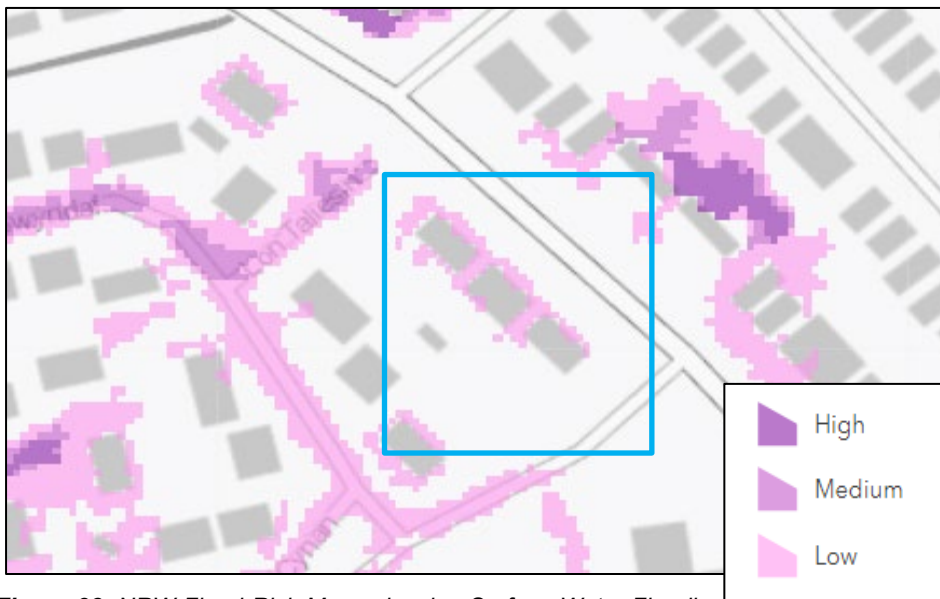
Figure 38. NRW Flood Risk Maps showing Surface Water Flooding risk at the enclosed ground floor flats on Ffordd Penwhylfa

Figure 38 from The NRW flood risk maps shows a low risk of surface water flooding for Ffordd Penwhylfa, although historically some these ground floor flats flooded in 2007 and 2008.

- To engage with all relevant stake-holders to understand how the drainage systems work and what can be done to improve the flood risk issue
- DCC strongly recommend residents investigate PLP

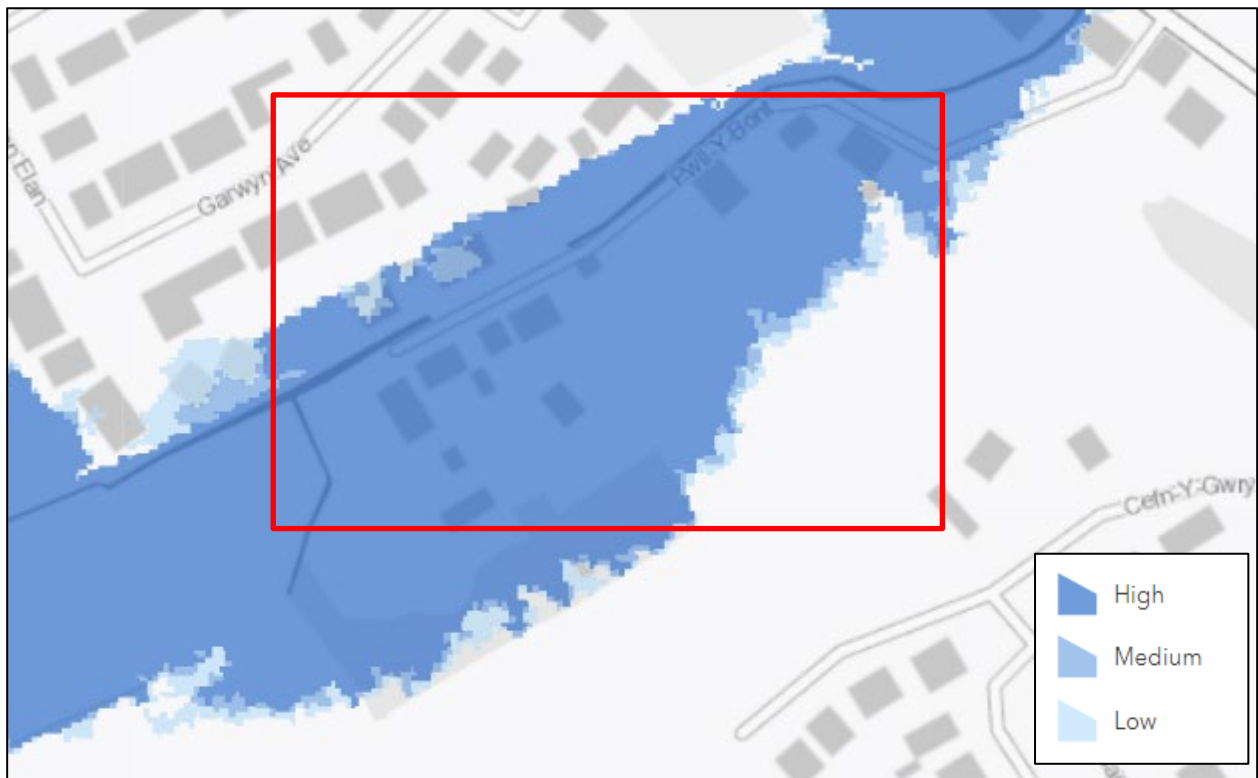
Figure 40: NRW Flood Risk from Rivers at the Pwll y Bont Investigation area

3 properties were flooded at Pwll Y Bont as a result of Storm Christophe 2021. Residents commented at post Christophe that the Prestatyn Gutter was blocked, causing a restriction to flow. The depth of water outside “The Mallows” flooded to a depth of almost 2 foot and remained in place for about three hours.

Figure 40 below shows the Fluvial flood extent at Pwll Y Bont taken from the NRW Flood Risk Maps for Rivers.

Approximately 9 properties along Pwll y Bont are within the fluvial flood extent

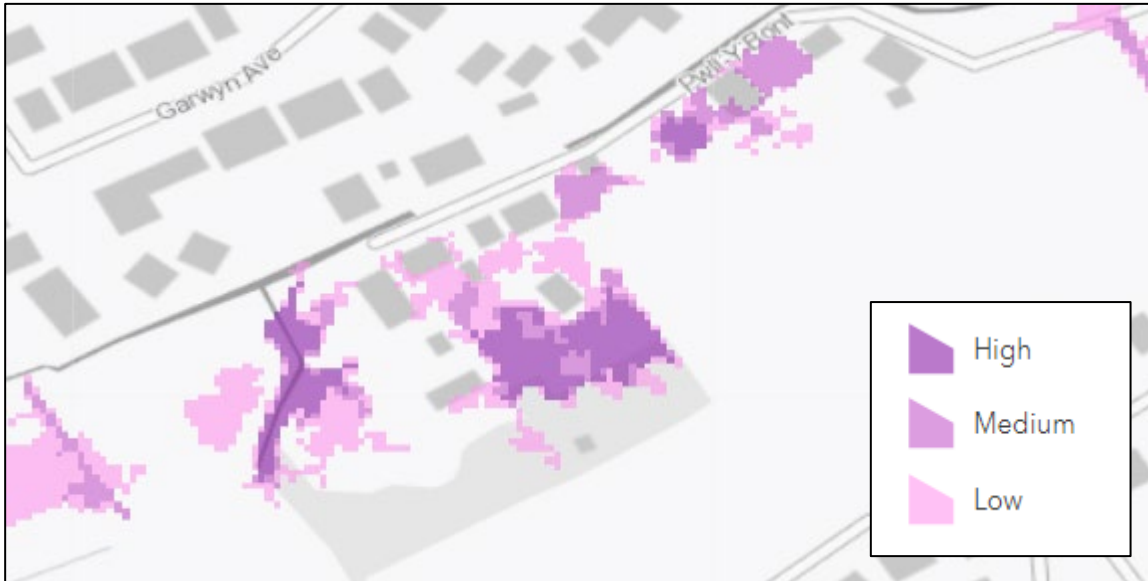
Figure 41: Flood risk from surface water at Pwll Y Bont, taken from the NRW flood risk Maps

With regard to the flood risk extent from surface water at Pwll Y Bont, there is a low to medium risk of such flooding occurring for 4 of the properties within the investigation area, as shown in figure 41 below.

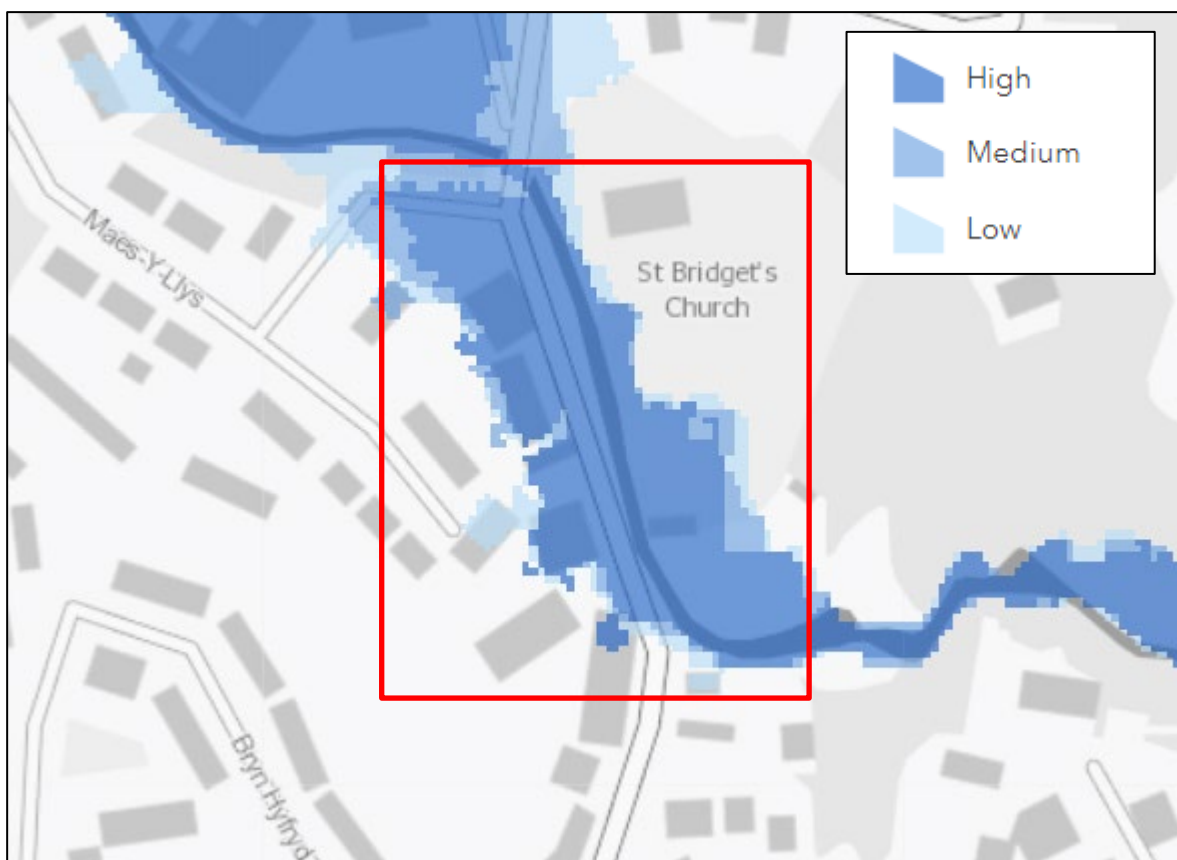
Figure 42: NRW Flood Risk Maps for Rivers for the investigation area at Waterfall Road

The upstream catchment (see section 4.2.1) for the Afon Ffyddion during storm events such as Babet brings a high volume of water to the lower reaches of the Watercourse where it passes through the Village of Dyserth. Given this volume, the main cause of

flooding is lack of capacity within the channel to cope, as well as crossings/culverts along this section restricting flows further. Therefore, on the 20th October, this scenario played out, which caused the Afon Ffyddion to over-top onto Waterfall Road and consequently cause internal flooding to 3 properties and 1 business.

Figure 42 below from the NRW Flood Risk Maps for Rivers shows the investigation area to have a high risk of fluvial flooding

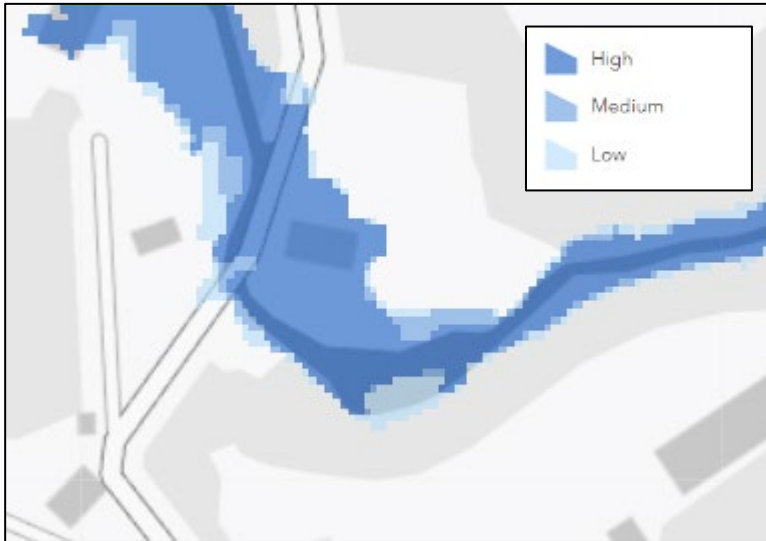
Figure 43: NRW Flood and Coastal Risk Maps for Rivers at Glan y Afon

Glan Y Afon was flooded in 2021 as a result of Storm Christophe. The NRW Flood and Coastal Risk Maps for Rivers has it classed as high risk as shown in figure 43 below.

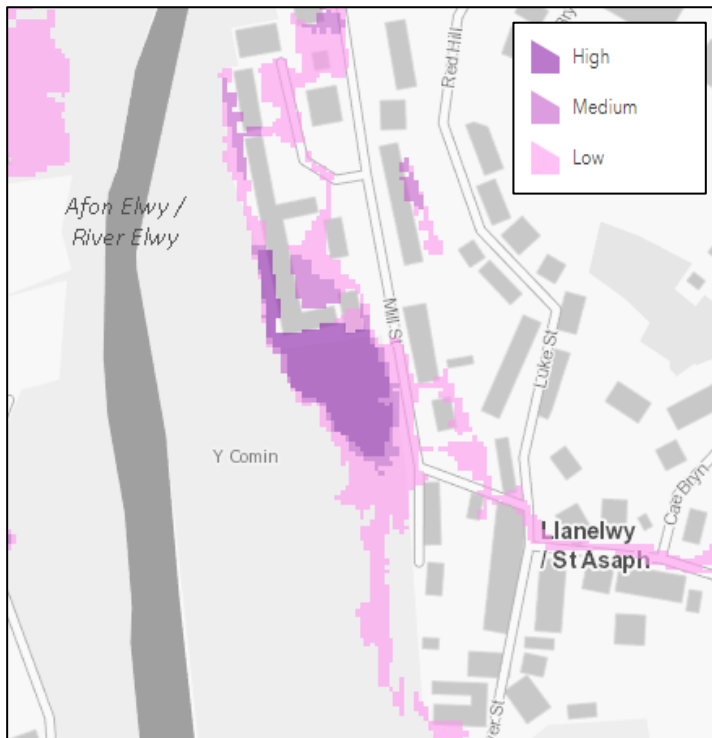
Figure 45: NRW Flood and Coastal Risk Maps for Llys y Felin showing risk of flooding from surface water and small watercourses.

Flooding to Llys y Felin also occurred in 2021 following Storm Christophe. Figures 45 and 46 from The NRW Flood and Coastal Risk Maps show that for Llys y Felin it has a high

risk of flooding from surface water and small watercourses, whereas for for flooding from rivers, it is low risk.

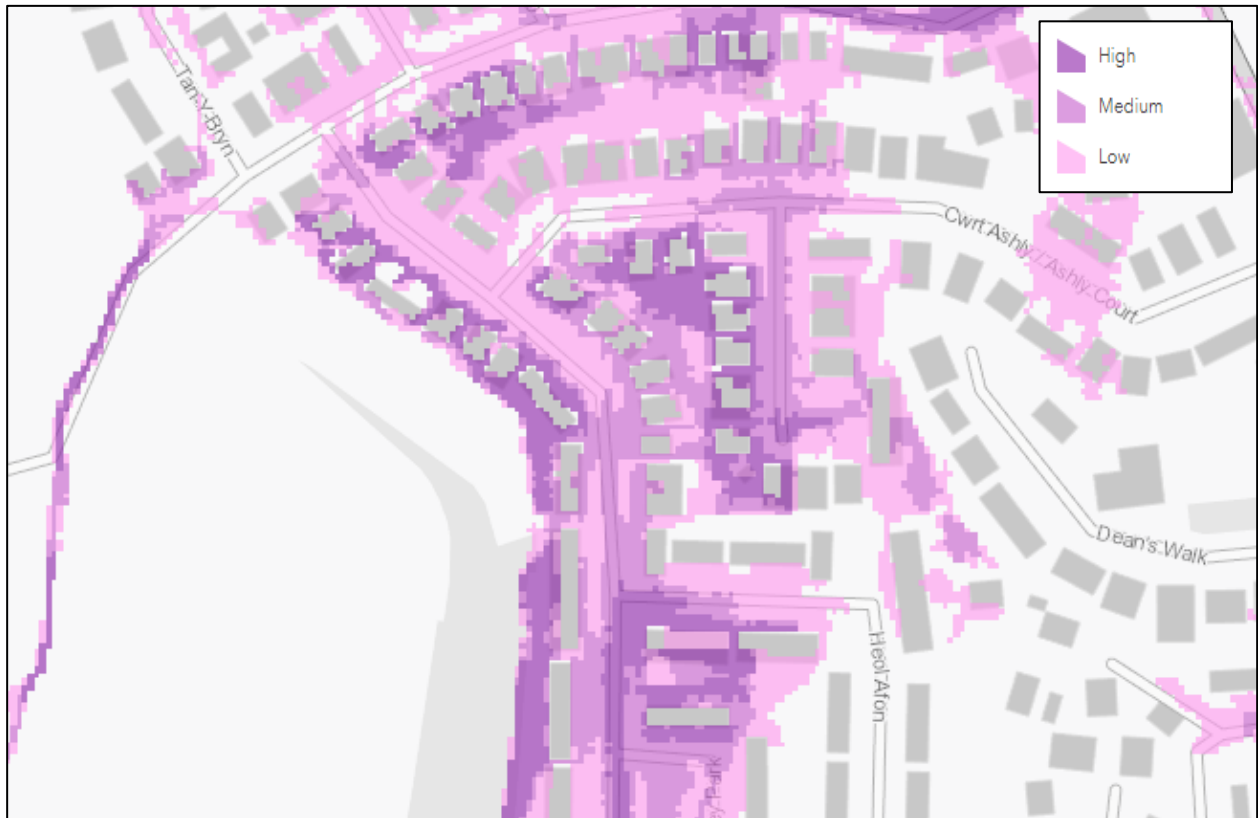
Figure 47: NRW Flood and Coastal Risk Maps showing flood risk from surface water and small watercourses at Hoel Esgob/Ashley Court

Figure 47 from the NRW Flood and Coastal Risk Maps has Hoel Esgob and Ashley Court as high to low risk from surface water and small watercourse flooding.

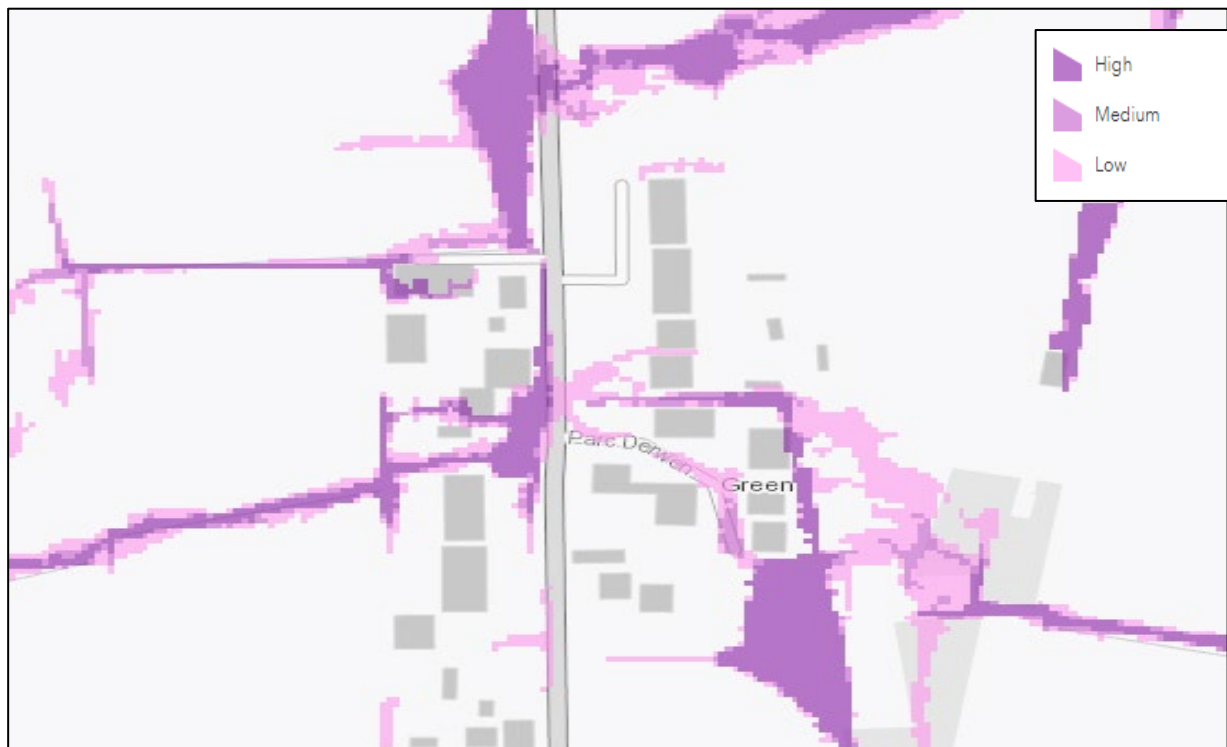
Figure 48: NRW Flood Risk Maps showing flood risk from surface water and small watercourses at Denbigh Green

Flooding occurred to multiple properties along the A525 in the Denbigh Green Area, with the flood water entering properties from the rear via numerous watercourses/ditches, which flow from the West to the East. DCC's current understanding of the causes of this flooding relates to issues with culverts under private landownership, notably the one within described in section 4.4.2. Either blockage or capacity led to the flooding, with culverts unable to cope with the large volumes of water.

Figure 48 below from the NRW Risk Maps has the effected properties in close proximity to being at high risk from surface water and small watercourse flooding.

- to work with landowners and assess what improvements can be made to these culverts, which may include reconstruction of headwalls or complete replacements of the culverts.

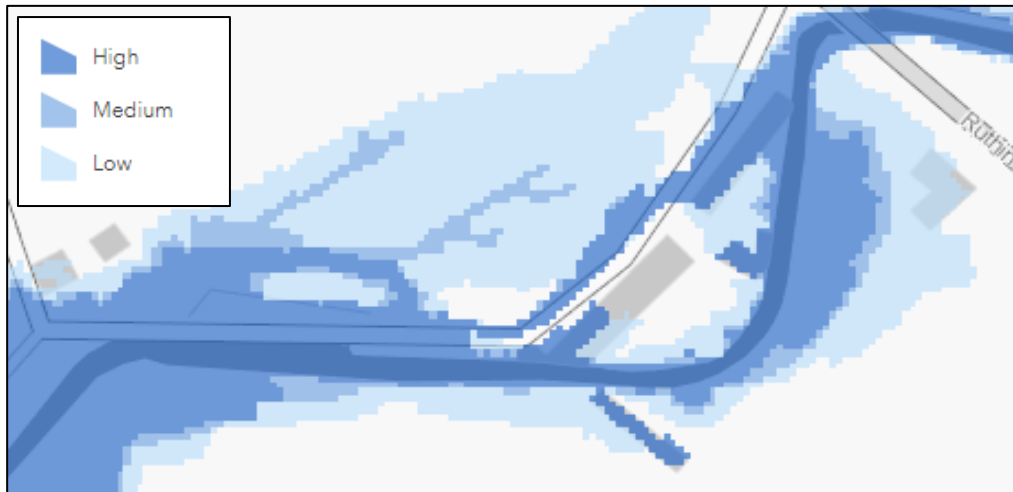
Figure 49: NRW Flood and Coastal Risk Maps for Rivers at Brookhouse

The NRW Flood and Coastal Risk Maps confirms that Brookhouse is at high risk of flooding from rivers, that is, the River Ystrad, as shown in figure 49

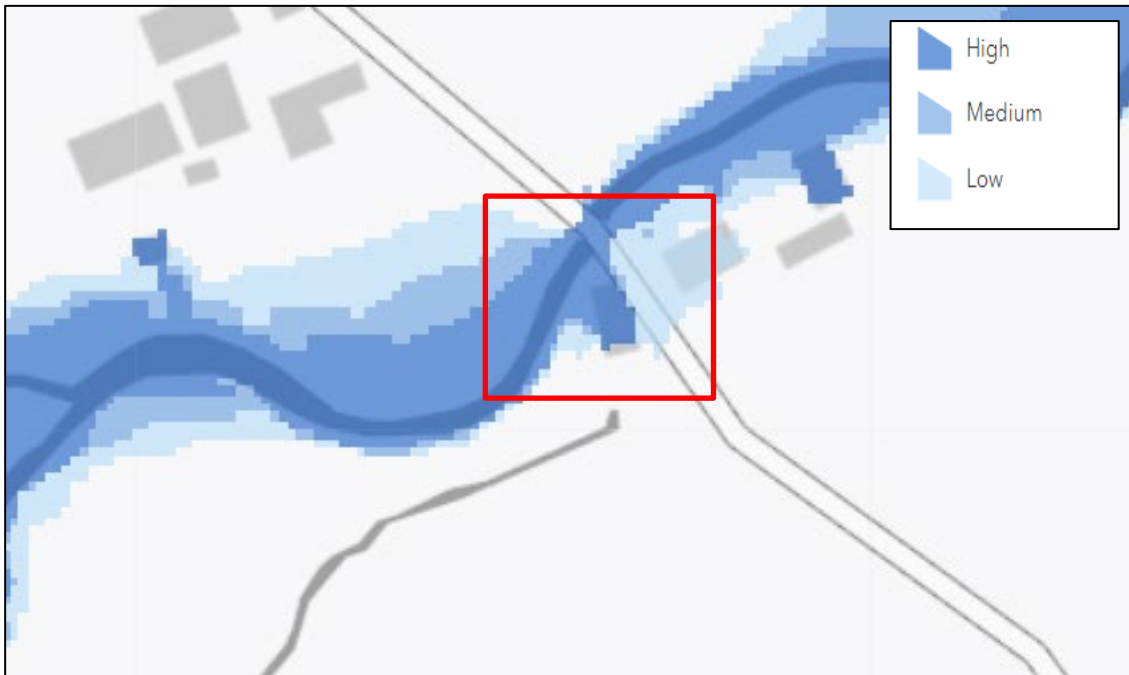
Figure 50: NRW Flood and Coastal Risk Maps for Rivers at Sergwyd Mill

The NRW Flood and Coastal Risk Maps puts the Mill at high risk from river flooding, as shown in figure 50 below.

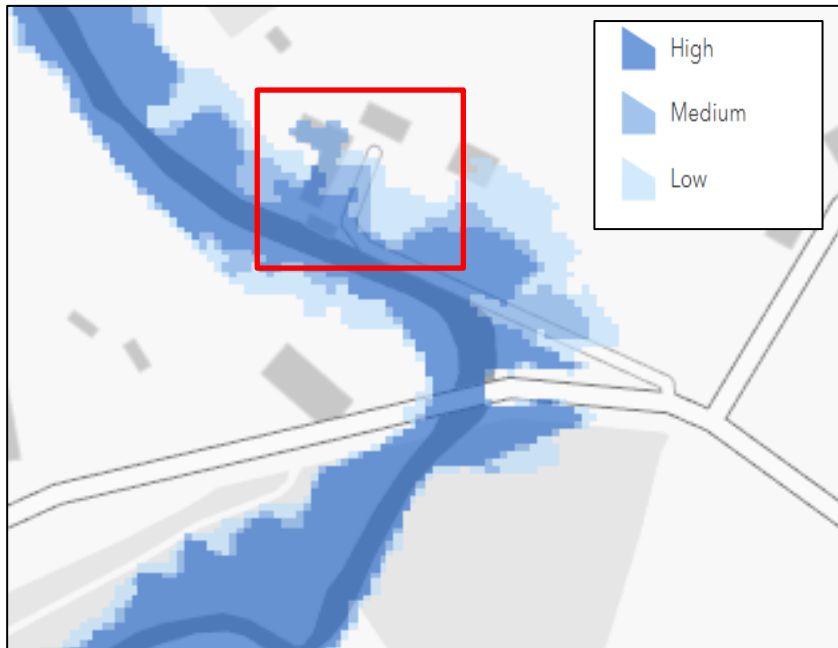
Figure 51: NRW Flood and Coastal Risk Maps for Rivers at Plas Isaf

The NRW Risk Maps for rivers, as shown in figure 51, has the effected Property at high risk from flooding.

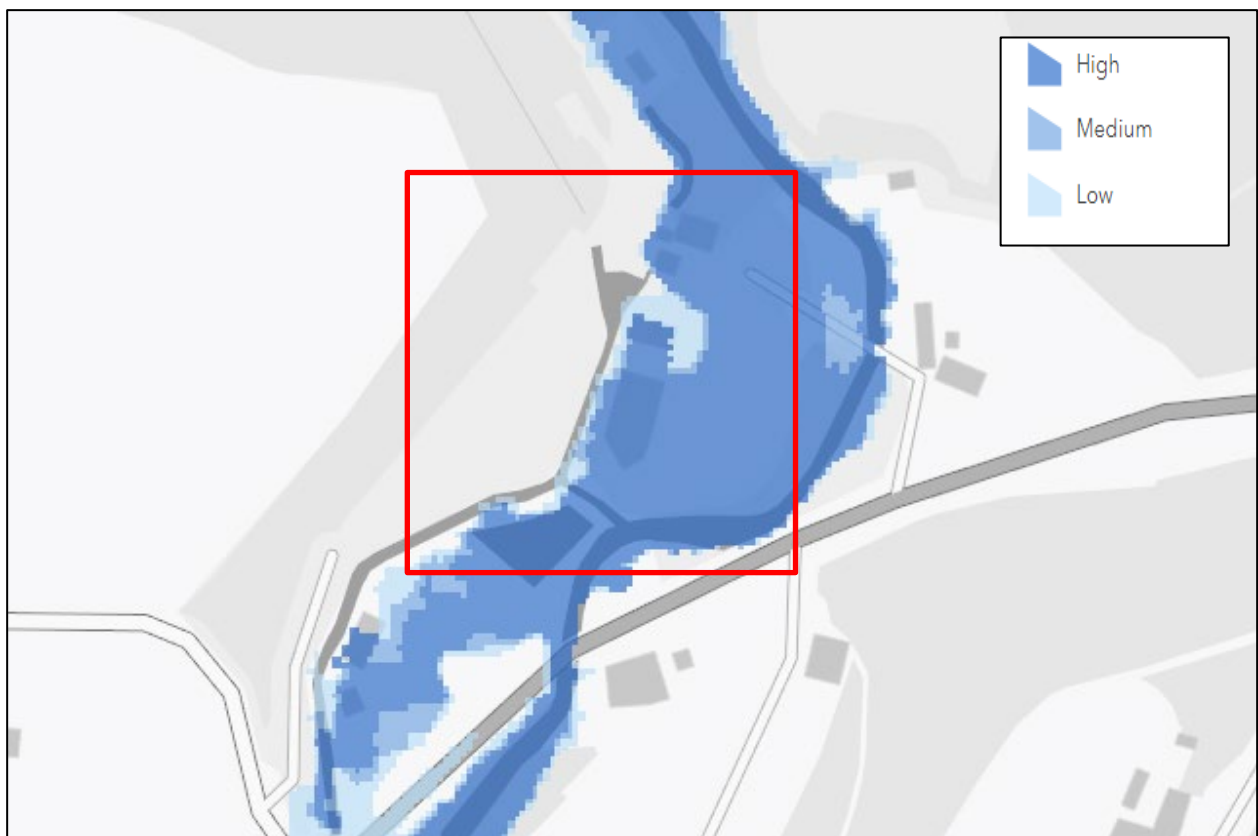
Figure 52: NRW Flood and Coastal Risk Maps for Rivers at Llogerheads Country Park

The NRW Flood and Coastal Risk Maps for rivers as shown in figure 52 below puts the investigatory area in the high risk bracket for flooding

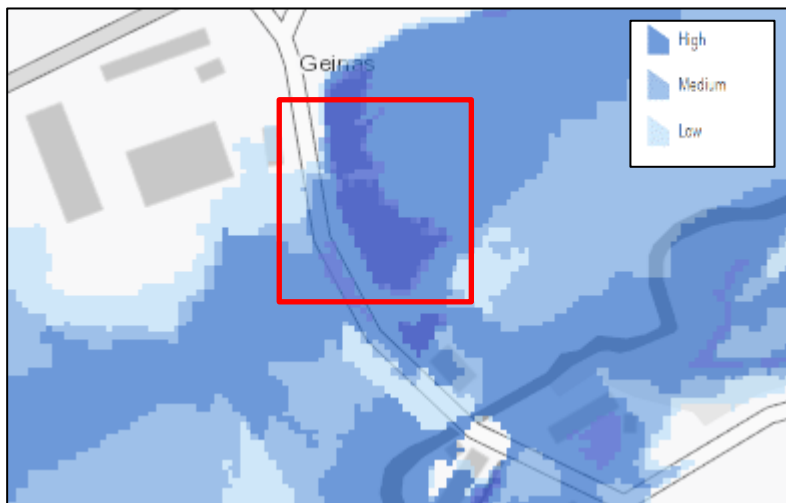
Figure 53: NRW Flood and Coastal Risk Maps for Rivers at Geinas, Aberwheeler

There is however a high risk that the Property could be flooded by the Main River known as the Afon Wheeler, which is located close by, as shown by figure 53 below
