SECTION 19 FLOOD INVESTIGATION REPORT

**20th OCTOBER 2023
FLOOD EVENT**

LOCATION: DENBIGHSHIRE

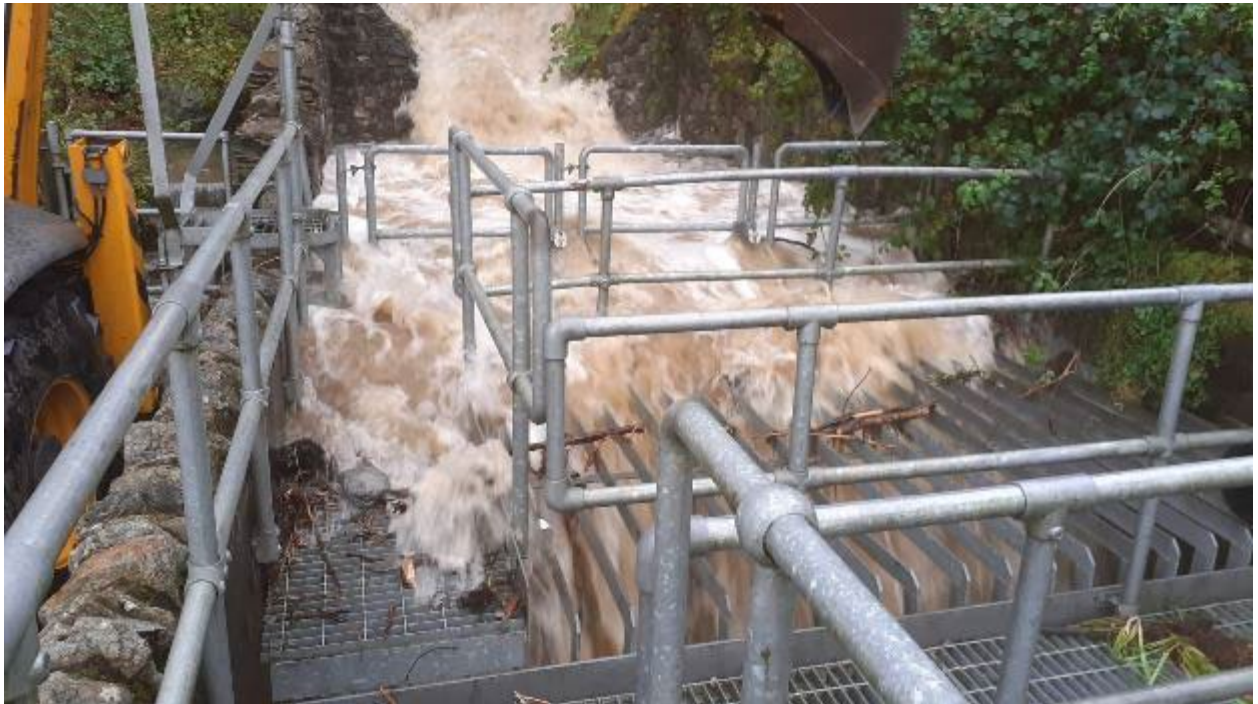
Photo 12: Flood Alleviation Culvert below Pen y Pigyn at Corwen during Storm Babet

A crew had to continually clear out the flood alleviation culvert below Pen y Pigyn for a number of hours on the morning of Storm Babet. Without this level of maintenance, a large proportion of Corwen Town would have been flooded by water over-topping the culvert. Photo 12 below shows the intensity of the water almost over-topping the flood alleviation culvert.

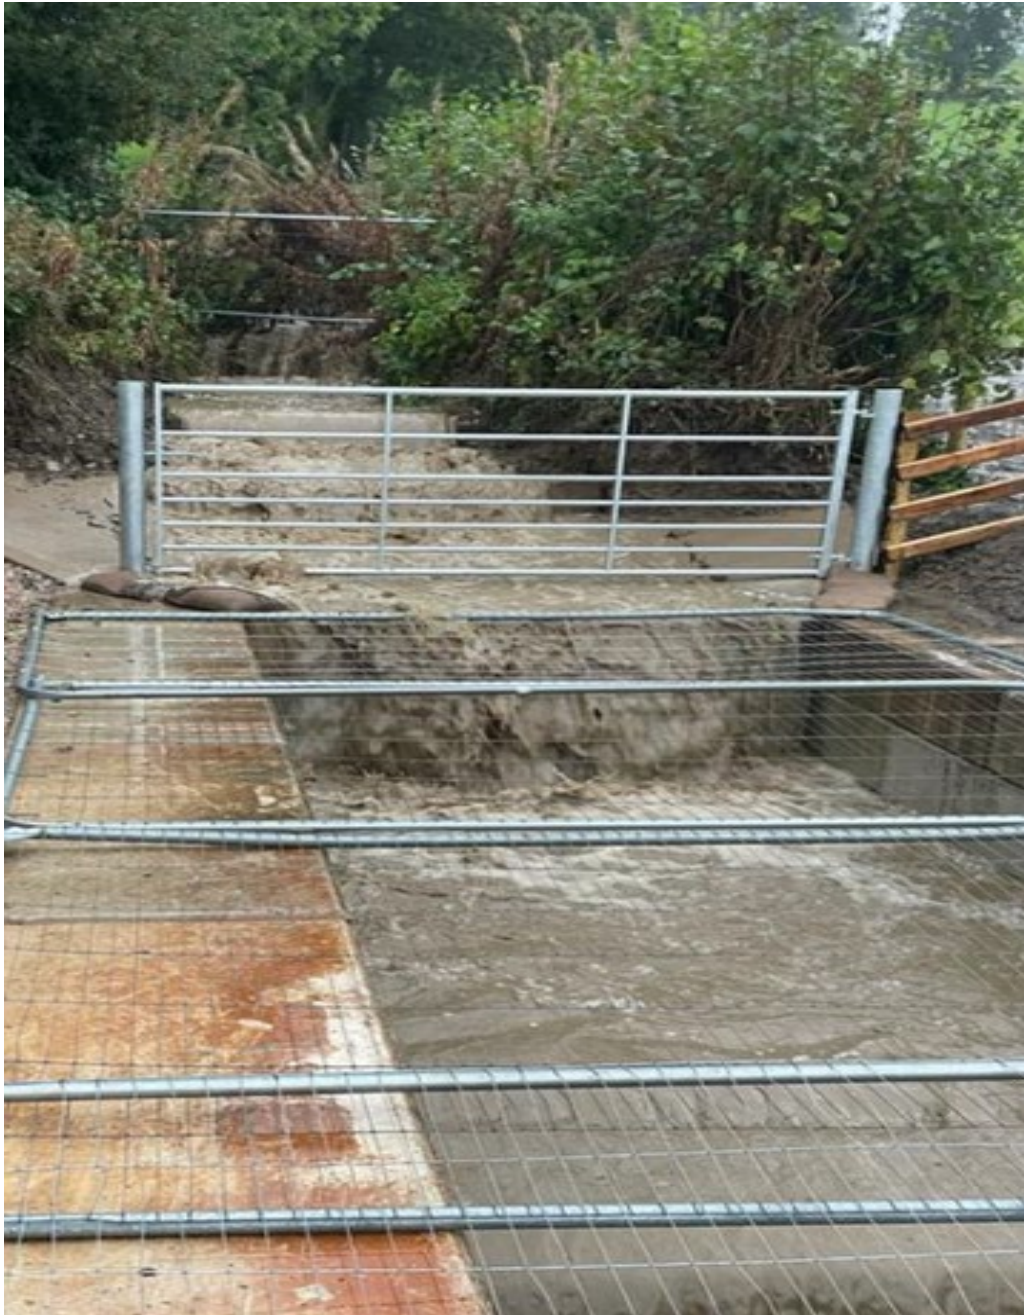
Photo 13: New culvert structure at Nantglyn Village during Storm Babet

The highway culvert within the Village, which historically overtops during storm events, flooding properties in the process, had just been replaced prior to Storm Babet. Its replacement came on the back of a recommendation in the Section 19 report for Storm Christophe in 2021, which caused flooding to a couple of properties within the Village. The new structure coped well during Storm Babet despite the torrential amount of water entering the inlet, as shown by photo 13 below.

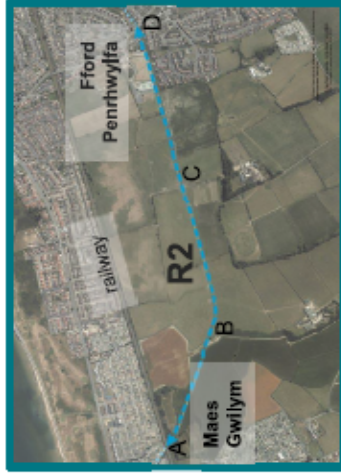
Rhyl Cut R2

Main River Flood Risk Summary	There is no significant flood risk to properties from Rhyl Cut but there is flooding of farmland, in particular to the south of the cut. Properties around Maes-Y-Gog and Lon Hedyn are at risk of flooding from Maes Gwilym (MG) drain.
Current River Condition	Rhyl Cut is currently in good (if unnatural) condition with channel clearance undertaken relatively frequently. There can be substantial invasive weed growth. There could be significant benefits if the river was restored to a more natural state. Maes Gwilym drain is currently in reasonably good condition, except for a culvert under the railway which is partially collapsed (see impact below).
Maintenance Impacts	Maintaining the Rhyl Cut in this reach has no significant impact on property flooding from the main river. Reducing maintenance will lead to some additional flooding of farmland to the south and north of the cut. Drainage could be affected by silt levels. Maes Gwilym drain channel vegetation and raised bed levels increase flood risk. Maes Gwilym drain railway culvert increases flood risk downstream and will therefore not be maintained.

NRW Maintenance Activity	Main Constraints	Frequency
channel vegetation and weed clearance	bird nesting, water vole habitat	Rhyl Cut: partial clearance 5 yearly or as required for silt clearance Maes Gwilym drain: partial clearance annually (Sep/Oct)
bankside tree and hedge management	bird nesting, bats	Rhyl Cut: 5 yearly or as required for silt clearance Maes Gwilym drain: annually (Jan/Feb)
channel blockage removal	biosecurity, hazardous waste	Rhyl Cut: not required (riparian responsibility) Maes Gwilym drain: reactively before heavy rain
<u>riverbed level management</u>	fish spawning, water vole habitat	annual monitoring (both watercourses)

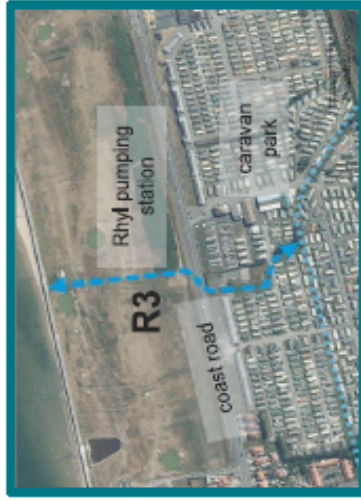
Rhyl Cut R3

Main River Flood Risk Summary	There is no significant risk of flooding from Rhyl Cut in this reach but high water levels could affect properties in reach R4. A few caravans are at risk of flooding during infrequent floods (above approximately 1 in 30 annual chance).
Current River Condition	The river is currently in good condition with channel clearance undertaken relatively frequently. The left hand bore of the Ash Grove culvert upstream is partially blocked but the culvert has spare capacity.
Maintenance Impacts	Rhyl Pumping Station will continue to be operated and maintained (subject to pumping station review and impact of set-back sea defences), as it reduces flood risk to a large area and lots of properties. Maintaining the river channel in this reach has minimal impact on main river flooding but some clearance is required for Rhyl pumping station to operate effectively. Drainage could also be affected by silt levels.

NRW Maintenance Activity	Main Constraints	Frequency
channel vegetation and weed clearance	bird nesting, water vole habitat	partial clearance annually (Sep/Oct)
channel blockage removal	biosecurity, hazardous waste	reactively before heavy rain
Rhyl Pumping Station debris screen clearance	biosecurity, hazardous waste	weekly and before heavy rain
<u>riverbed level management</u>	fish spawning, water vole habitat	annual monitoring

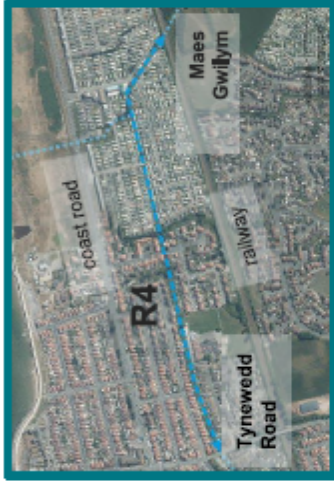
This reach of Rhyl Cut and Fron Hall drain are in fair condition but there has been siltation between Tynewydd Road and Brynheddyd Road which requires clearance. Maintenance is difficult due to poor access in some locations along both watercourses.

Maintaining conveyance along this reach of Rhyl Cut slightly reduces the extent of flooding and reduces peak water levels, which may benefit incoming drainage; drainage could also be affected by silt levels. Channel vegetation and raised bed levels along Fron Hall drain increases flood risk.

NRW Maintenance Activity	Main Constraints	Frequency
channel vegetation and weed clearance	access, bird nesting, water vole habitat	Railway Culvert to Fron Hall drain: partial clearance annually (Sep/Oct) Fron Hall drain to Tynewydd Road: twice annually (Jun/Jul and Sep/Oct)
bankside tree and hedge management	access, bird nesting, bats	Rhyl Cut and Fron Hall drain: annually (Jan/Feb)
channel blockage removal	access, biosecurity, hazardous waste	Rhyl Cut and Fron Hall drain: reactively before heavy rain
riverbed level management	access, fish spawning, water vole habitat	Rhyl Cut and Fron Hall drain: annual monitoring (clearance currently required)
